PROPERTY INSPECTION REPORT

805 Eastbrook Court, Danville, CA 94506

DATE OF INSPECTION: 1/1/2025

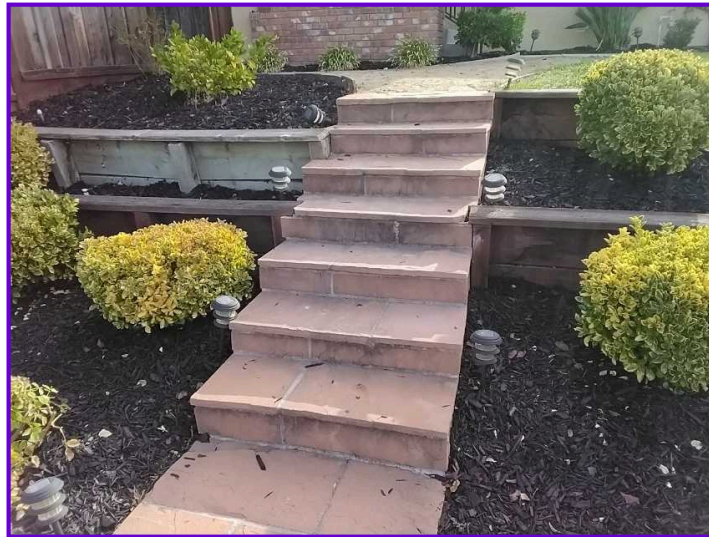
COMMENTS: The detached steps located at the side of the property were functional and in satisfactory condition.

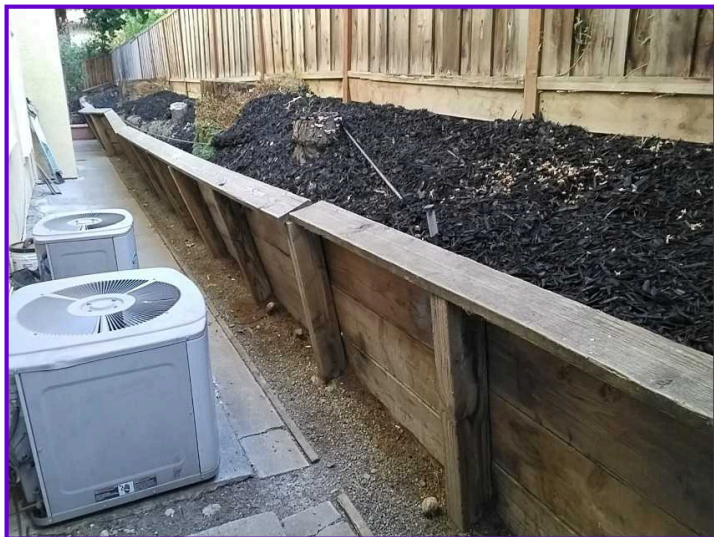
- **MONITOR:** The retaining wall at the side of the property has questionable or unknown structural value as a retaining wall in that it is not engineered as would normally be required for a wall over four feet high and will therefore need to be periodically monitored for movement/failure. These types of walls are far more prone to failure than walls that are engineered, and we cannot endorse them.

MONITOR: The retaining wall at the side of the property has questionable or unknown structural value.

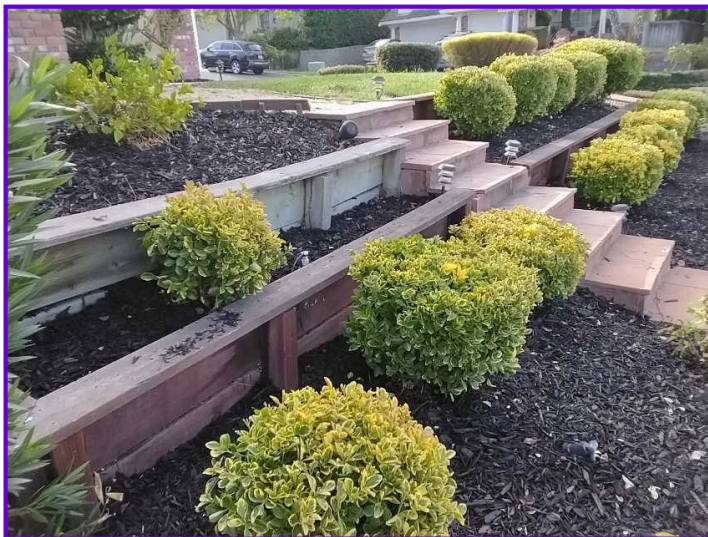
COMMENTS: The retaining walls in the front of the home appear to be functional and displayed no evidence of failure or damage.

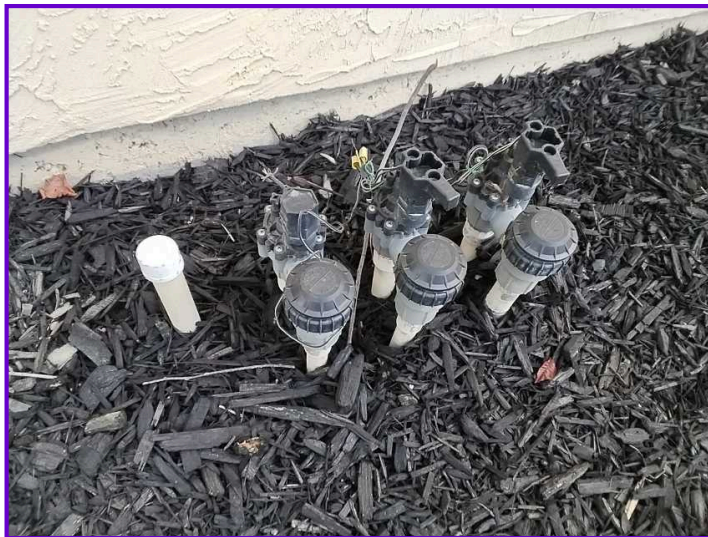
DEFERRED: The property is equipped with an automated watering system.

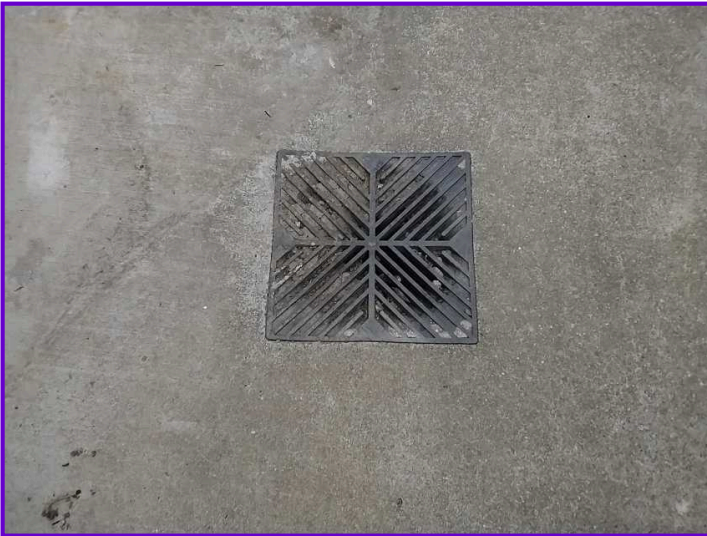
PREVENTIVE: There are area drains on the property.

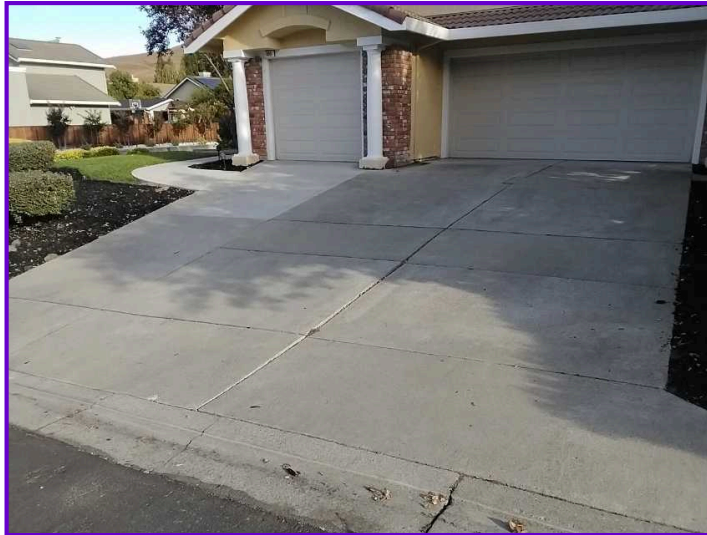
COMMENTS: The concrete driveway is functional but has some minor cracks.

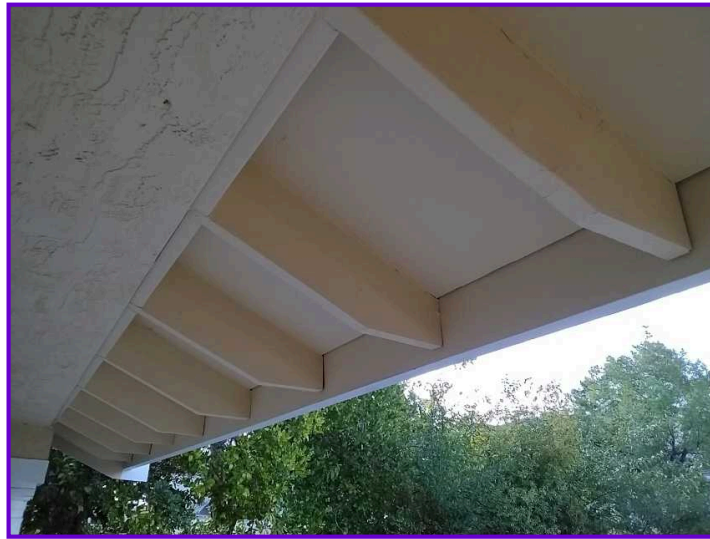
COMMENTS: The eaves and soffits appear to be in functional condition.

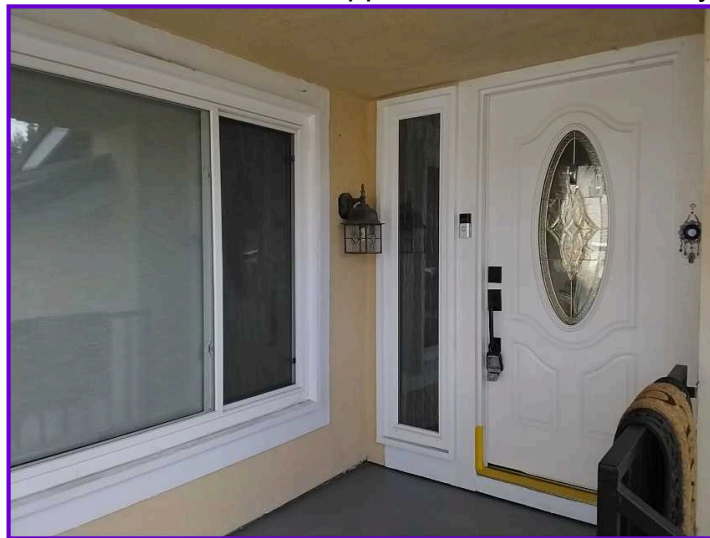
COMMENTS: The door and window exteriors appear to be in satisfactory condition.

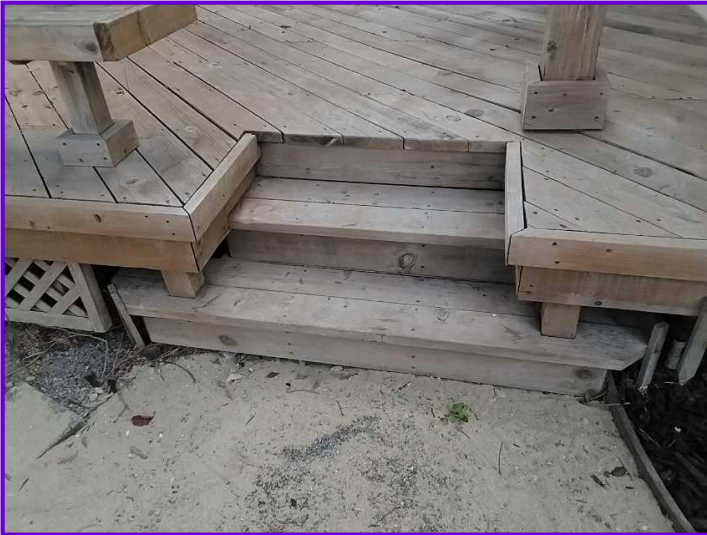
COMMENTS: The attached stairs and landing at the rear of the residence are in satisfactory condition.

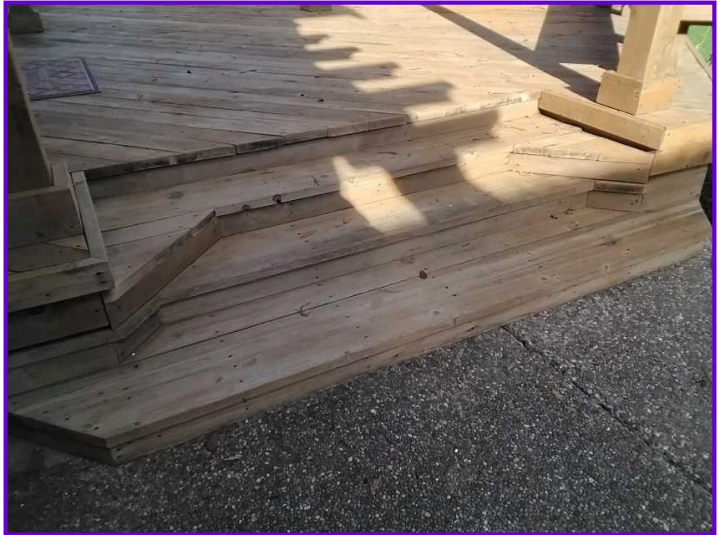
COMMENTS: The attached stairs at the rear of the residence are in satisfactory condition.

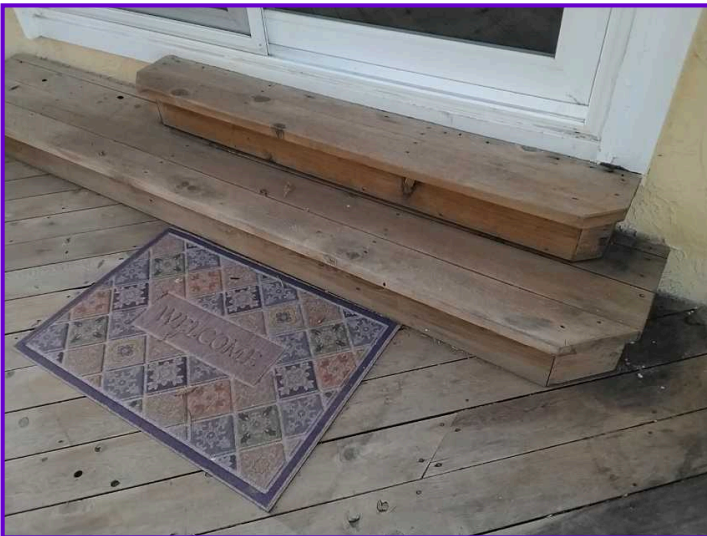
COMMENTS: The attached stairs at the rear of the residence are in satisfactory condition.

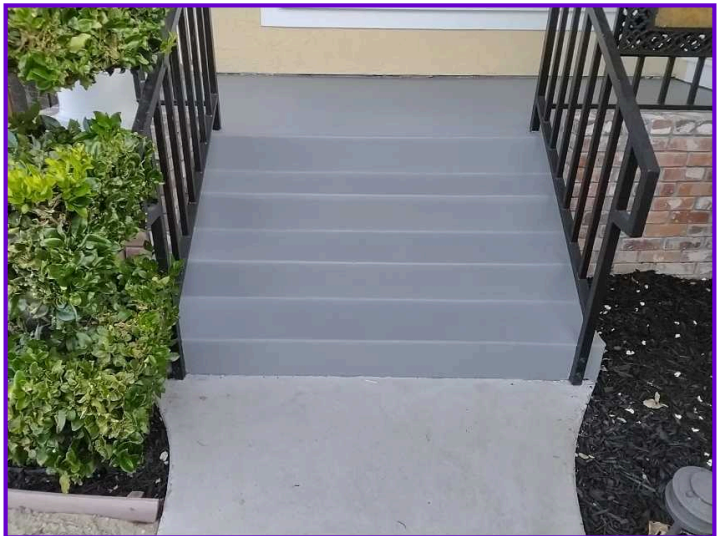
COMMENTS: The attached stairs at the front of the residence are in satisfactory condition.

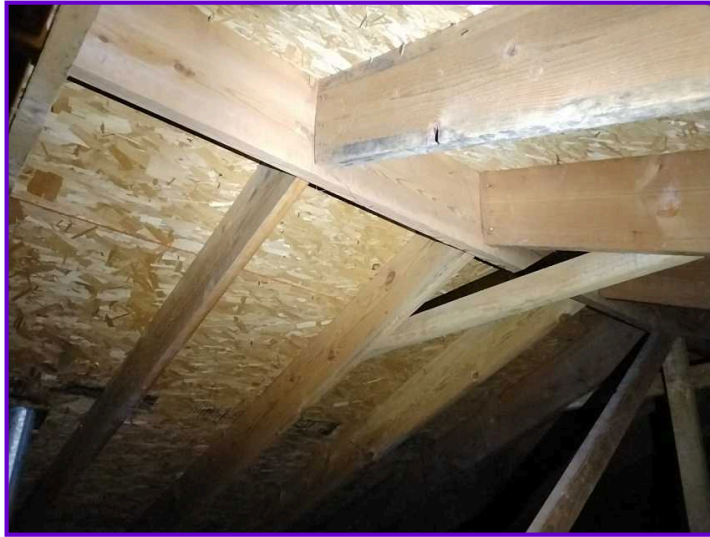
COMMENTS: The ceiling and roof structure appeared functional.

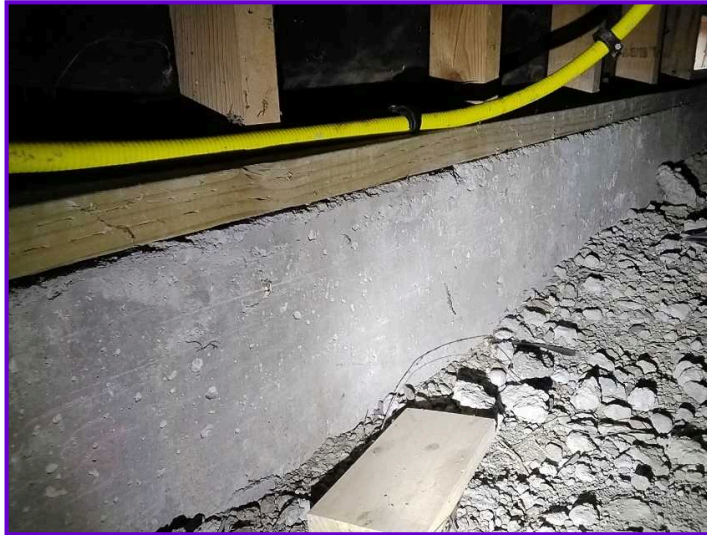
COMMENTS: The poured concrete foundation walls appear to be functional.

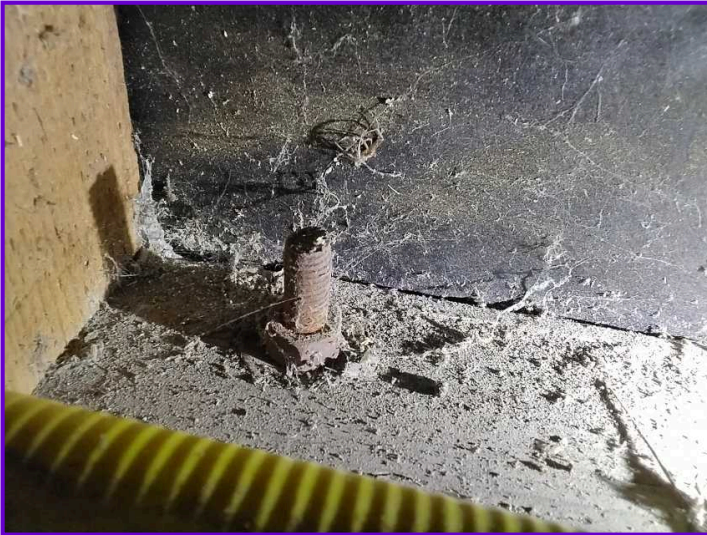
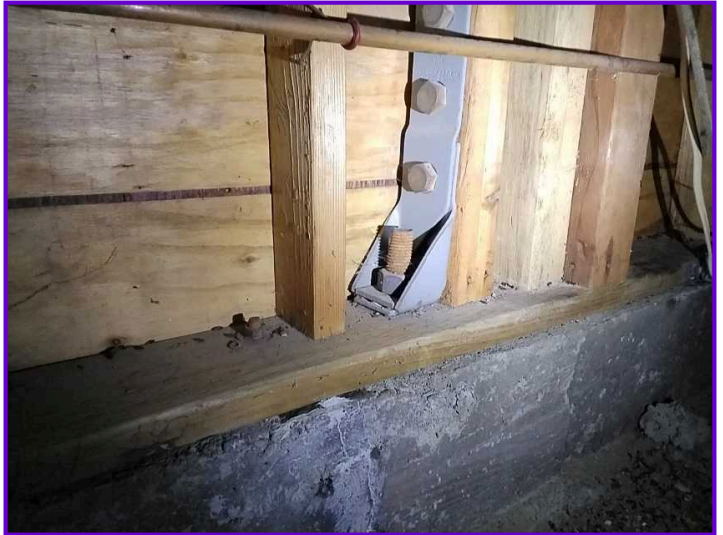
COMMENTS: Bolting of the framing sill plates to the foundation concrete stem walls was observed under the residence.

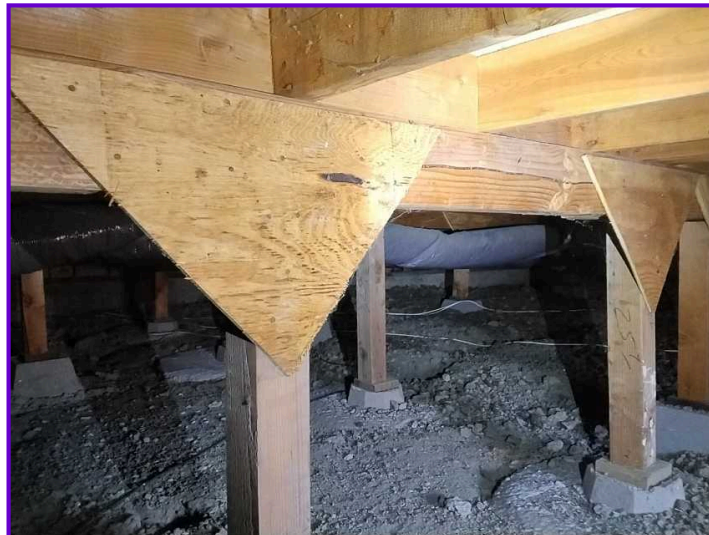
COMMENTS: The foundation has been retro-fit with brackets and braces for additional seismic strengthening.

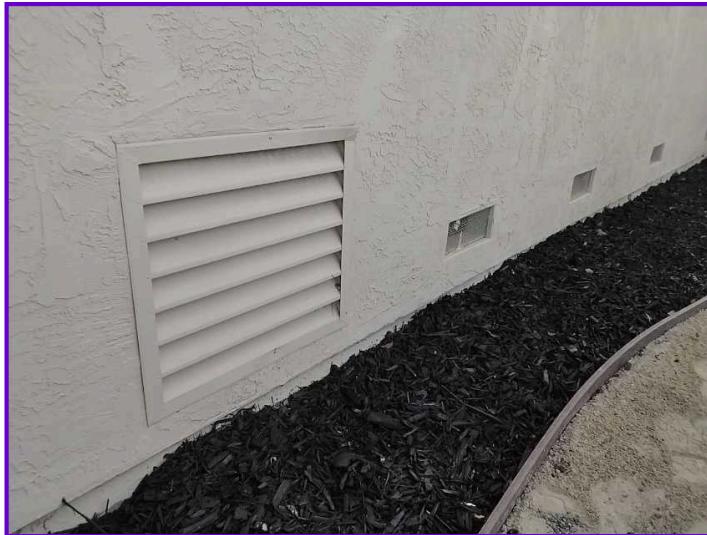
COMMENTS: Ventilation of the foundation crawlspace appears conventional and should be sufficient.

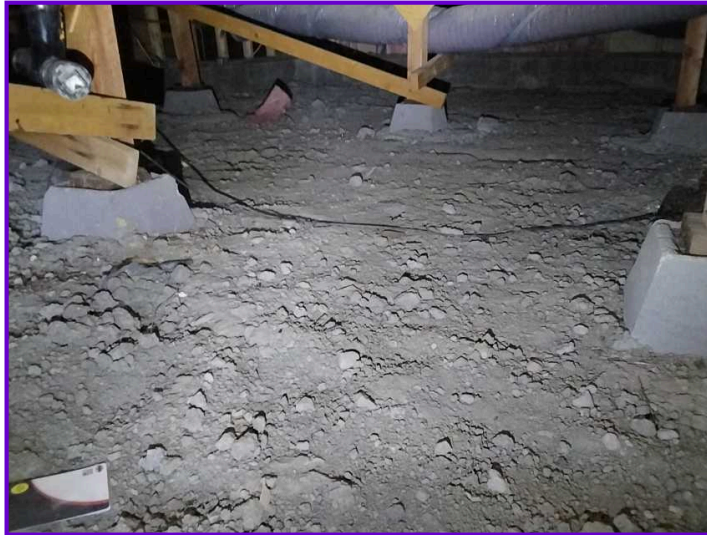
COMMENTS: There was no visible evidence of excessive moisture penetration of the underfloor areas observed at the time of the inspection.

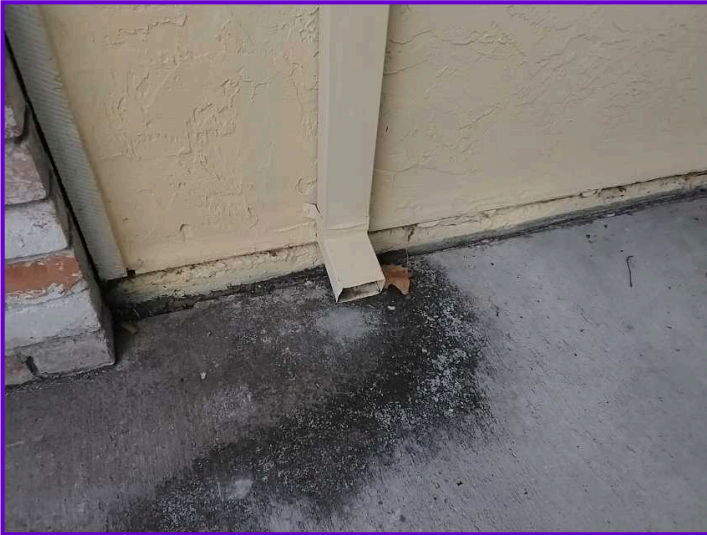
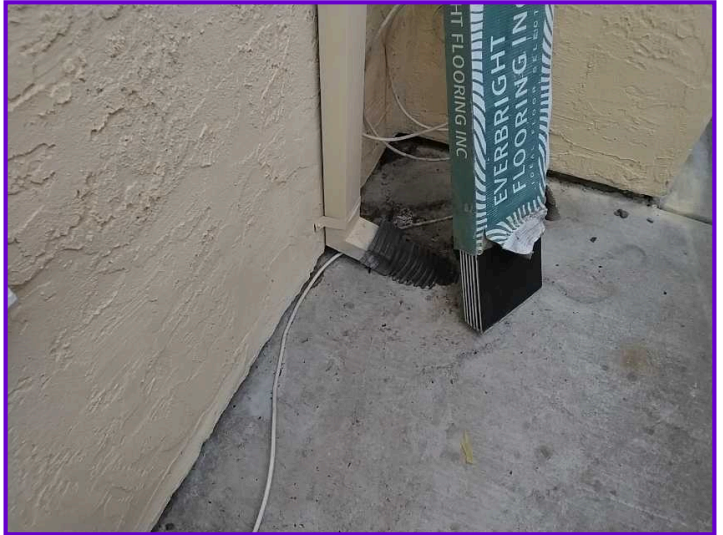
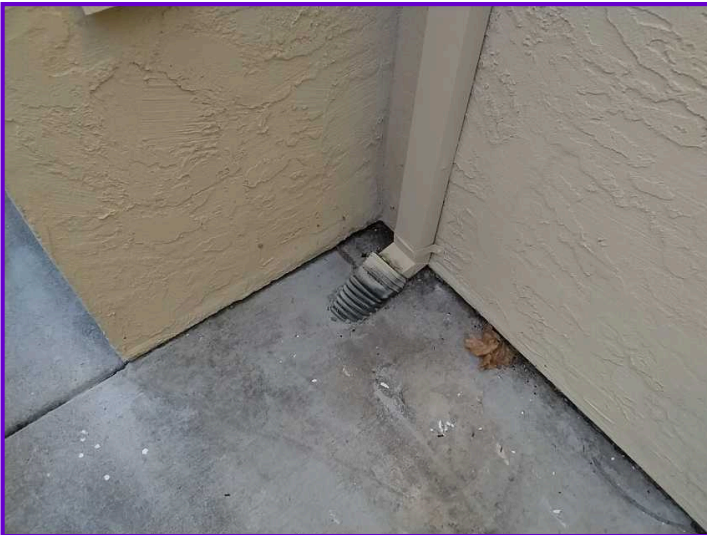
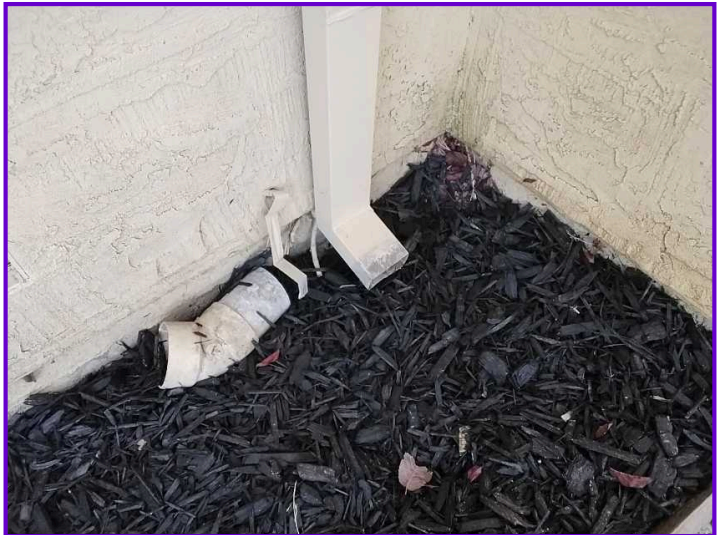
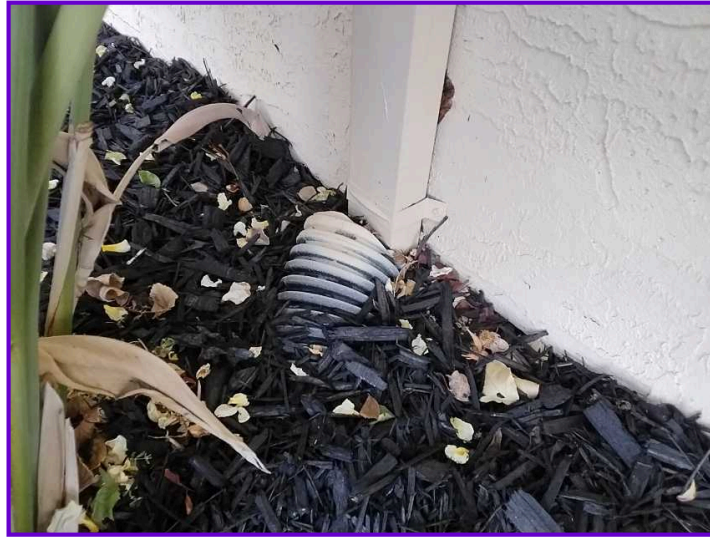
COMMENTS: The downspouts appeared to be clear and in satisfactory condition.

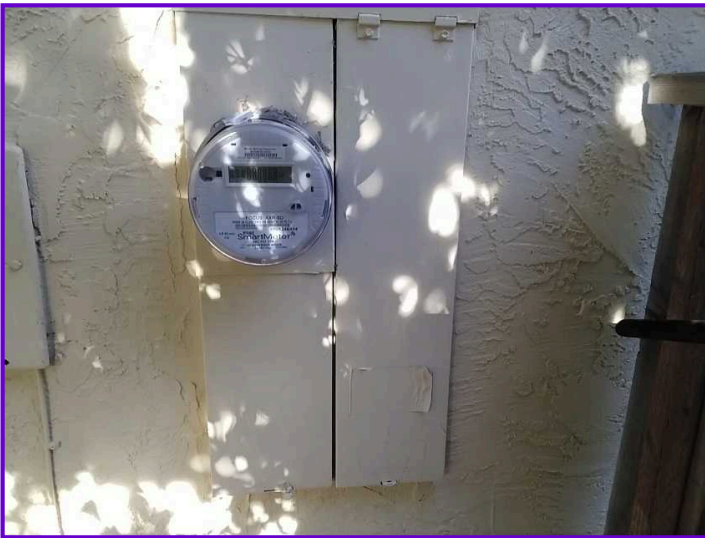
COMMENTS: The exterior cover at the main panel appears functional.

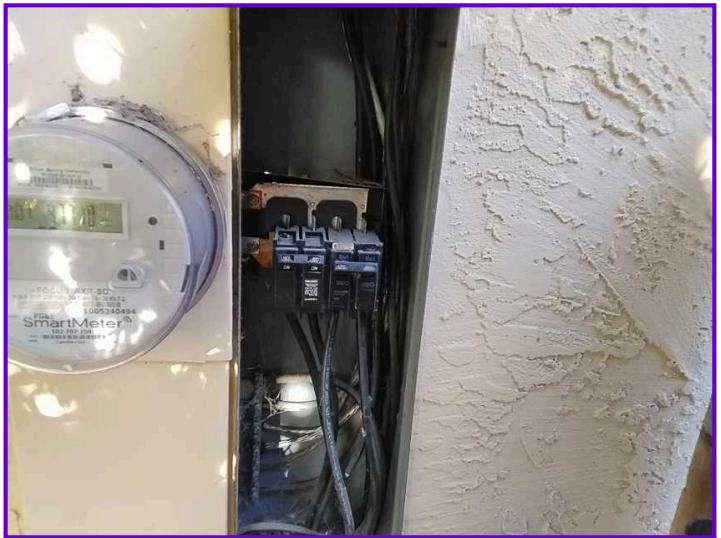
PREVENTIVE: The interior cover for the main electrical panel is missing.

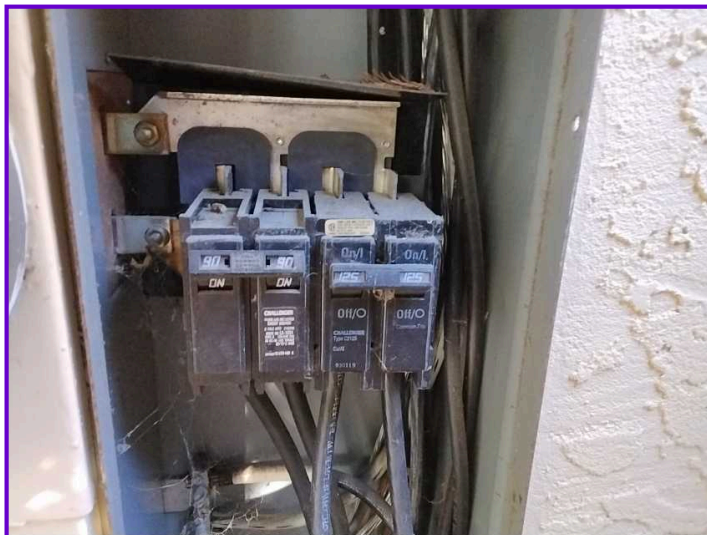
COMMENTS: There were no visible deficiencies with the circuit breakers in the main electrical panel.

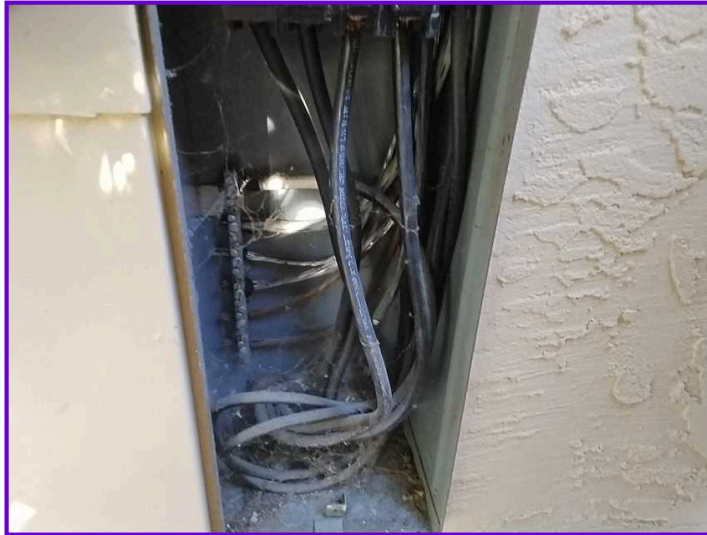
COMMENTS: We observed no deficiencies at the visible and accessible branch circuit wiring within the main panel.

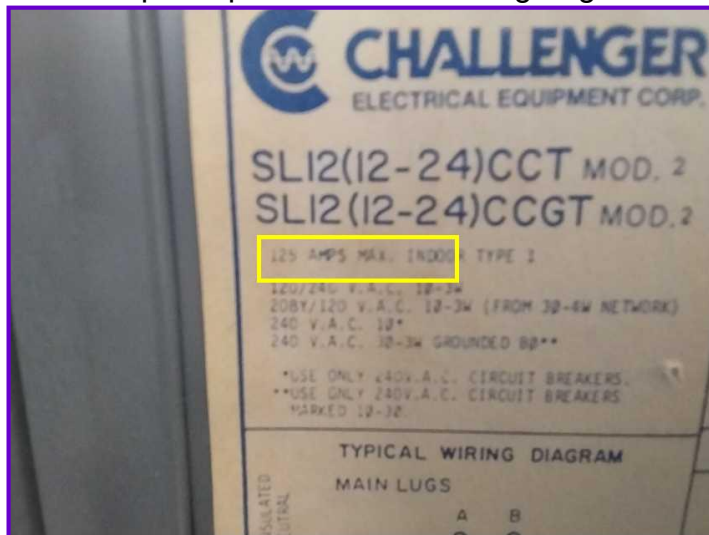
COMMENTS: There is a 125 amp sub panel located in the garage.

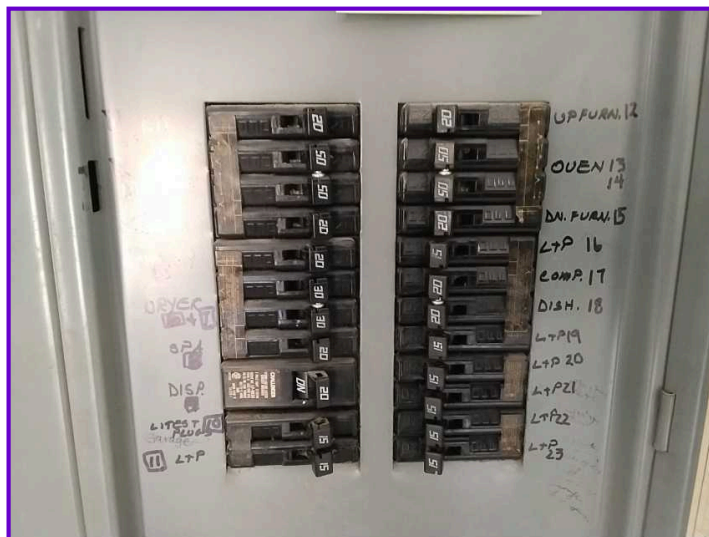
COMMENTS: There were no visible deficiencies with the circuit breakers in the sub panel.

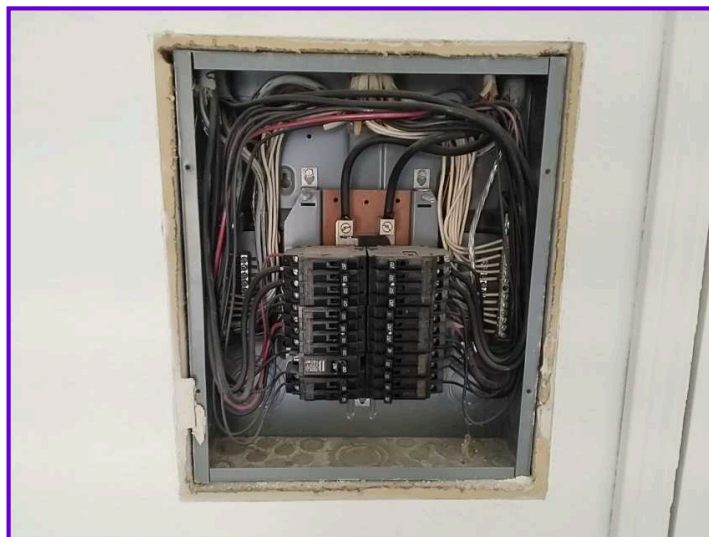
COMMENTS: We observed no deficiencies at the visible and accessible branch circuit wiring within the sub panel.

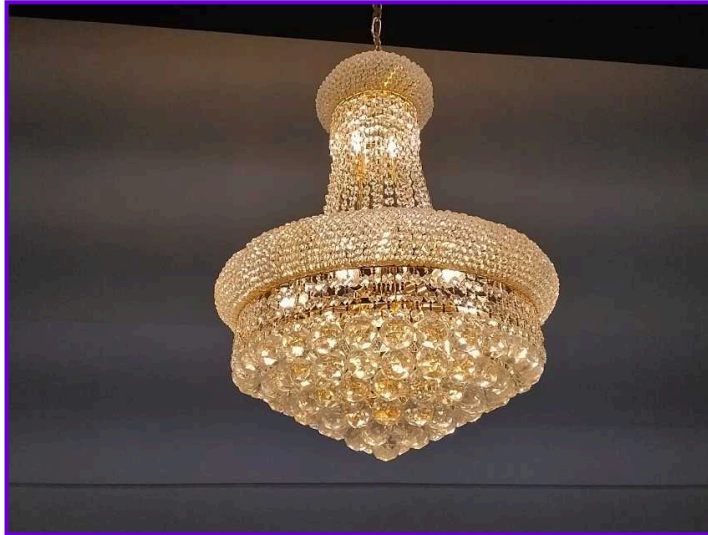
COMMENTS: The tested interior light fixtures were functional unless otherwise noted.

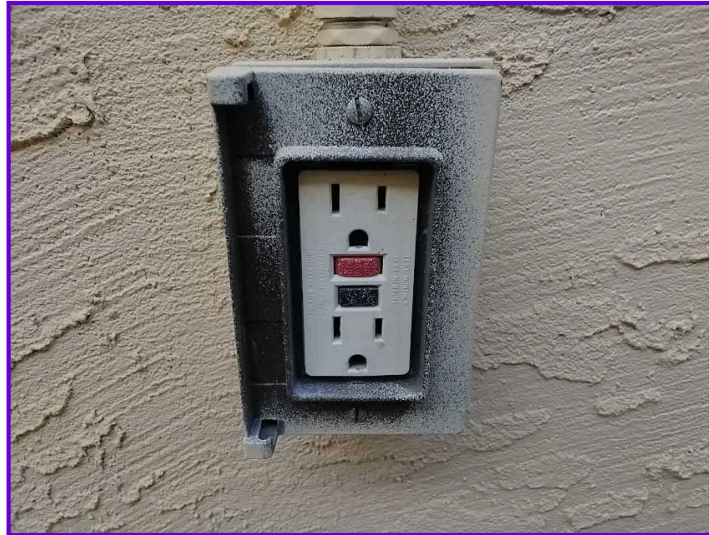
SAFETY: There is an outlet at the exterior of the residence that need to be fitted with waterproof cover.

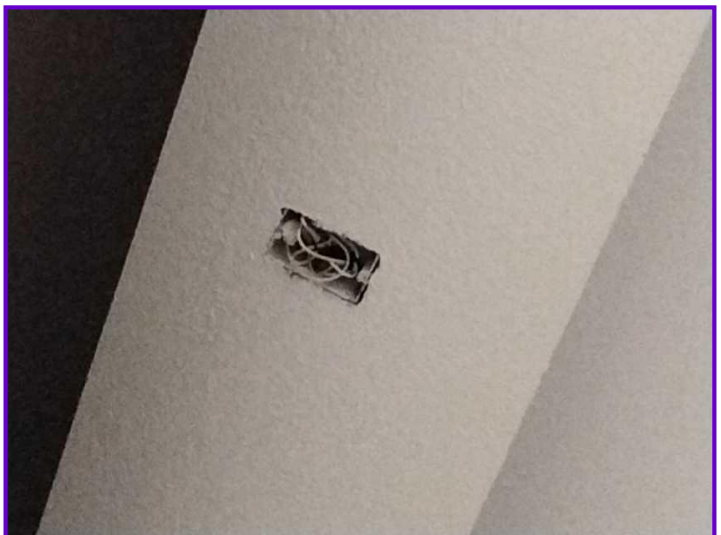
CAUTION: There are missing outlet covers that need to be replaced for safety reasons.

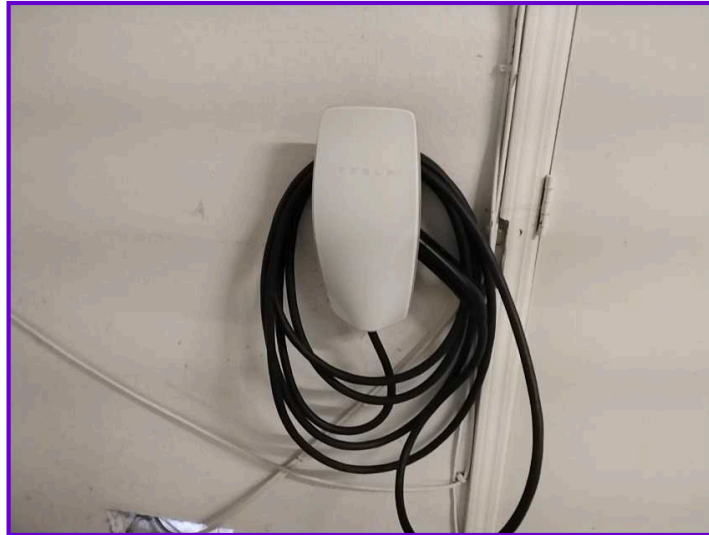
DEFERRED: The electrical system includes an electric vehicle charger (EVC) located in the garage.

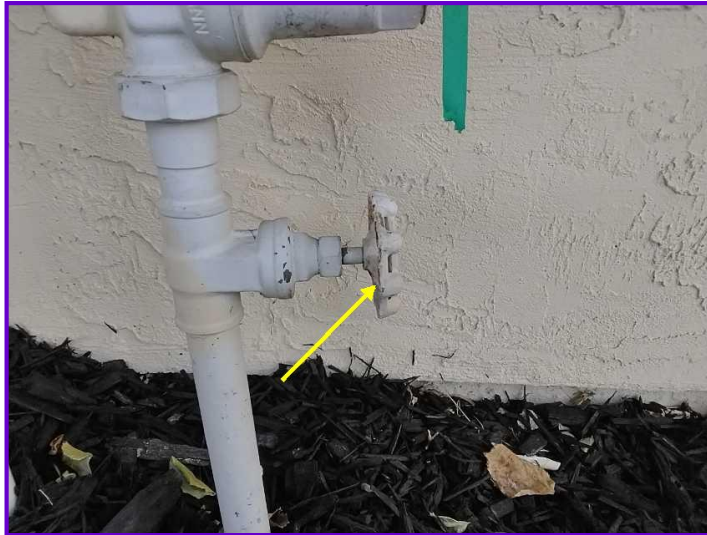
COMMENTS: The main water shut-off valve handle was in satisfactory condition.

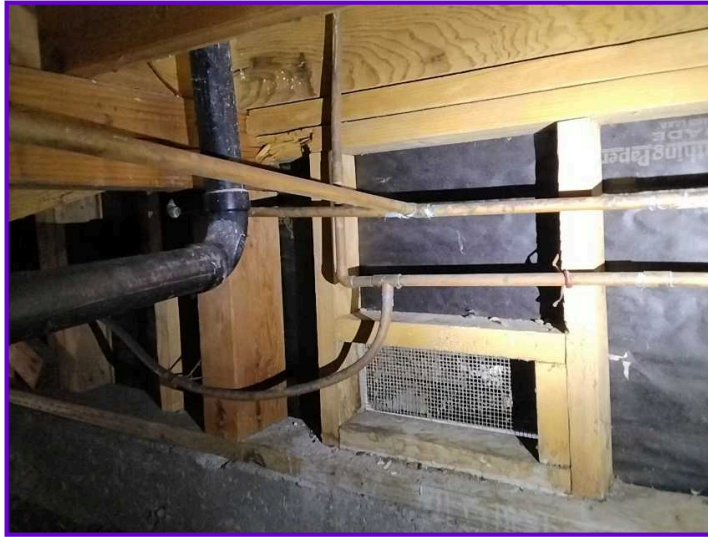
COMMENTS: The potable water pipes, where visible, are copper and appear to be in satisfactory condition.

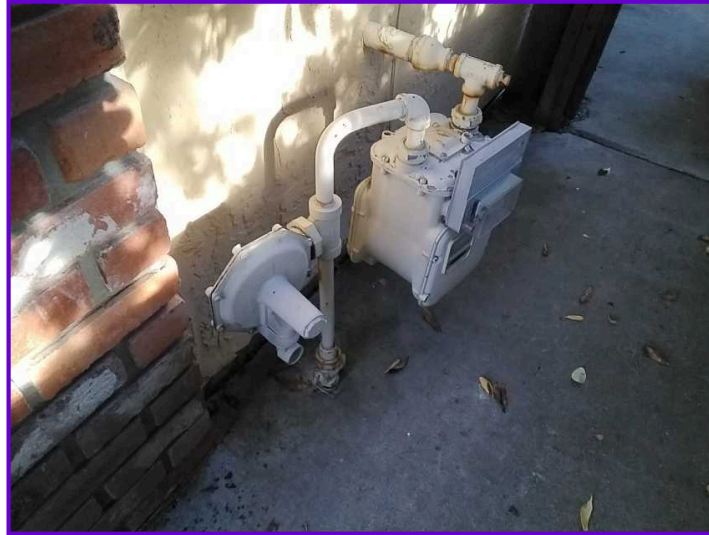
COMMENTS: The gas meter appeared to be in satisfactory condition and is located towards the front of the residence.

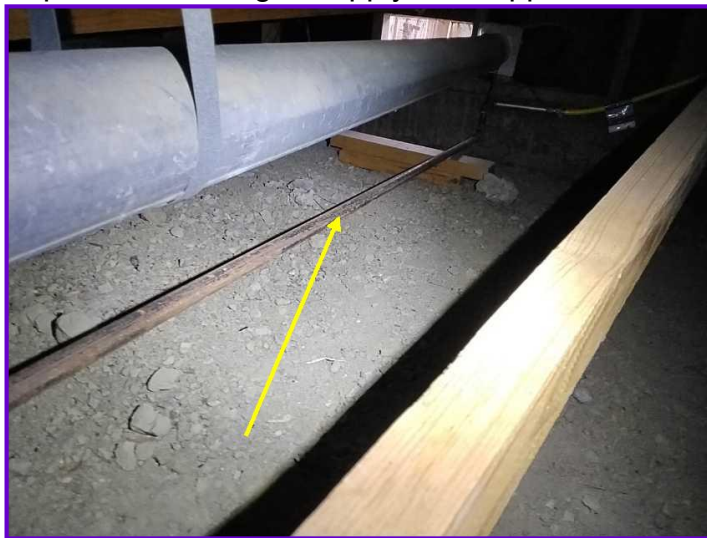
COMMENTS: The visible portions of the gas supply lines appear to be in satisfactory condition.

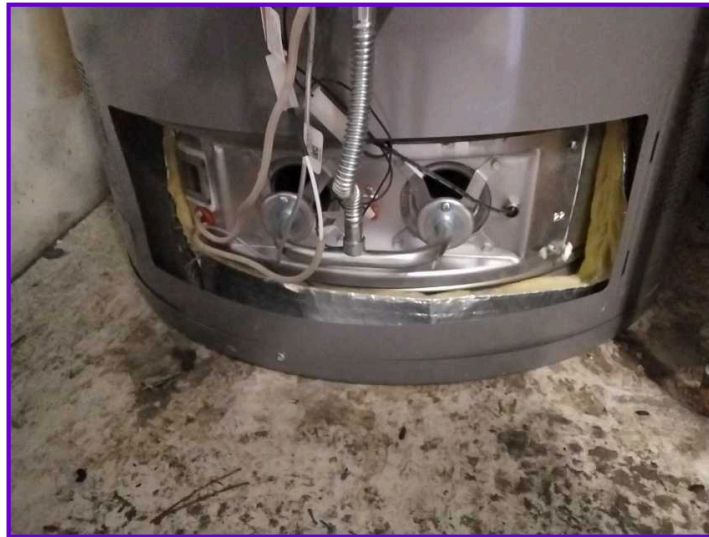
COMMENTS: The combustion chamber is free of leakage and excessive rust or corrosion.

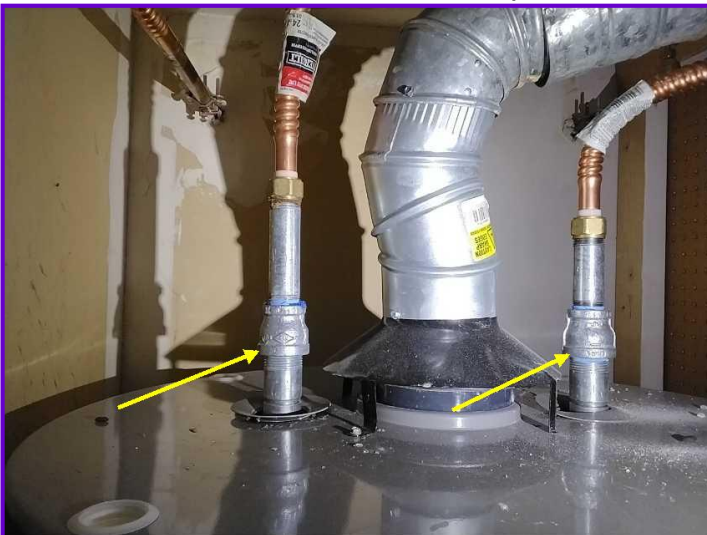
COMMENTS: The water supply lines and connectors appeared to be in satisfactory condition.

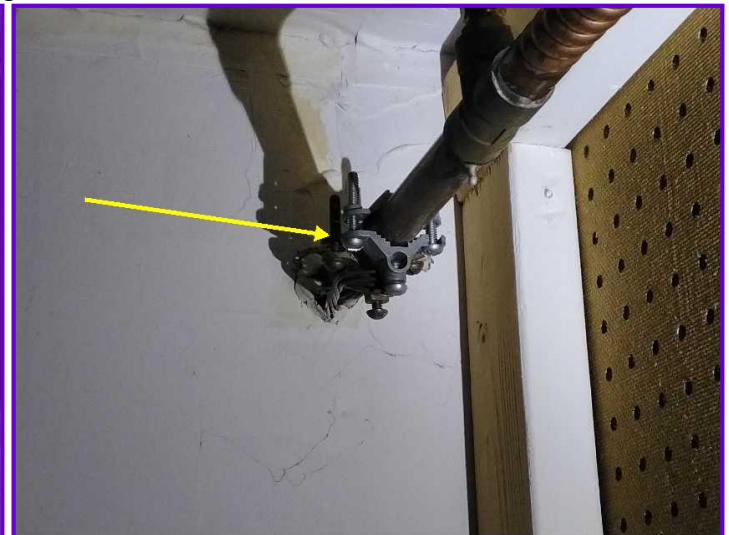
COMMENTS: The supply lines at the water heater are properly bonded.

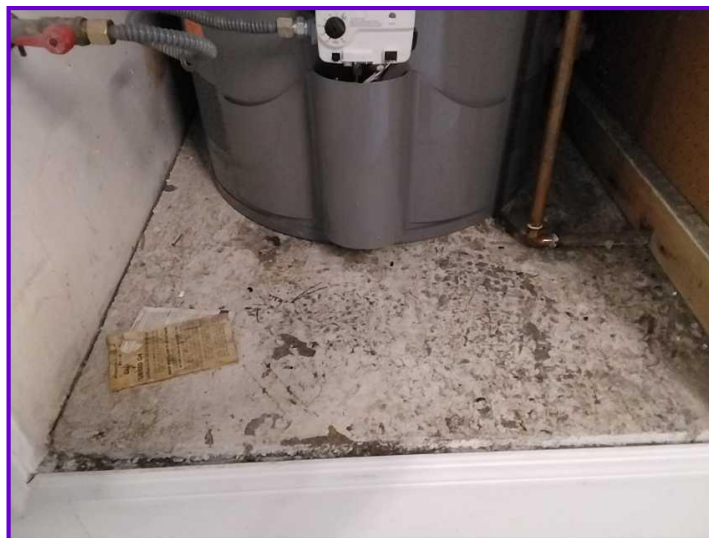
PREVENTIVE: The water heater was not equipped with a drip pan.

- **PREVENTIVE:** The water heater was not equipped with a drip pan or overflow pipe to minimize water damage from a leak. You may wish to install a drip pan and overflow pipe as a preventative measure.

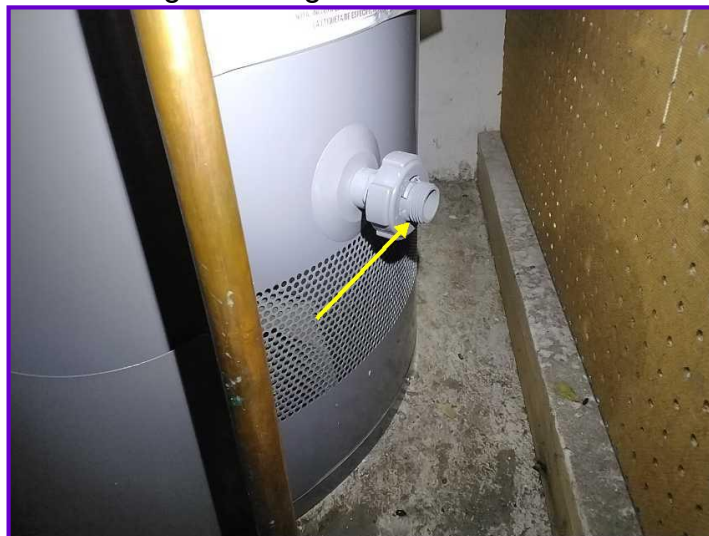
COMMENTS: A drain valve was installed on the water heater.

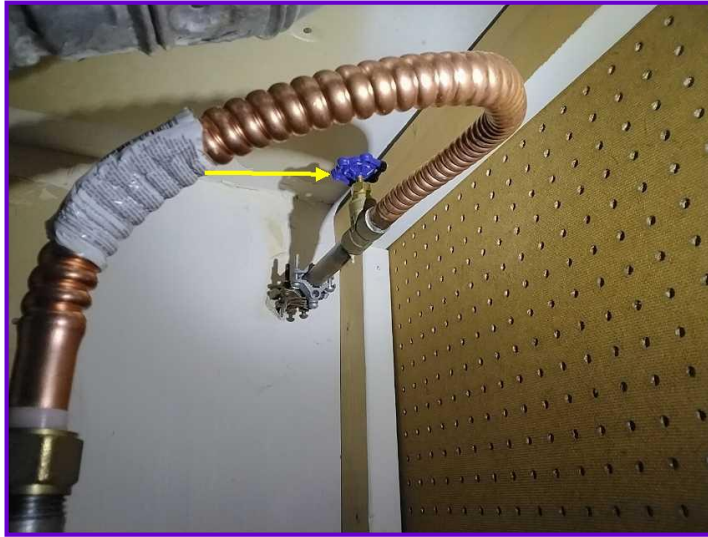
COMMENTS: The shut-off valve and water line connectors on the water heater appeared functional.

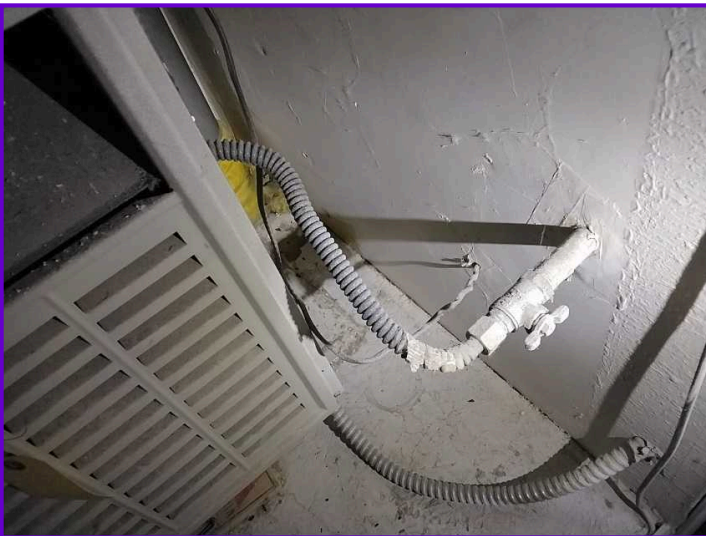
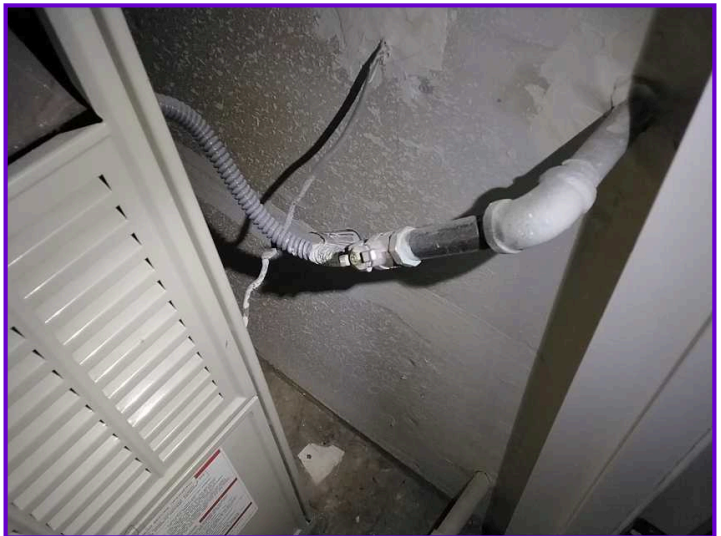
COMMENTS: The gas valve, connector and flexible gas feed line appear to be in satisfactory condition.

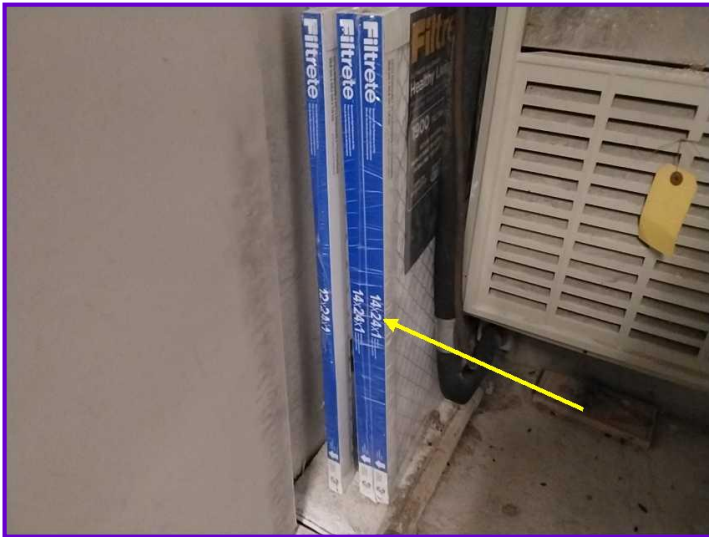
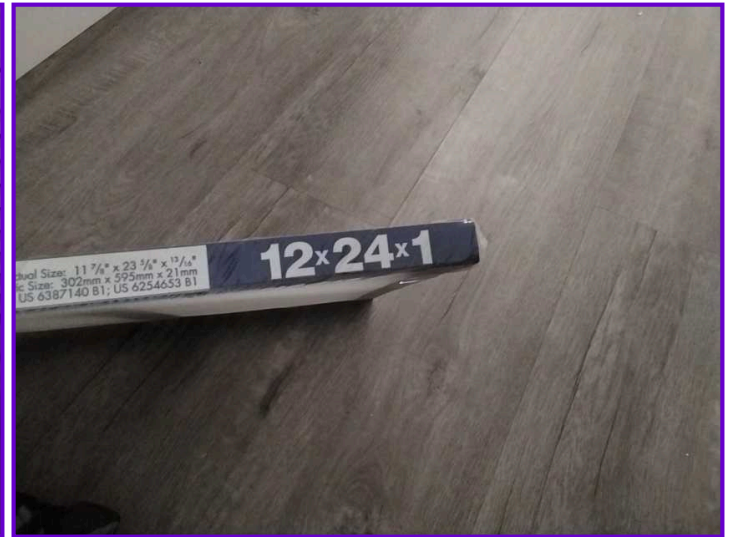
PREVENTIVE: Depending on filter type, it is important to replace or clean the filter every two or three months.

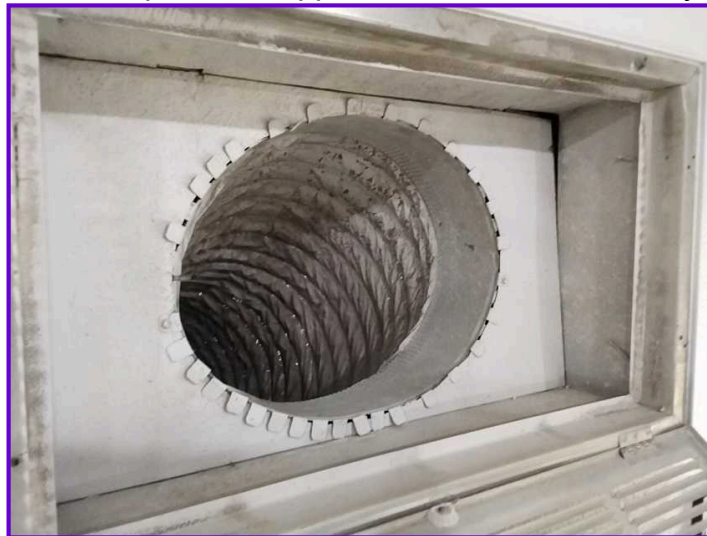
COMMENTS: The return air compartment appeared to be in satisfactory condition.

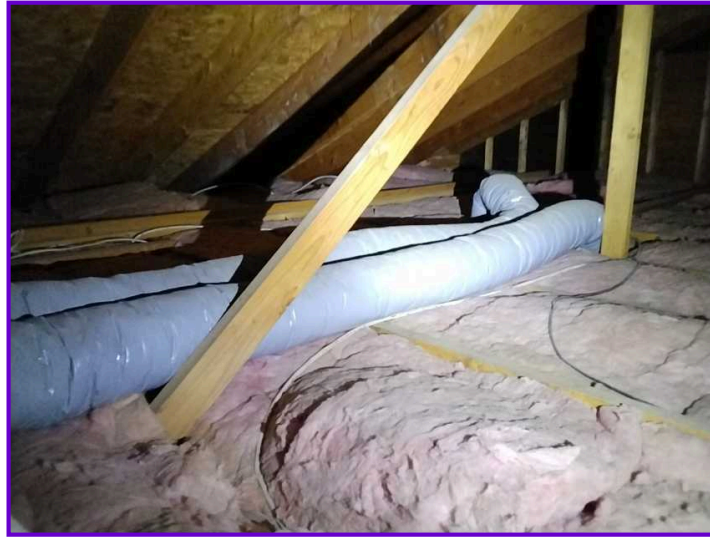
COMMENTS: Where visible and accessible, the supply ducts were in satisfactory condition.

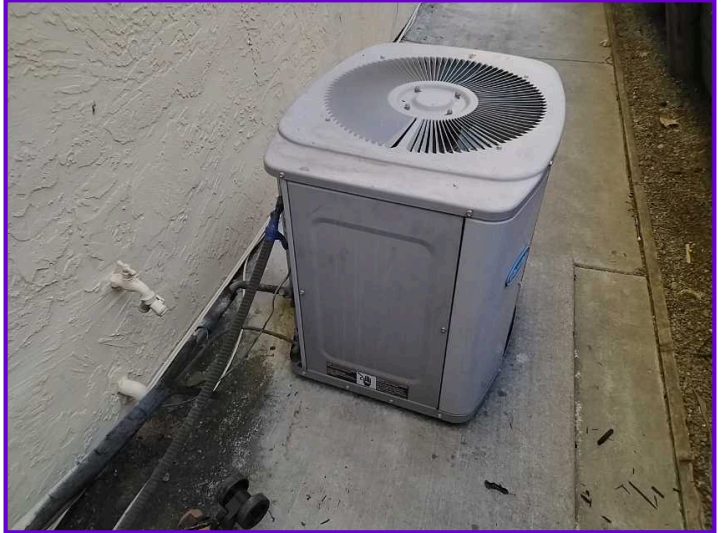
COMMENTS: All secondary condenser system components appeared to be functional and in satisfactory condition.

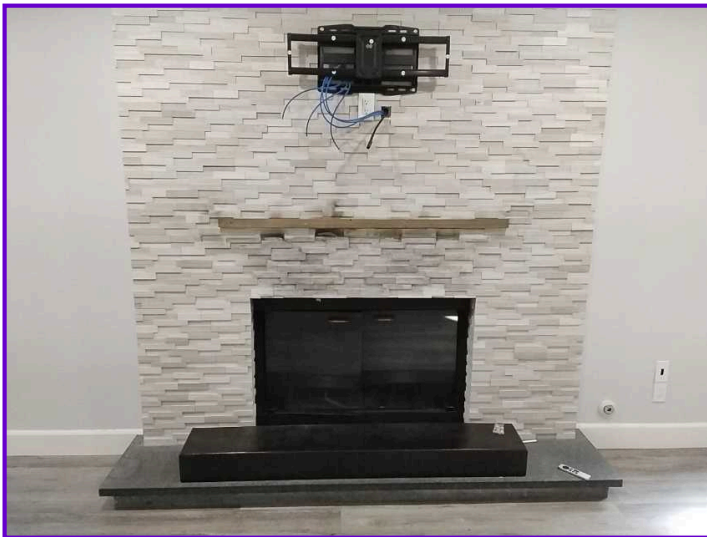
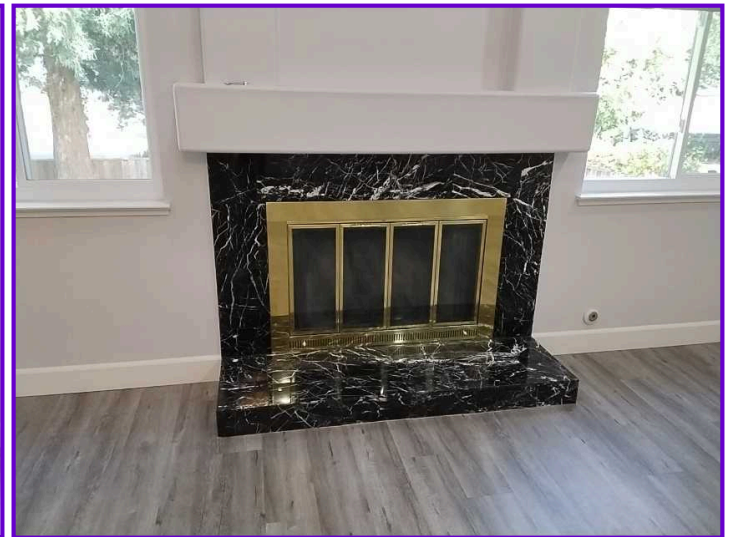
COMMENTS: The masonry fireplace appears to have no visible defects.

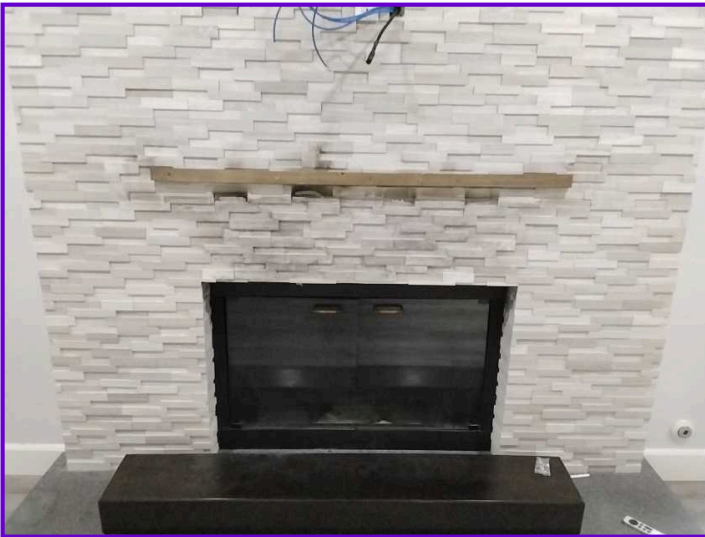
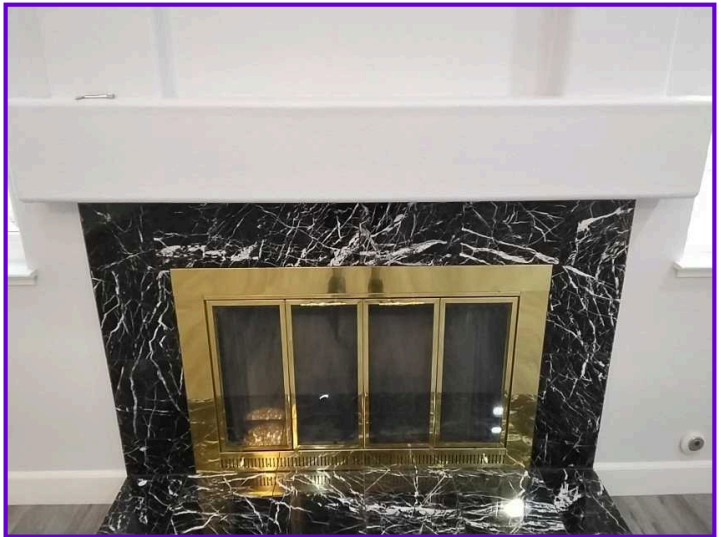
COMMENTS: The mantel and legs are in satisfactory condition.

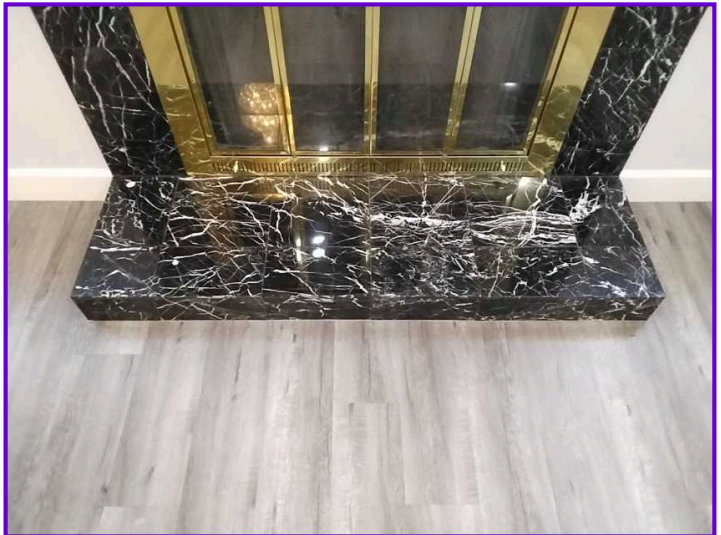
COMMENTS: The hearth extension is in satisfactory condition.
