PROPERTY INSPECTION REPORT

805 Eastbrook Court, Danville, CA 94506

DATE OF INSPECTION: 1/1/2025

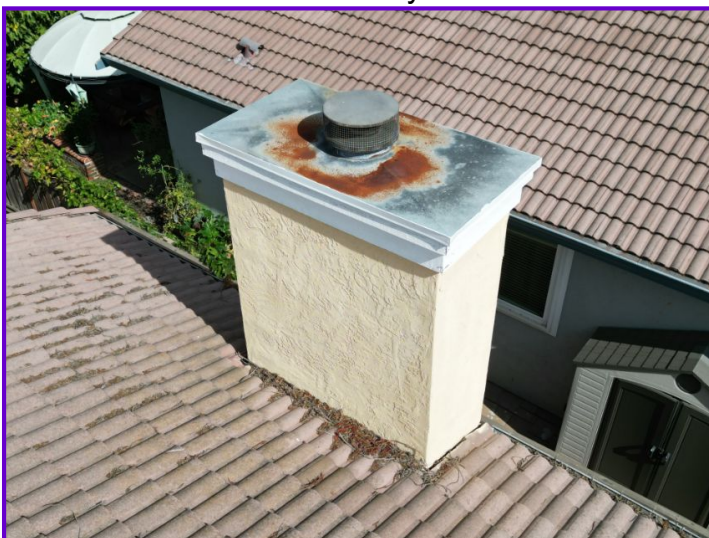
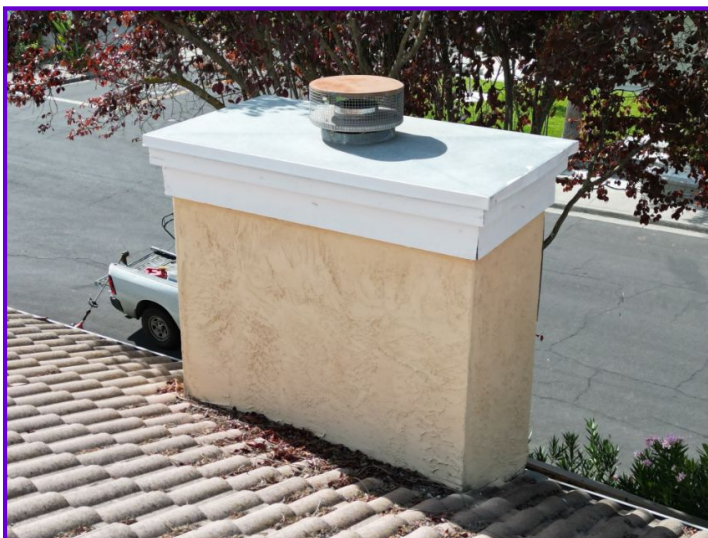
COMMENTS: The chimney structures had no visible defects.

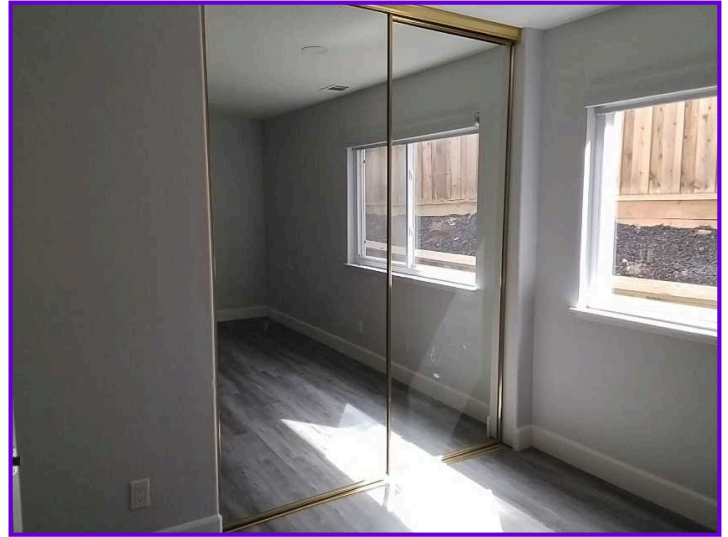
COMMENTS: The closet doors, guides and operating hardware appeared satisfactory and in functional condition.

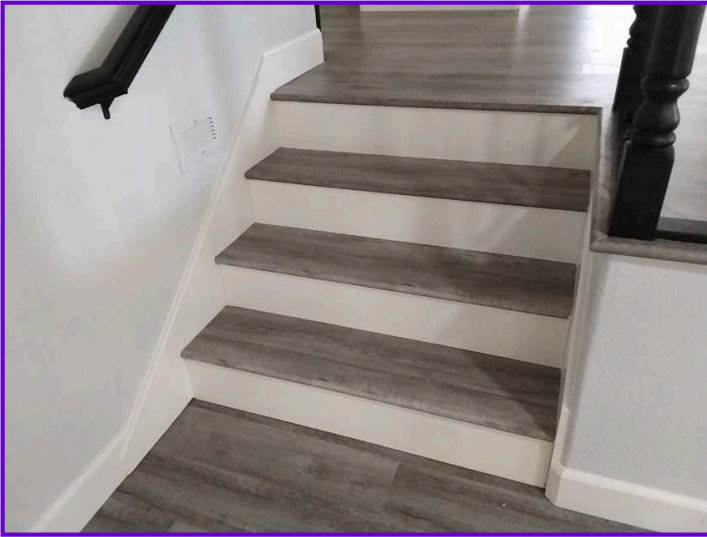
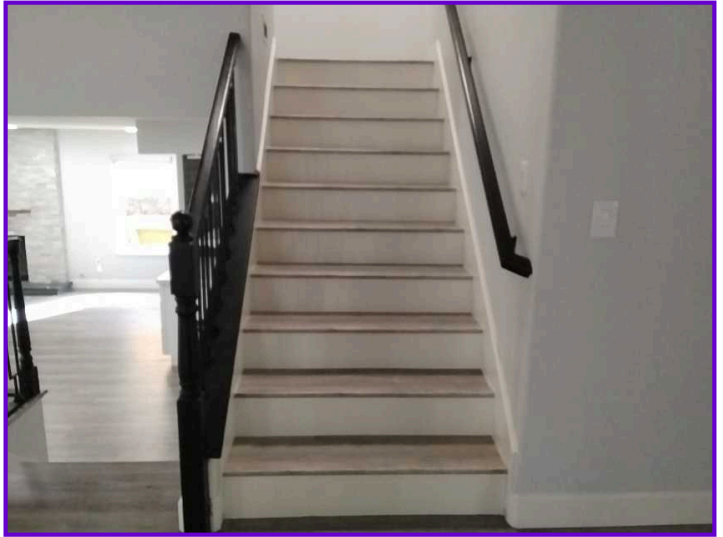
COMMENTS: The stairs appeared to be in satisfactory condition.

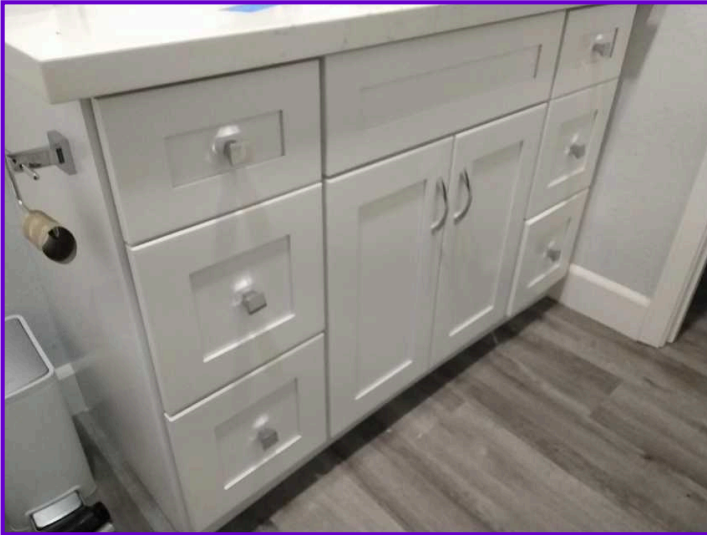
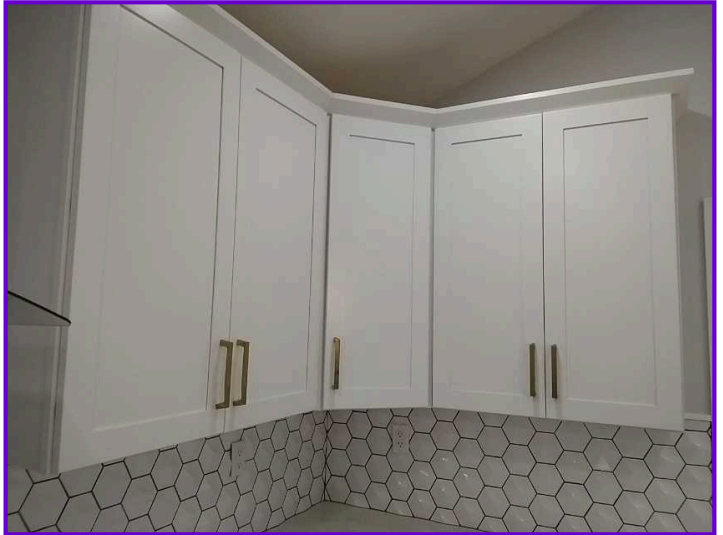
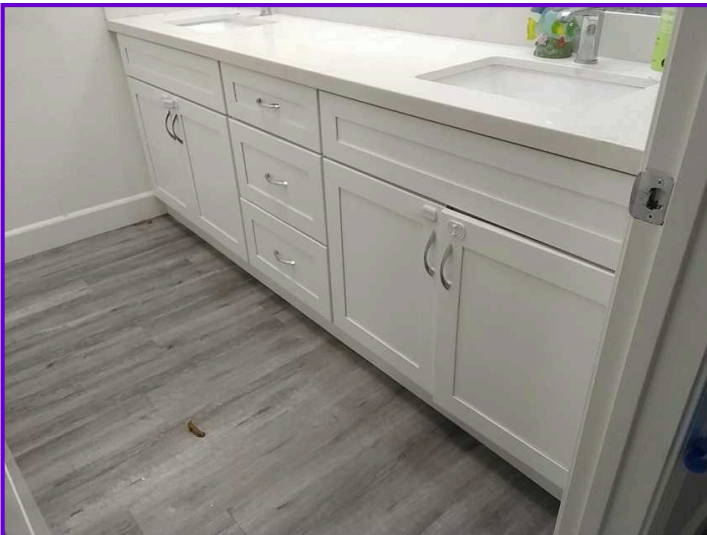
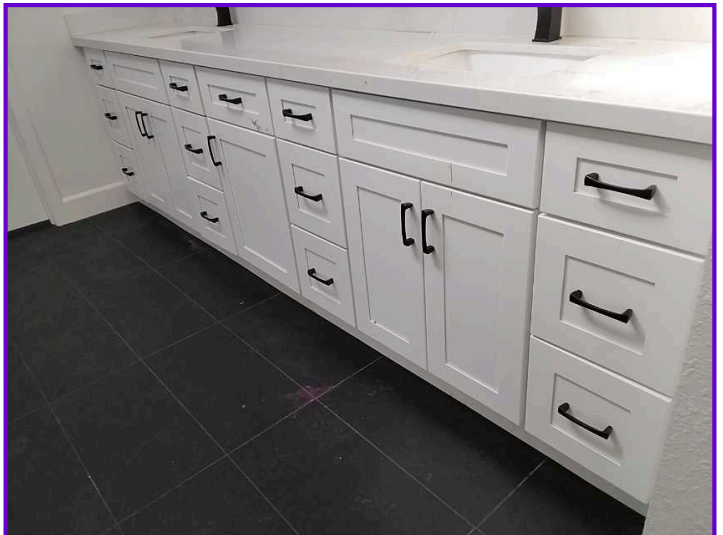
COMMENTS: The cabinetry is functional but may have minor wear that is commensurate with its age.

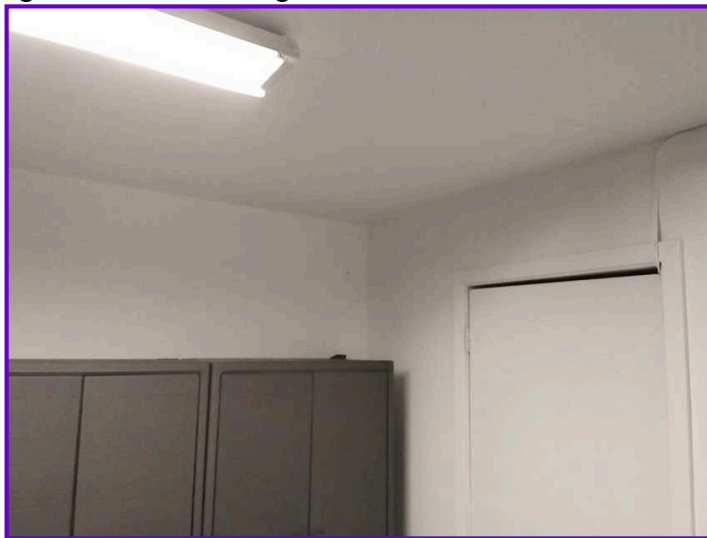
COMMENTS: The ceiling and wall coverings are functional.
