ROOF INSPECTION REPORT

805 Eastbrook Court, Danville, CA

CLIENT: Asante Realty

DATE OF INSPECTION: 10/10/2024

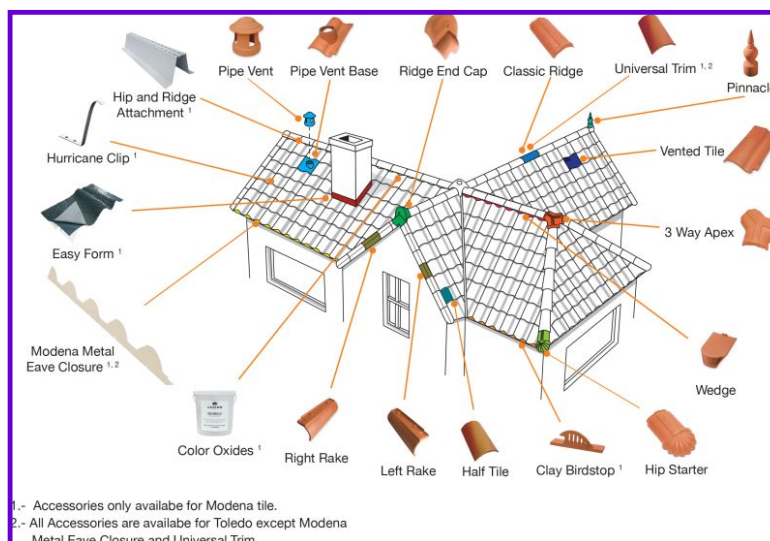
INFORMATION: The roof is a critical component of the home and requires regular inspections and maintenance to ensure its integrity.

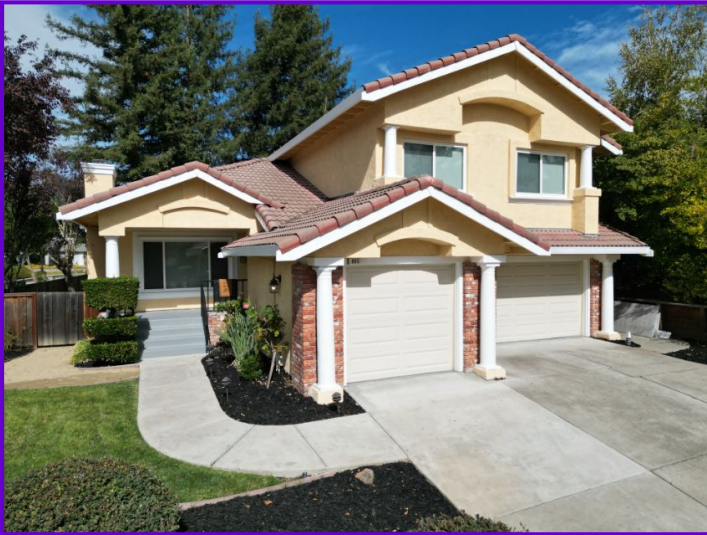
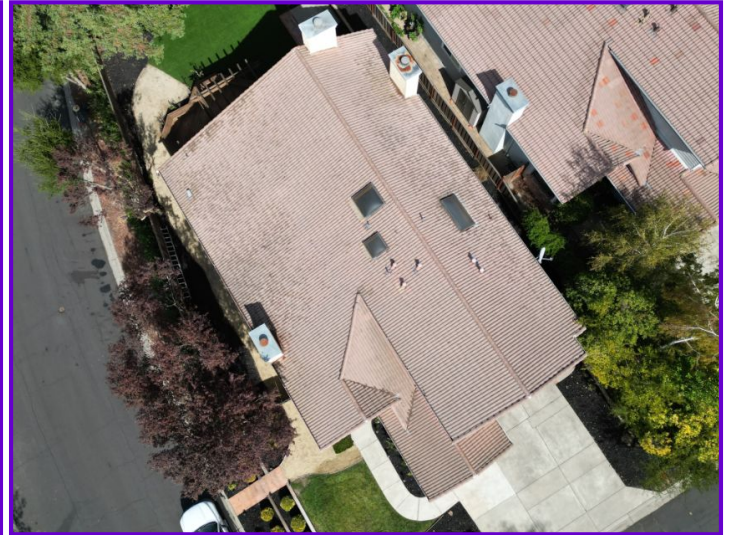
COMMENTS: The residence features a sloped or pitched roof.

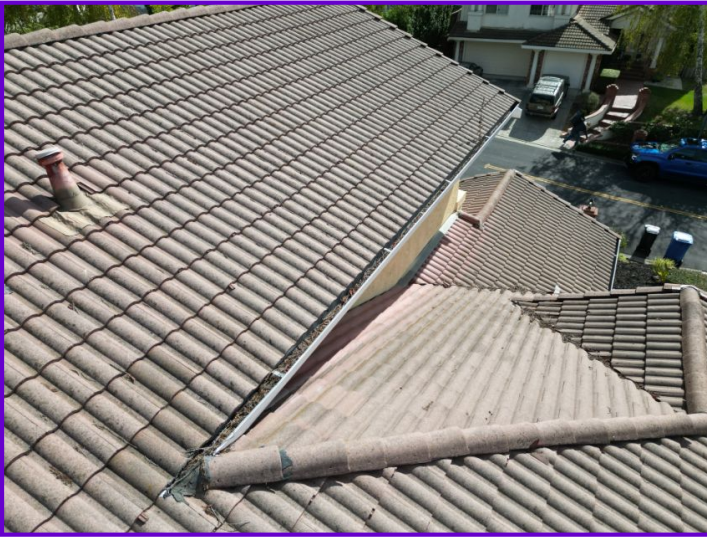
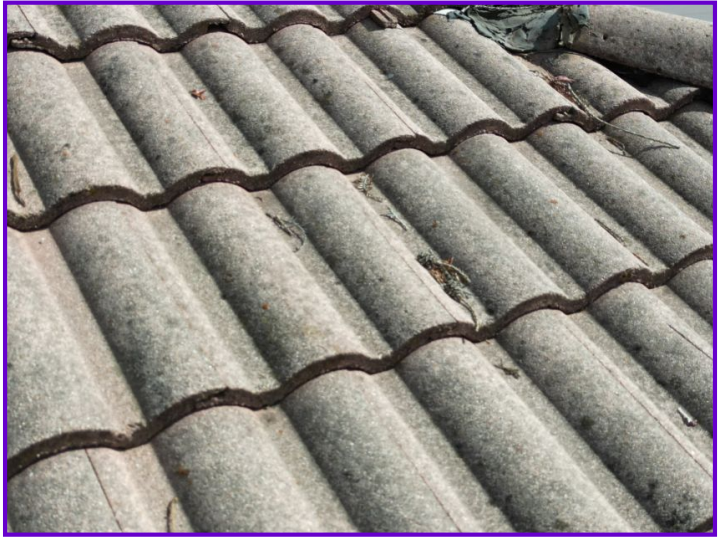
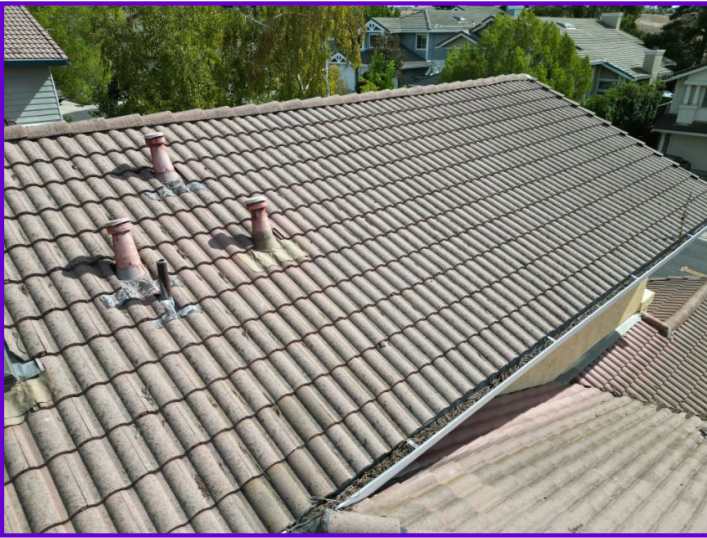
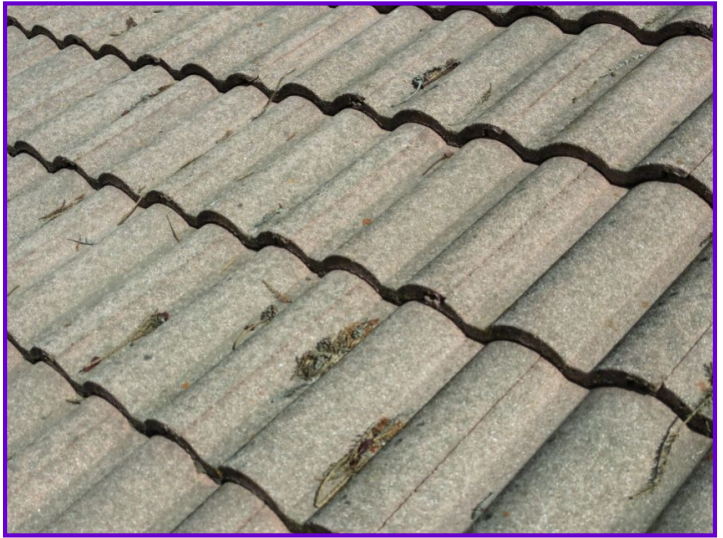
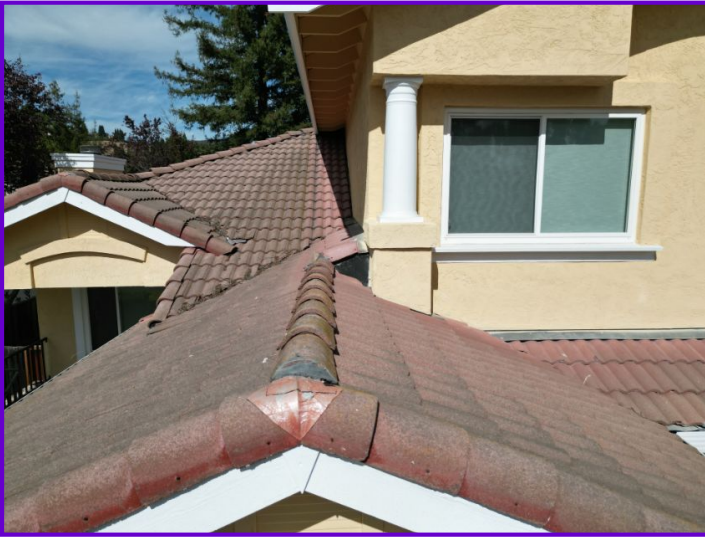
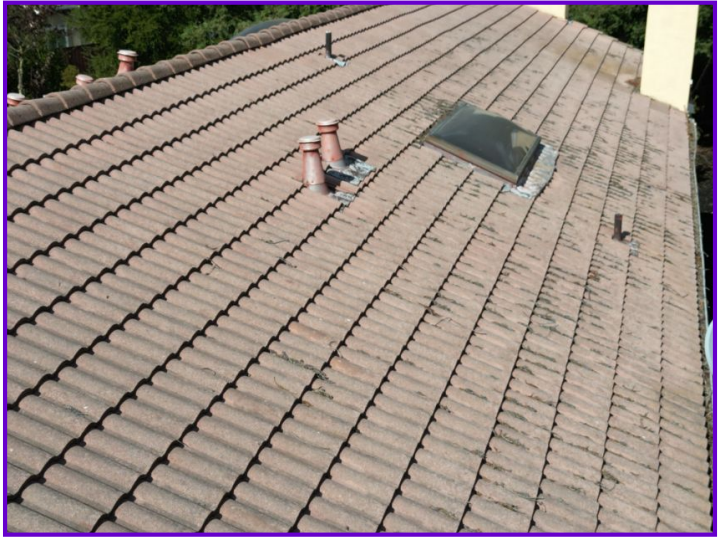
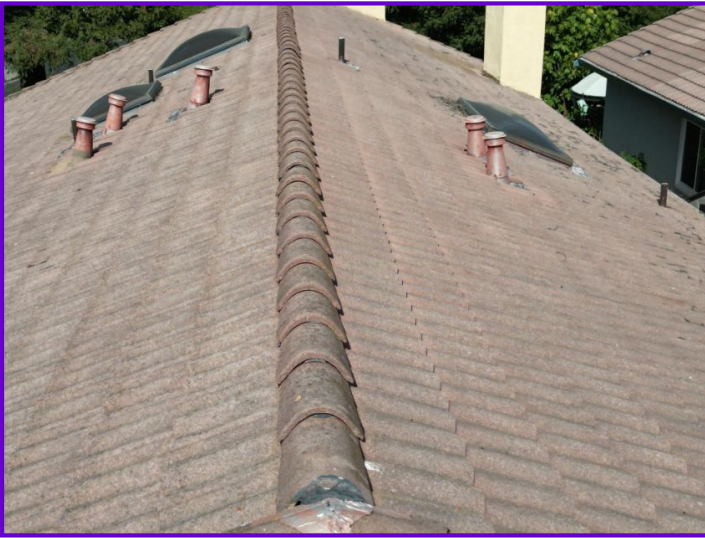
• **COMMENTS:** The composite tile roofing material appears to be in satisfactory condition relative to its age. **This type of normally comes with a 50-year or lifetime warranty. With normal cleaning and regular maintenance the roof could remain leak free for 20 or more years.**

COMMENTS: The composite tile roofing material appears to be in satisfactory condition relative to its age.

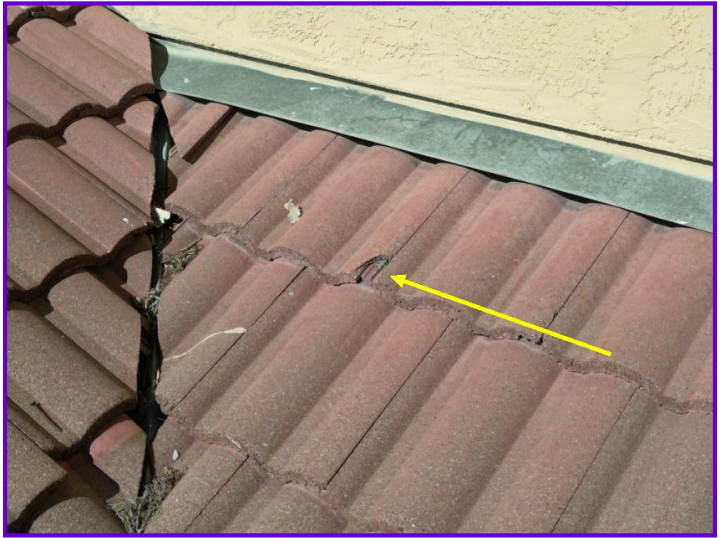
• **COMMENTS:** There may be the occasional cracked or chipped tiles, but none that would appear to warrant replacement of the tiles. This is common on tile roofs and is normally not a concern.

COMMENTS: There may be the occasional cracked or chipped tiles, but none that would appear to warrant replacement of the tiles.

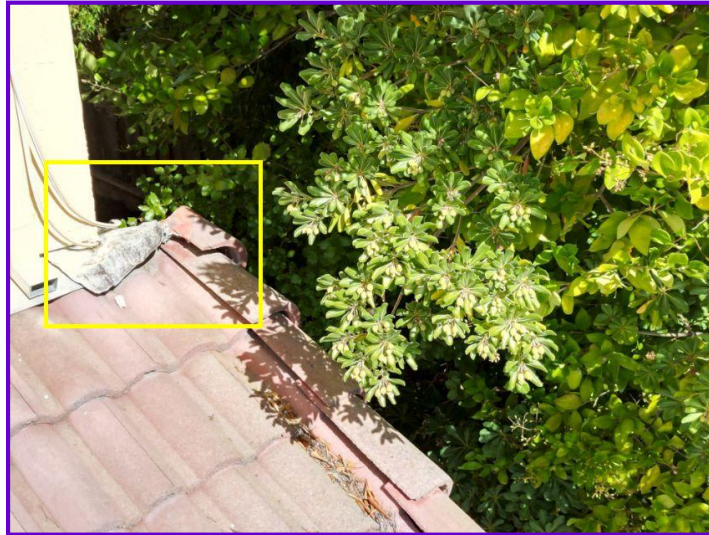
• **PREVENTIVE:** There is a ridge tile on the right side of the garage that is not properly fastened or secured to the roof deck. Concerned parties may wish to have this tile properly secured for safety and the flashing resealed. This should forestall the possibility of roof leakage. The estimated cost of this repair is \$275. Our office can facilitated this repair upon request.

PREVENTIVE: There is a ridge tile on the right side of the garage that is not properly fastened.

Page 5 Item: 3	Composite Tile	<ul style="list-style-type: none"> • PREVENTIVE: There is a ridge tile on the right side of the garage that is not properly fastened or secured to the roof deck. Concerned parties may wish to have this tile properly secured for safety and the flashing resealed. This should forestall the possibility of roof leakage. The estimated cost of this repair is \$275. Our office can facilitated this repair upon request.
----------------	----------------	---

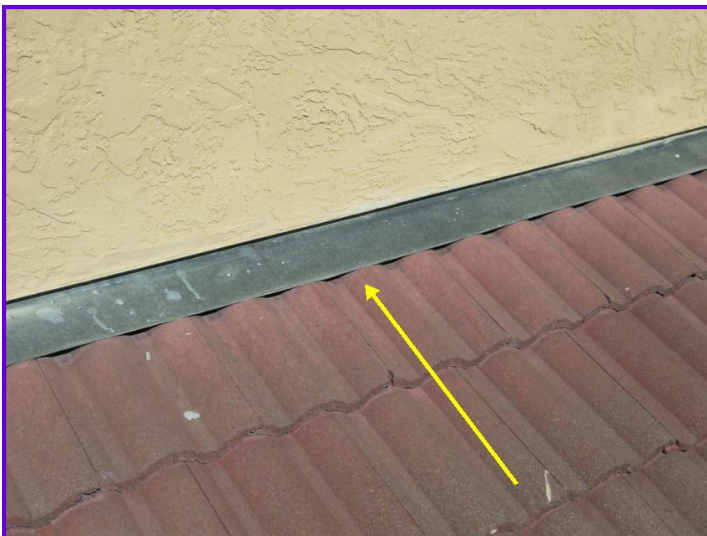
• **COMMENTS:** The visible roof flashing appears to be in satisfactory condition. Flashing is an impervious material (usually galvanized sheet metal) that comes in a variety of shapes and sizes and is used to cover, waterproof, and direct water away from roof penetrations and from intersections between the roof covering and other materials.

COMMENTS: The visible roof flashing appears to be in satisfactory condition.

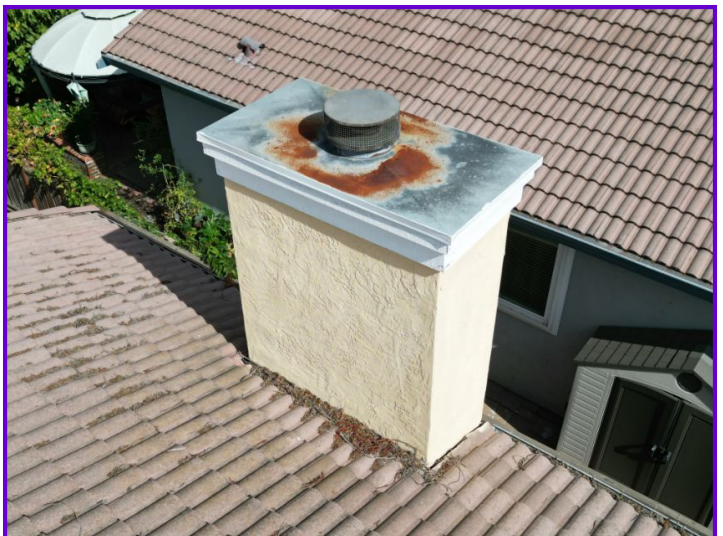
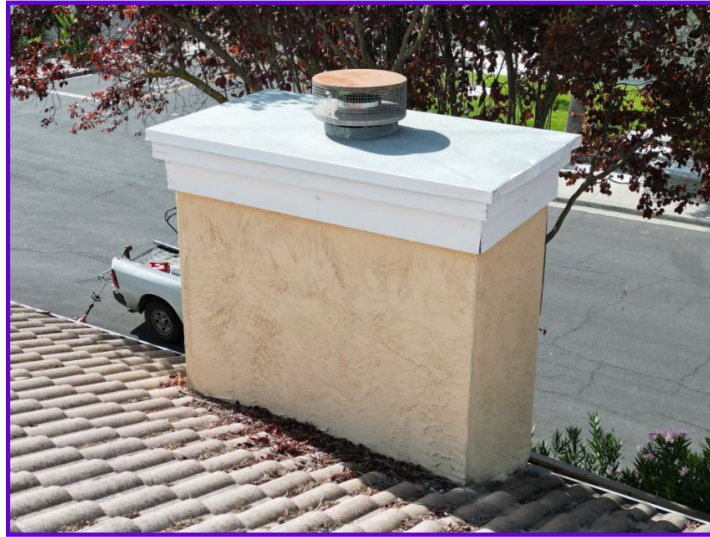
• **MONITOR:** There are two chimneys that are over 30 inches wide and do not have diverter flashings to help prevent water from pooling at the roof area directly behind them. This area is a common point for damming and leakage. Concerned parties may wish to monitor this area regularly and keep clear of debris.

MONITOR: There are two chimneys that are over 30 inches wide and do not have diverter flashings.

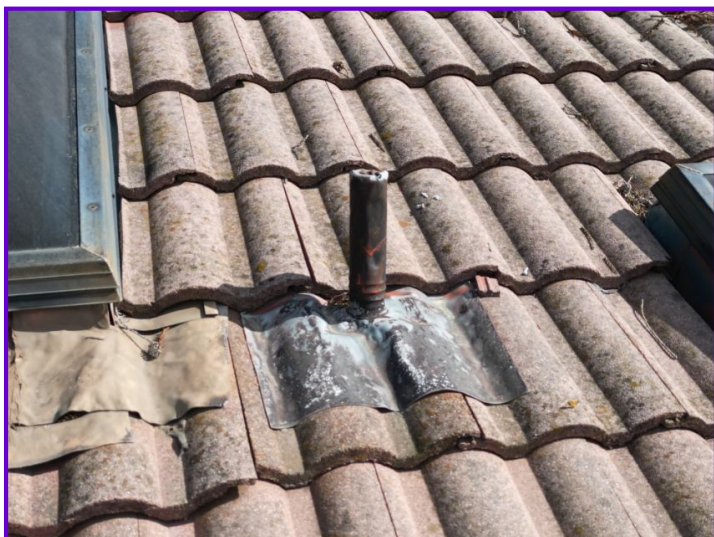
COMMENTS: The plumbing vent protrusions appeared to be well sealed, properly flashed and in satisfactory condition.

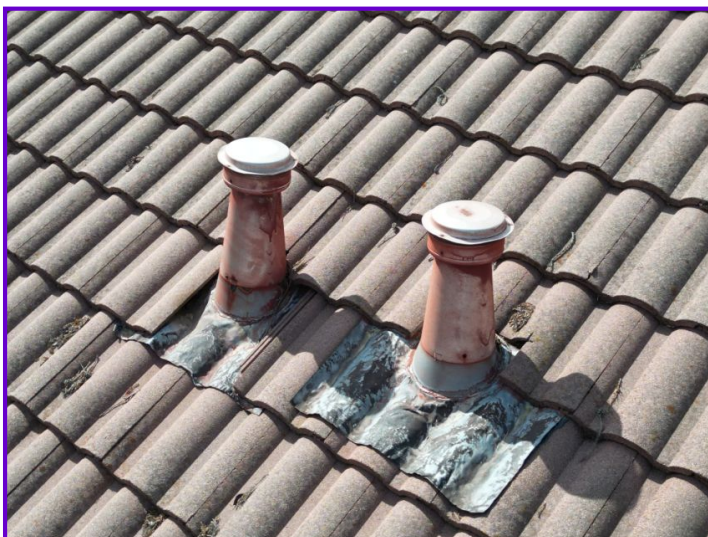
COMMENTS: The exhaust vent protrusions appeared to be well sealed, properly flashed and in satisfactory condition.

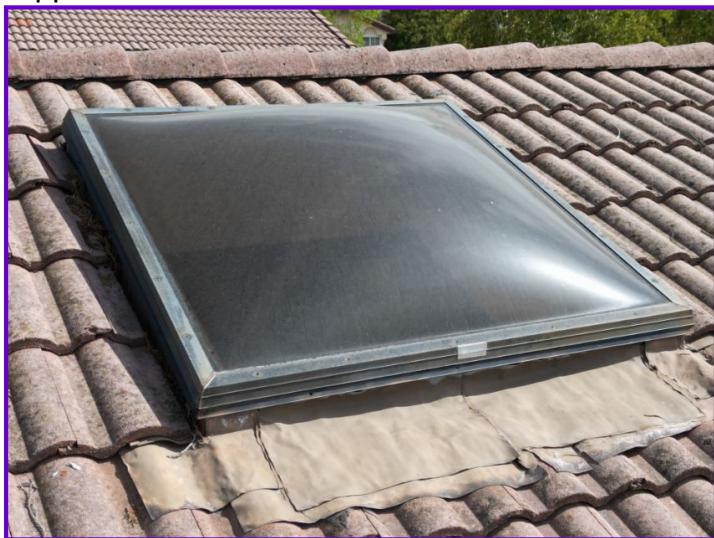
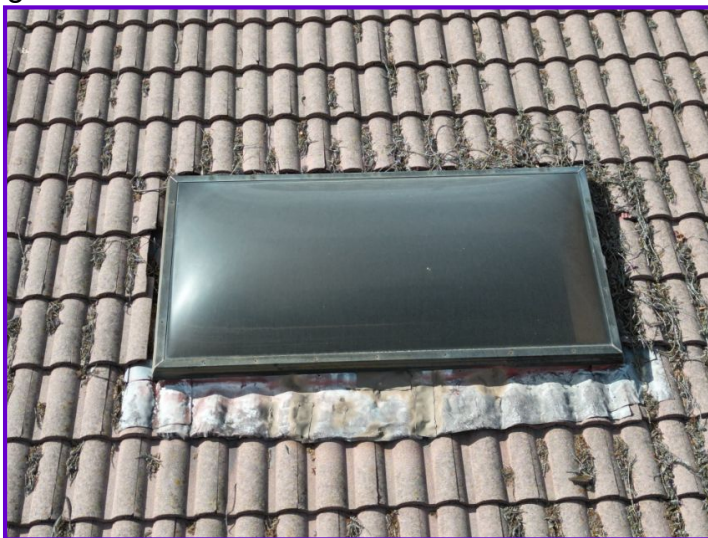
- COMMENTS: The roof includes skylights which appeared to be in satisfactory condition. Skylights are easily cracked and you should monitor them regularly for evidence of leakage. The skylights appear functional with no visible evidence of leakage at this time.

COMMENTS: The roof includes skylights which appeared to be in satisfactory condition.

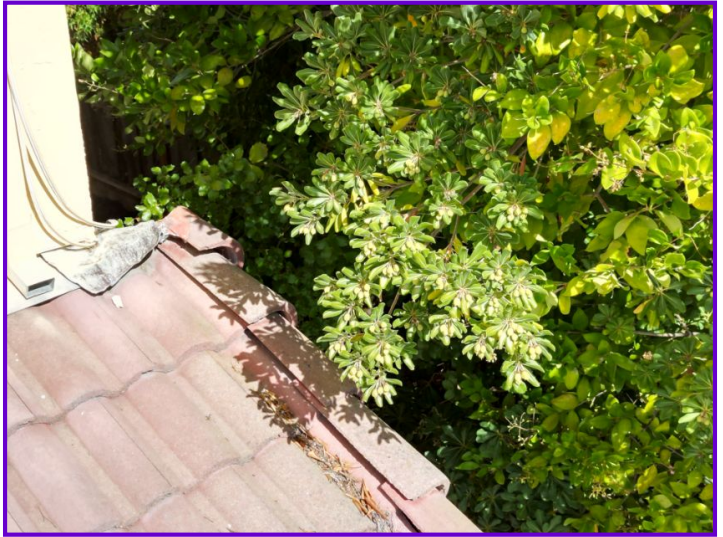
PREVENTIVE: The roof needs any foliage trimmed away and maintained to prevent damage to the roof covering and to facilitate proper drainage.
