FOUNDATION INSPECTION REPORT

1227 Salvadorean Blvd, Orinda, CA

DATE OF INSPECTION: 1/1/2025

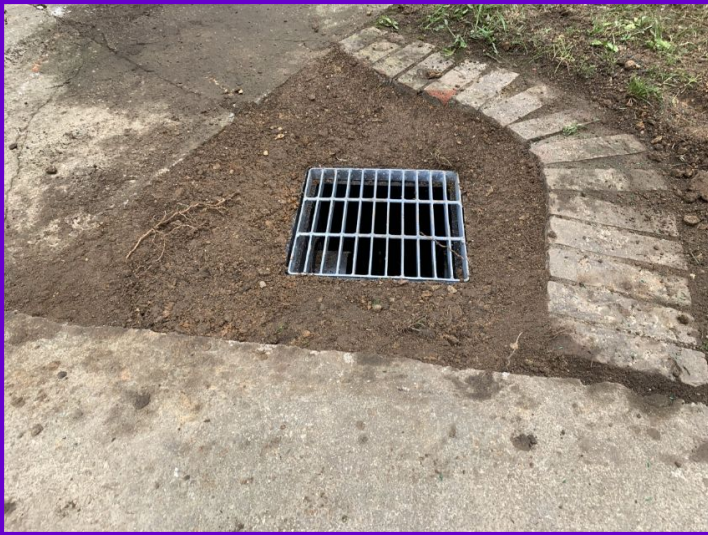
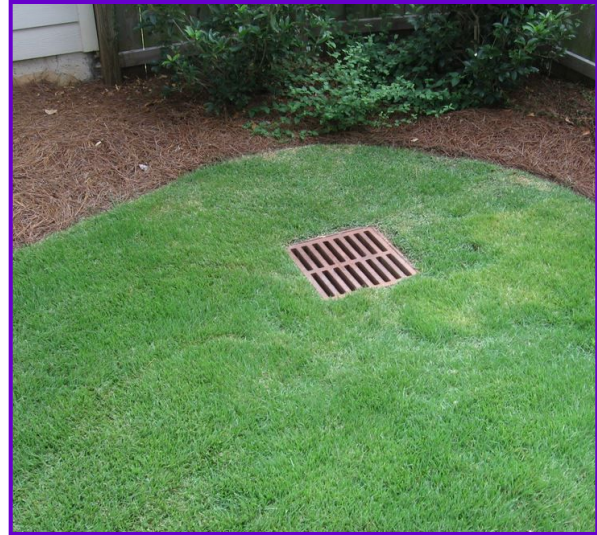
- **COMMENTS:** Surface drainage conditions within 10 feet of the inspected structure(s) appeared satisfactory.
- **MONITOR:** There are area drains on the property. This is an excellent system for maintaining proper surface drainage. The drain lines should be monitored, tested annually and the drain covers evaluated regularly for damage. Because dirt and/or debris can block the pipes, they should be tested (flushed through) to ensure the drain lines are functional. Area drains are not filled or tested by your home inspector.

MONITOR: There are area drains on the property. MONITOR: There are area drains on the property.

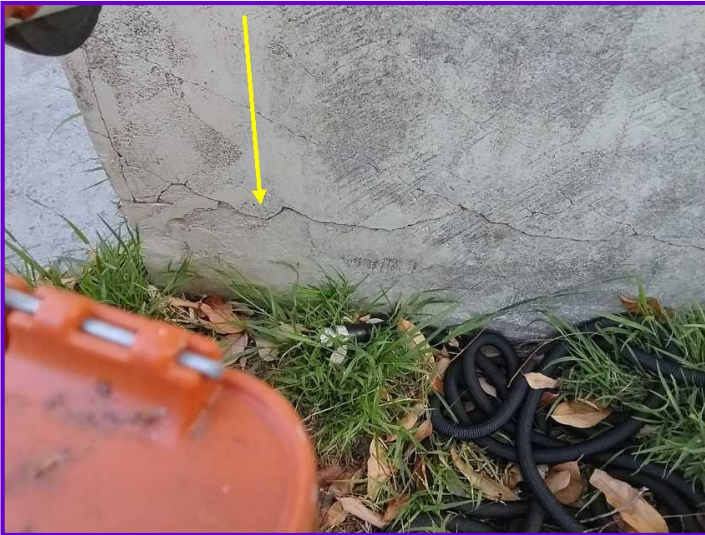
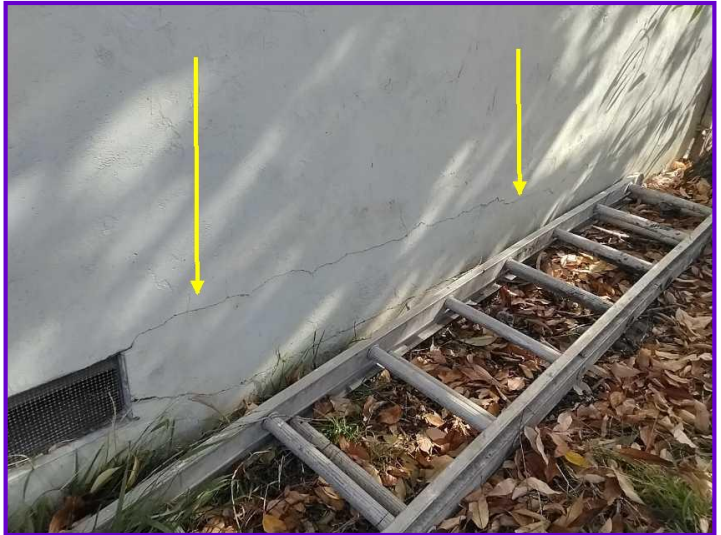
- **PREVENTIVE:** There horizontal cracks in the stucco along the base of the walls, likely due to seismic movement or structural shifting. This is common in homes where stucco wall covering extends to ground level, as the concrete foundation and wood-framed structures expand and contract differently with temperature and humidity changes. As long as no structural implications are noted elsewhere in this report, these cracks are not structurally significant. However, they can allow moisture entry and should be sealed or serviced as a preventive measure.
- **PREVENTIVE:** A minimum 6 inches of clearance from the siding to the soil is needed at multiple locations around the residence. We recommend providing proper clearance from the soil to help prevent moisture or termite damage.

PREVENTIVE: There horizontal cracks in the stucco along the base of the walls.

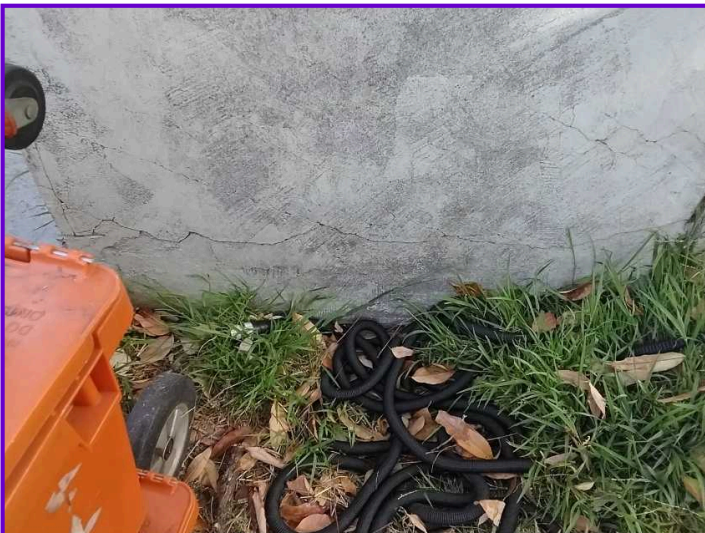
PREVENTIVE: A minimum 6 inches of clearance from the siding to the soil is needed at multiple locations around the residence.

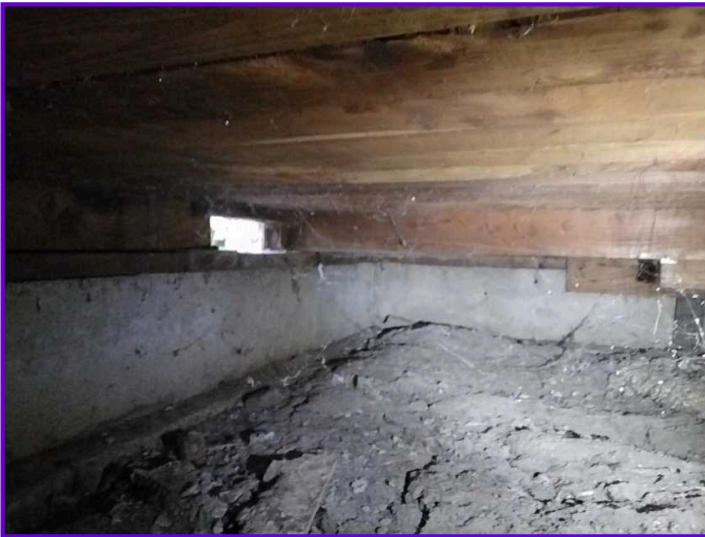
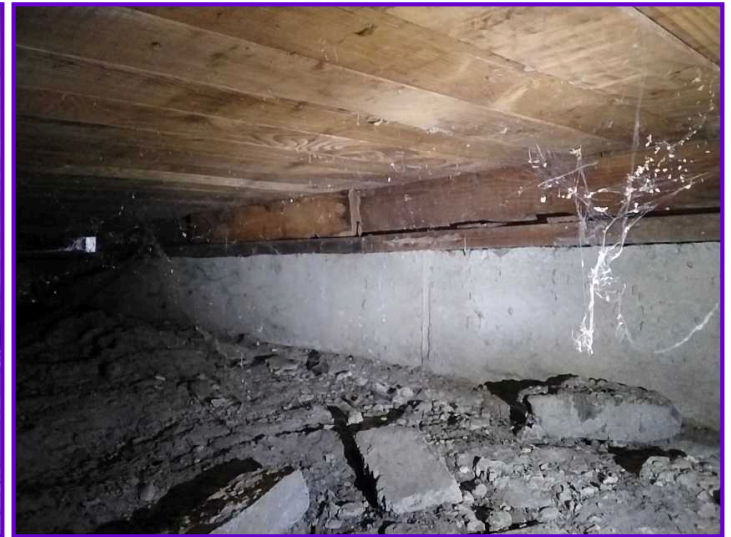
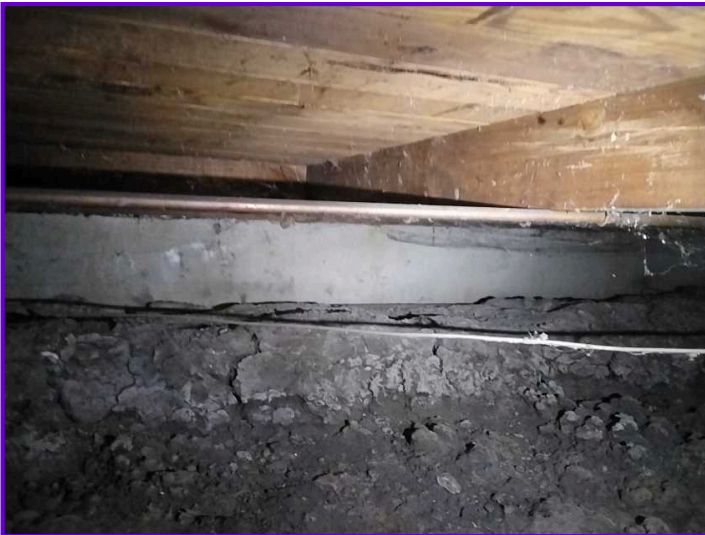
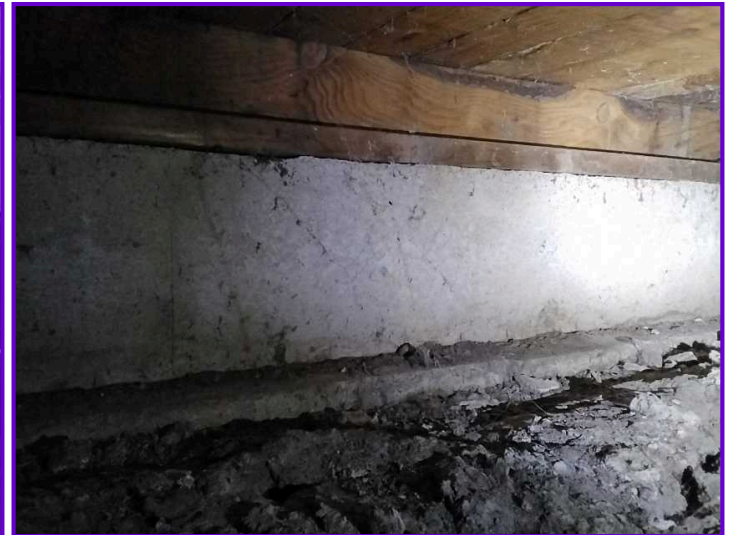
• **COMMENTS:** The poured concrete foundation walls demonstrate a strong and functional structure. This is indicative of quality craftsmanship and appropriate installation practices. The walls exhibit uniform thickness and a smooth texture, suggesting optimal mix design and pouring techniques which contribute to the overall integrity of the foundation. Signs of stability, such as minimal to no cracking, were observed, and any existing minor surface imperfections do not compromise structural performance. The walls are well-anchored and properly cured, ensuring resilience against environmental stressors, including soil movement and moisture changes.

COMMENTS: The poured concrete foundation walls appear to be functional.

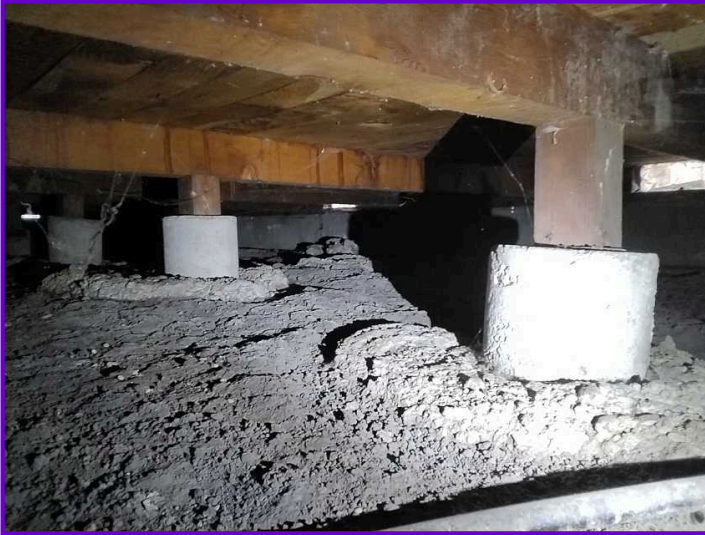
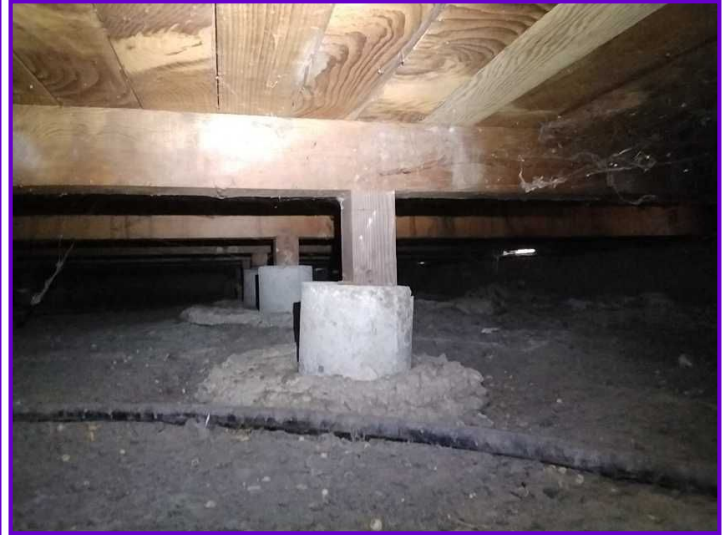
- **COMMENTS:** The supplemental support posts are properly placed and appeared functional at the time of inspection.
- **PREVENTIVE:** Strengthening of the pier and post with metal ties or straps is recommended as a preventative measure.

COMMENTS: The supplemental support posts are properly placed and appeared functional at the time of inspection.

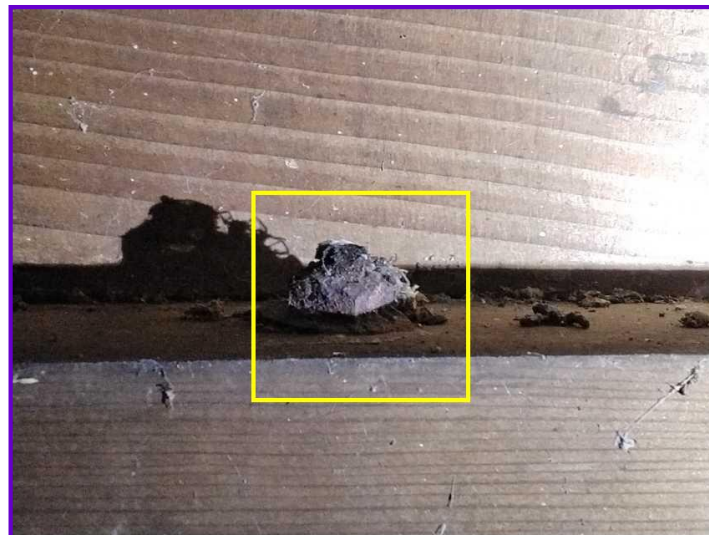
COMMENTS: Bolting of the framing sill plates to the foundation concrete stem walls was observed under the residence.

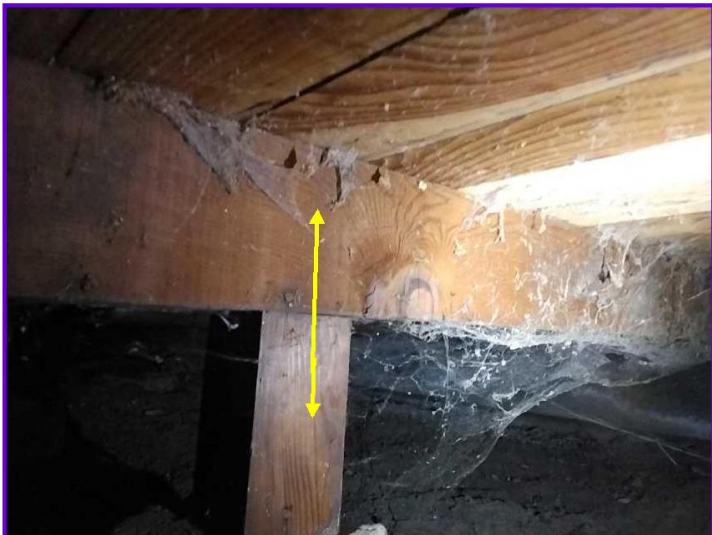
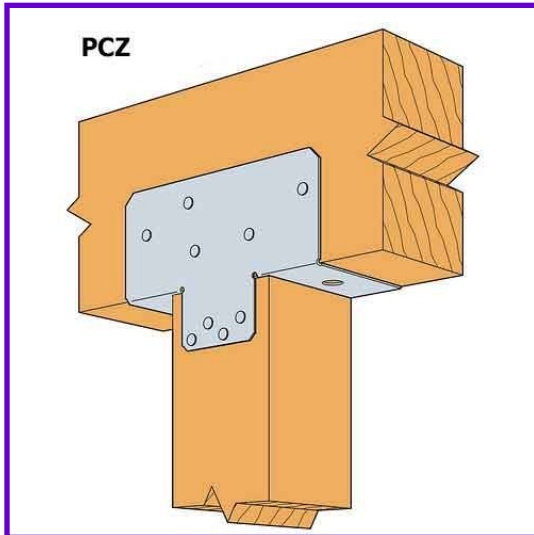
- **PREVENTIVE:** The lack of seismic bracing at the support framing of the foundation is recognized as being an inherent seismic weakness. This condition is easily overcome with the application of seismic metal bracing. Concerned parties may wish to consult an appropriately qualified specialist familiar with such procedures for further information and/or design details.

PREVENTIVE: Strengthening of the pier and post with metal ties or straps is recommended as a preventative measure.

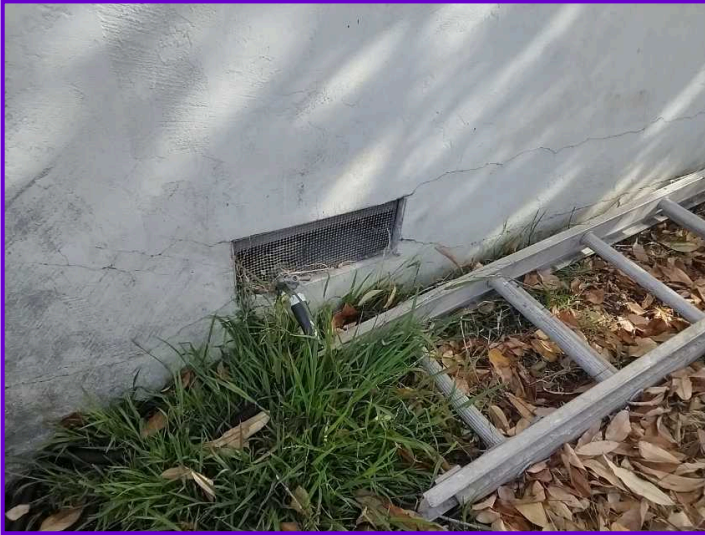
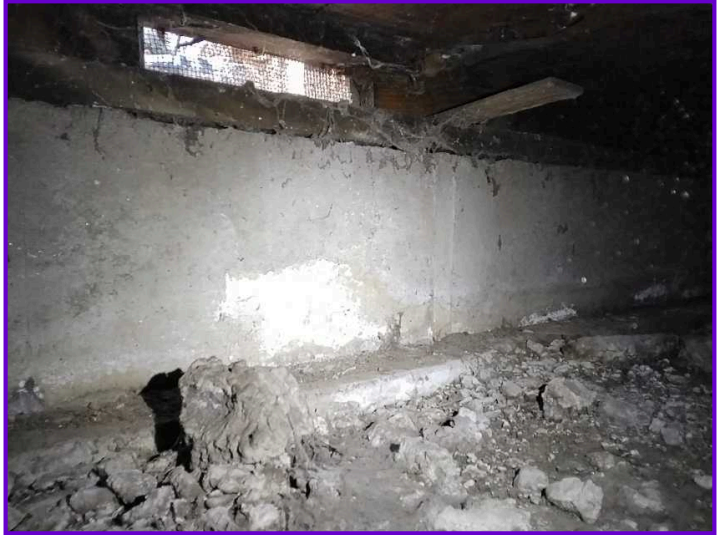
COMMENTS: Ventilation of the foundation crawlspace appears conventional and should be sufficient.

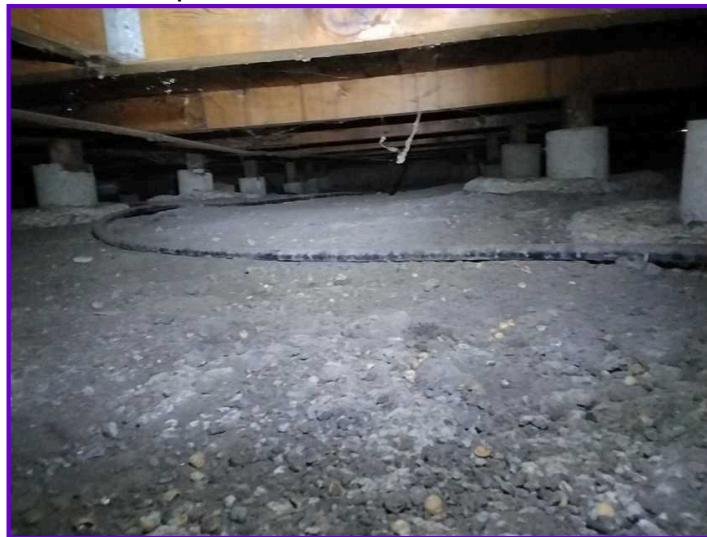
COMMENTS: There was no visible evidence of excessive moisture penetration of the underfloor areas.

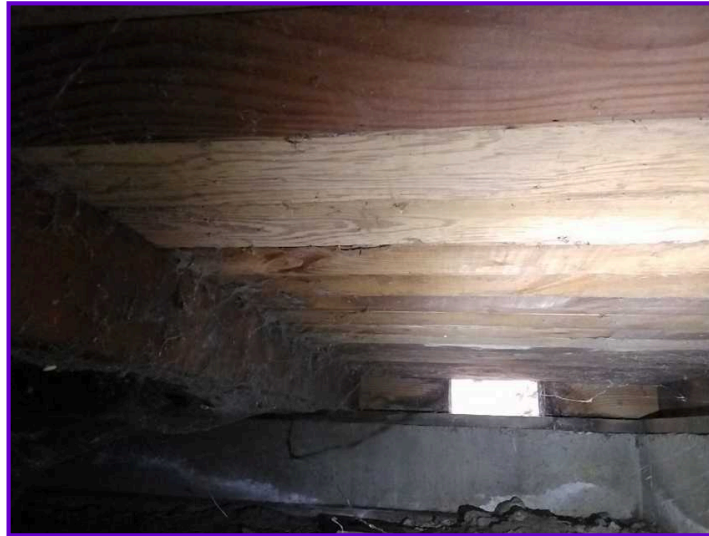
- **PREVENTIVE:** There was no insulation visible in the underfloor areas of the home. Although it may not have been a requirement at the time of construction, retrofitting the crawlspace with insulation can significantly increase the energy efficiency of the home.

PREVENTIVE: There was no insulation visible in the underfloor areas of the home.

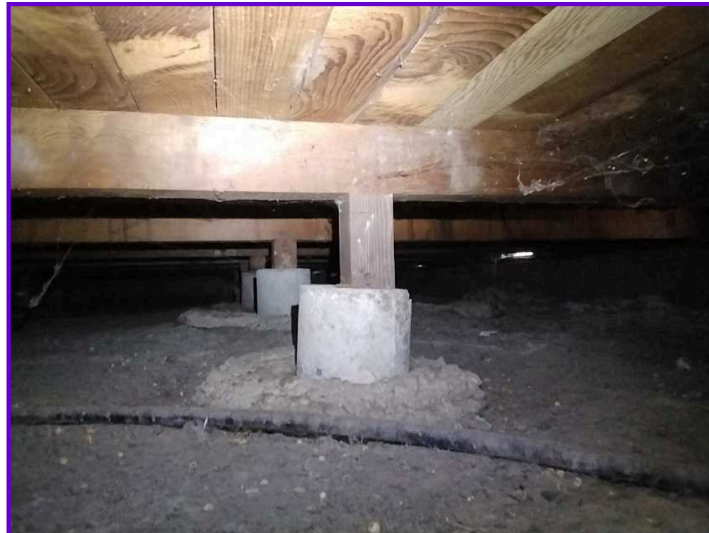
COMMENTS: Where visible and accessible, wood clearances from soil appeared satisfactory.

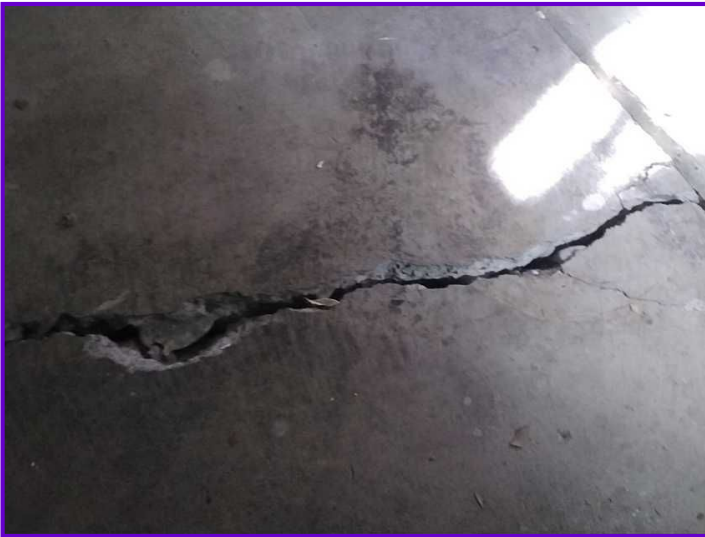
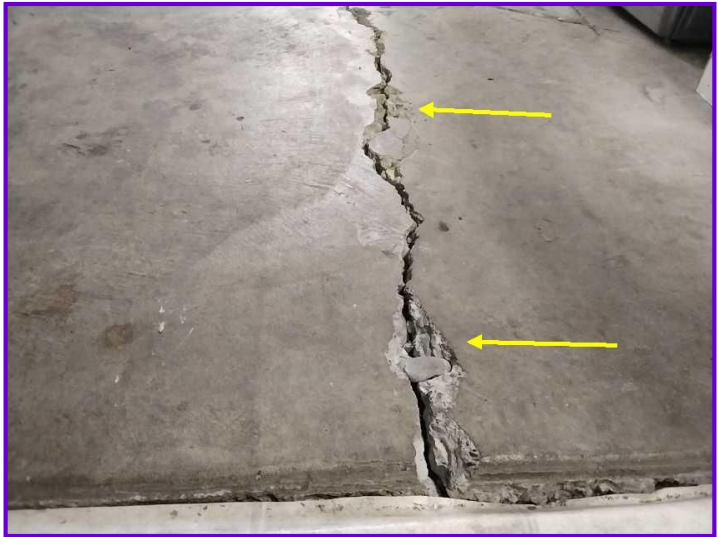
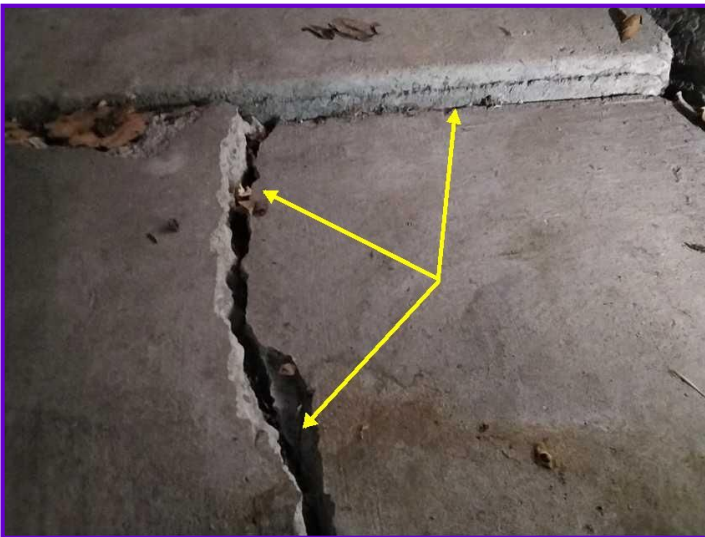
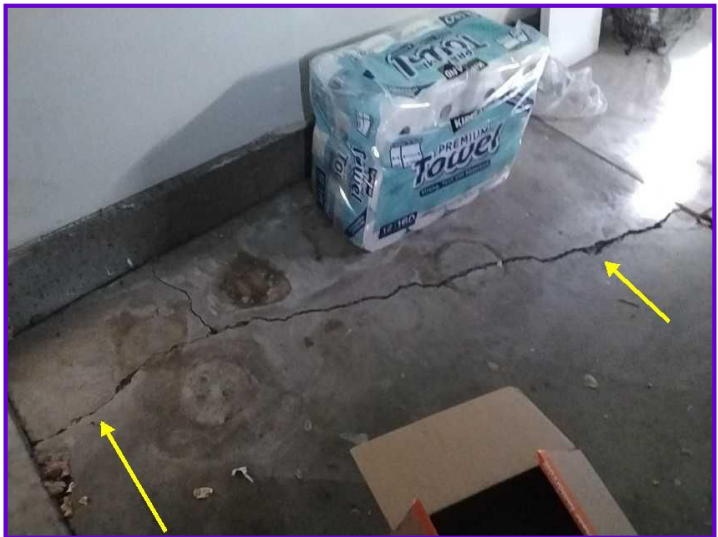
• **DEFERRED:** There are significant separations in the garage concrete slab. This issue may be the result of seismic activity, settlement, unstable soil, or a combination of same. Although the slab is not load bearing, and the cracks do not appear to be structurally threatening, they may allow water to pass through them. Concerned parties may wish to have the cracks evaluated by an appropriately qualified specialist for further remarks and recommendations. **The estimated cost to replace/repair the garage slab is approximately \$20-\$25 per square foot.**

DEFERRED: There are significant separations in the garage concrete slab.
