FOUNDATION INSPECTION REPORT

1227 Salvadorean Blvd, Orinda, CA

DATE OF INSPECTION: 1/1/2025

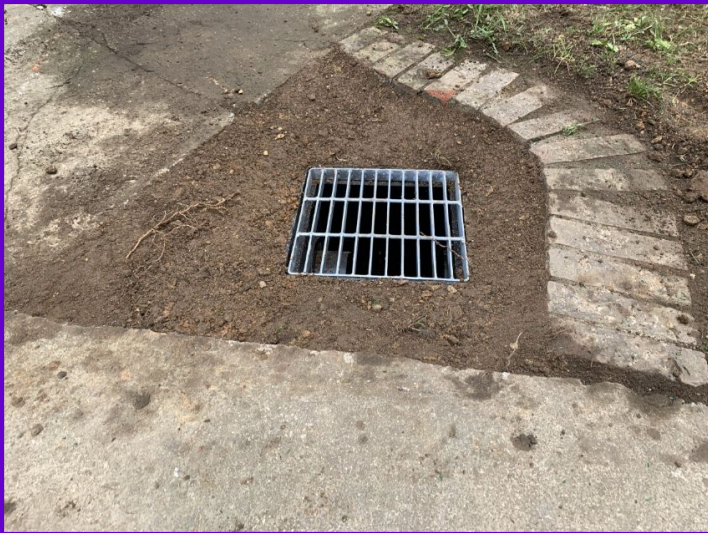
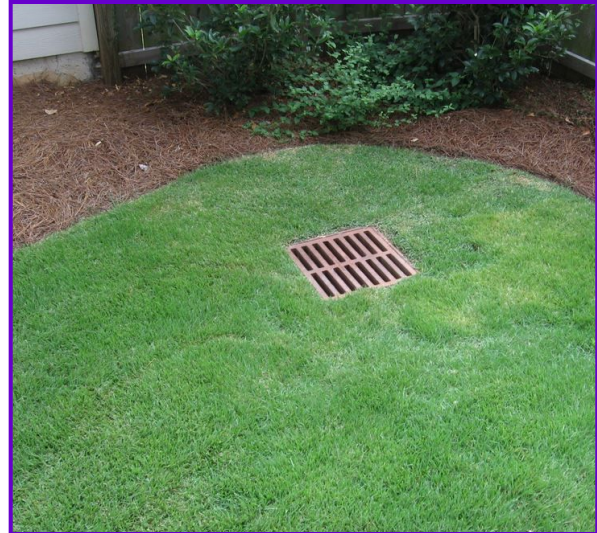
- **COMMENTS:** Surface drainage conditions within 10 feet of the inspected structure(s) appeared satisfactory.
- **MONITOR:** There are area drains on the property. This is an excellent system for maintaining proper surface drainage. The drain lines should be monitored, tested annually and the drain covers evaluated regularly for damage. Because dirt and/or debris can block the pipes, they should be tested (flushed through) to ensure the drain lines are functional. Area drains are not filled or tested by your home inspector.

MONITOR: There are area drains on the property. MONITOR: There are area drains on the property.

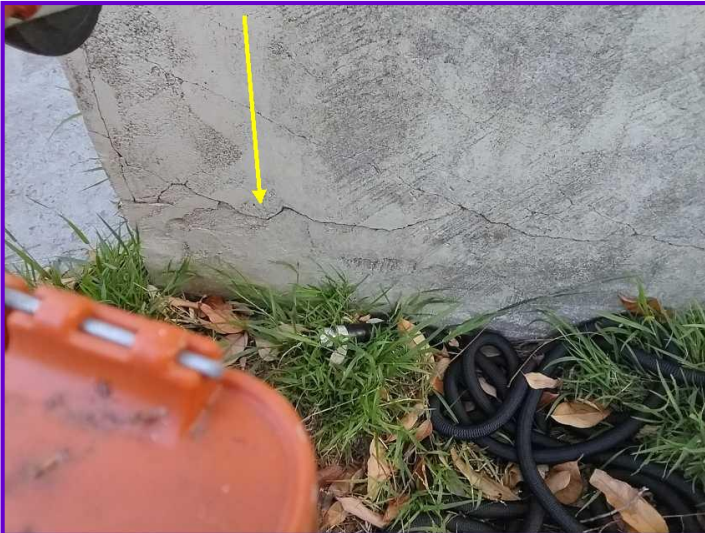
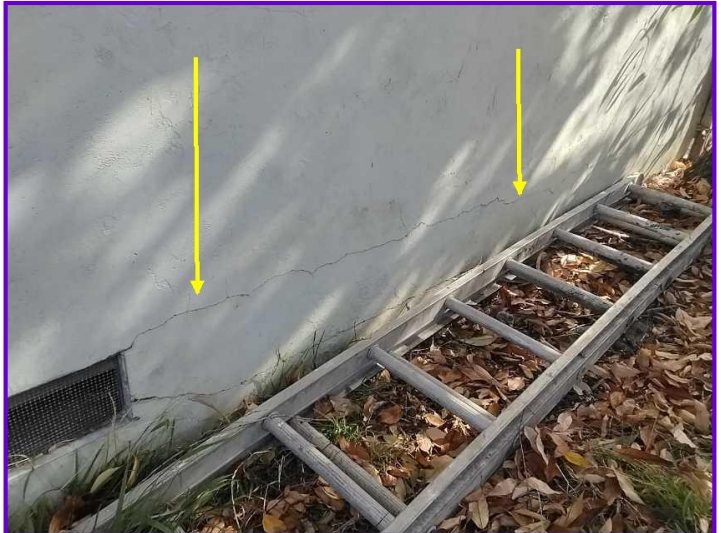
- **PREVENTIVE:** There horizontal cracks in the stucco along the base of the walls, likely due to seismic movement or structural shifting. This is common in homes where stucco wall covering extends to ground level, as the concrete foundation and wood-framed structures expand and contract differently with temperature and humidity changes. As long as no structural implications are noted elsewhere in this report, these cracks are not structurally significant. However, they can allow moisture entry and should be sealed or serviced as a preventive measure.
- **PREVENTIVE:** A minimum 6 inches of clearance from the siding to the soil is needed at multiple locations around the residence. We recommend providing proper clearance from the soil to help prevent moisture or termite damage.

PREVENTIVE: There horizontal cracks in the stucco along the base of the walls.

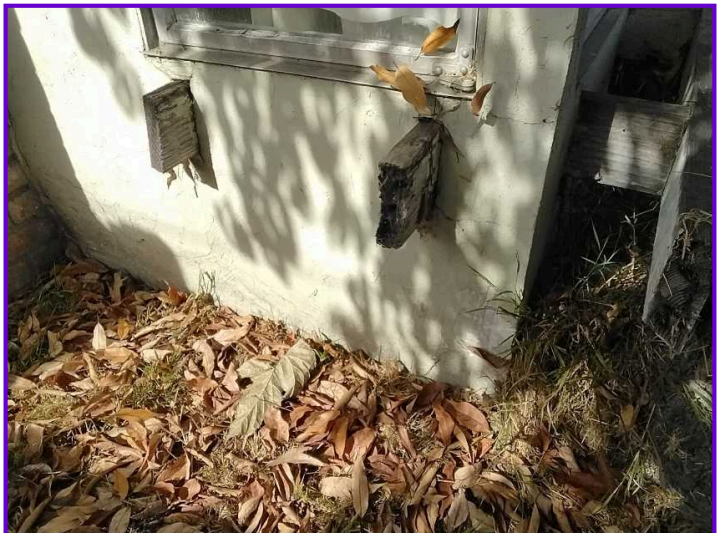
PREVENTIVE: A minimum 6 inches of clearance from the siding to the soil is needed at multiple locations around the residence.

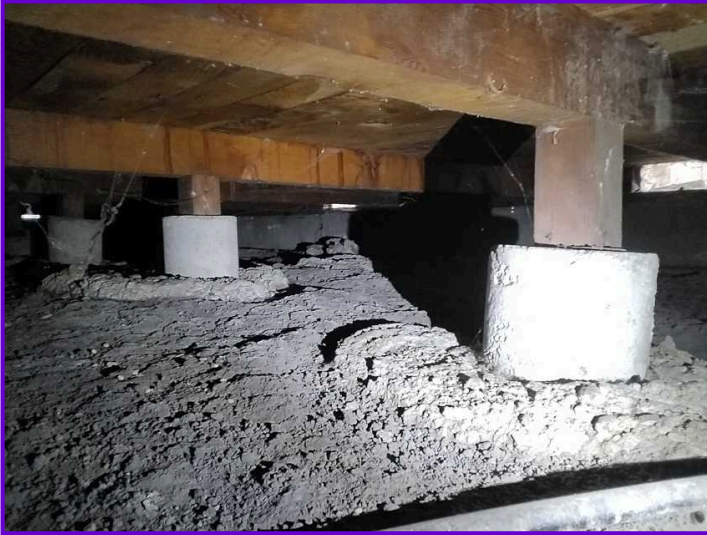
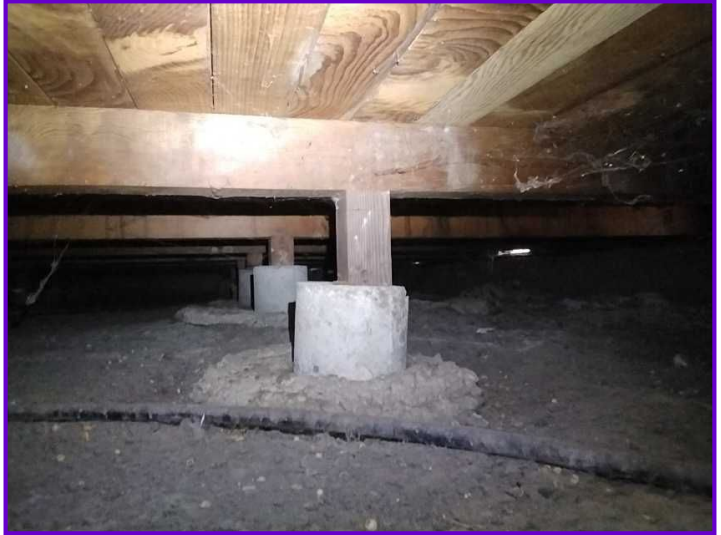
COMMENTS: The supplemental support posts are properly placed and appeared functional at the time of inspection.

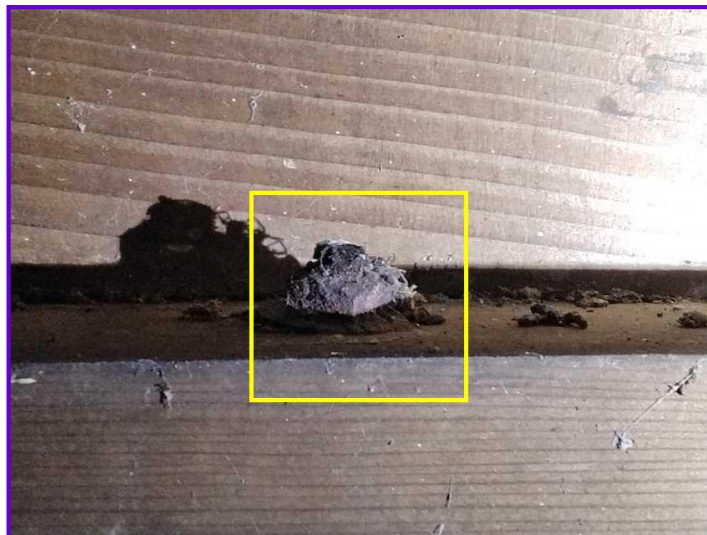
COMMENTS: Bolting of the framing sill plates to the foundation concrete stem walls was observed under the residence.

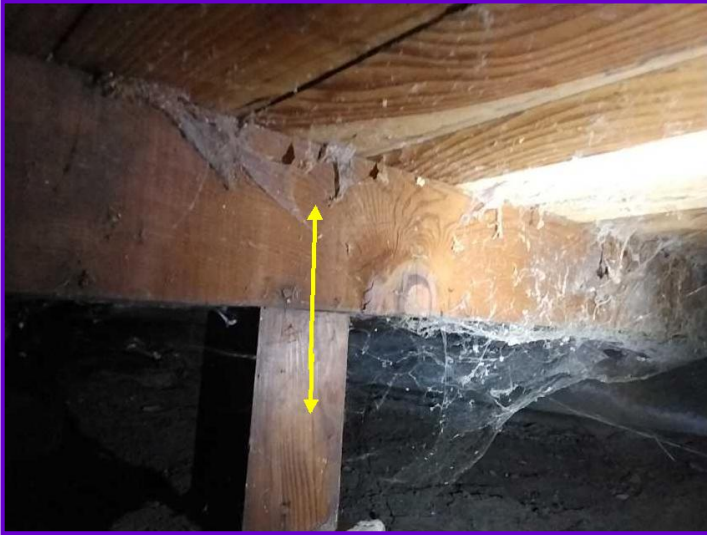
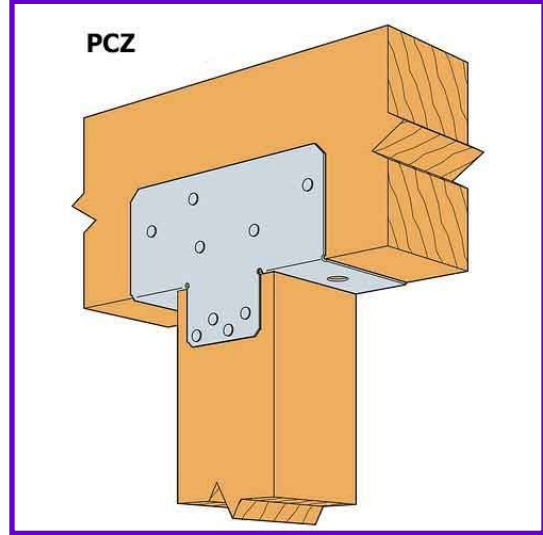
- **PREVENTIVE:** The lack of seismic bracing at the support framing of the foundation is recognized as being an inherent seismic weakness. This condition is easily overcome with the application of seismic metal bracing. Concerned parties may wish to consult an appropriately qualified specialist familiar with such procedures for further information and/or design details.

PREVENTIVE: Strengthening of the pier and post with metal ties or straps is recommended as a preventative measure.

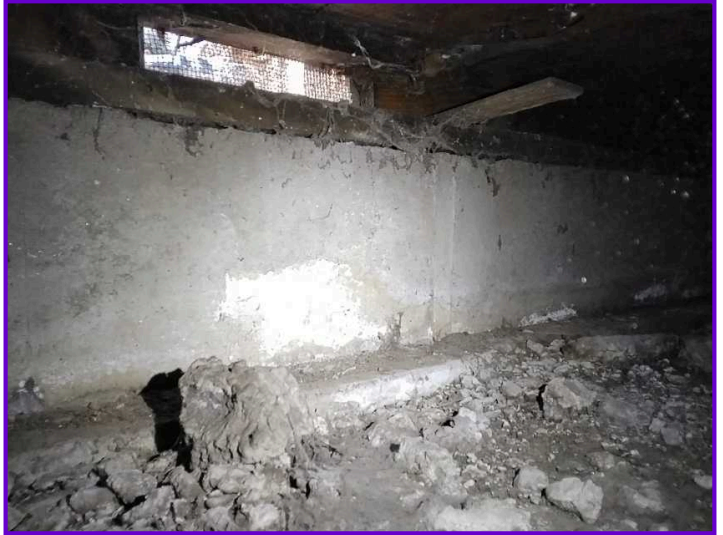
COMMENTS: Ventilation of the foundation crawlspace appears conventional and should be sufficient.

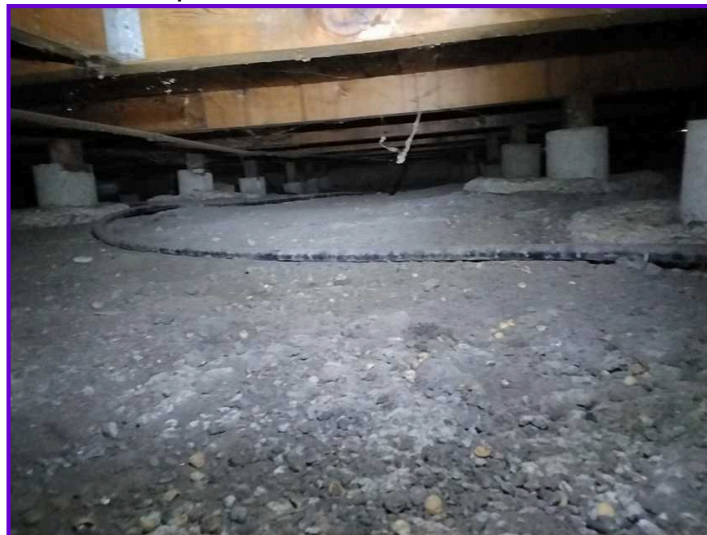
COMMENTS: There was no visible evidence of excessive moisture penetration of the underfloor areas.

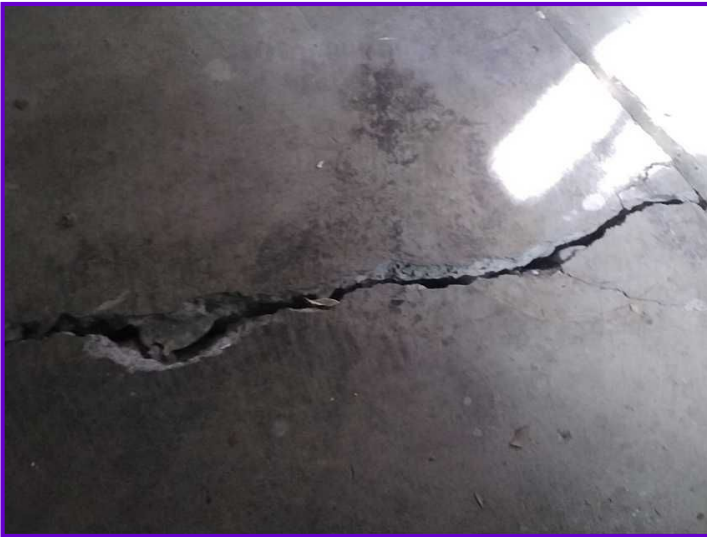
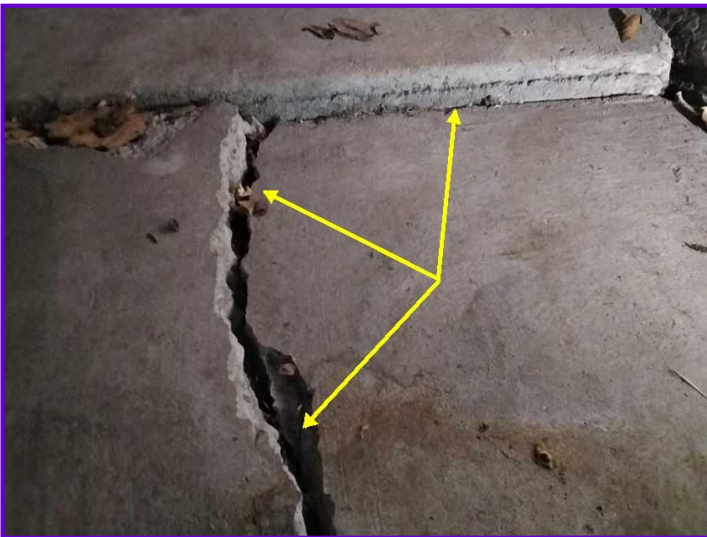
• **DEFERRED:** There are significant separations in the garage concrete slab. This issue may be the result of seismic activity, settlement, unstable soil, or a combination of same. Although the slab is not load bearing, and the cracks do not appear to be structurally threatening, they may allow water to pass through them. Concerned parties may wish to have the cracks evaluated by an appropriately qualified specialist for further remarks and recommendations. **The estimated cost to replace/repair the garage slab is approximately \$20-\$25 per square foot.**

DEFERRED: There are significant separations in the garage concrete slab.
