PROPERTY INSPECTION REPORT

805 Eastbrook Court, Danville, CA 94506

DATE OF INSPECTION: 1/1/2025

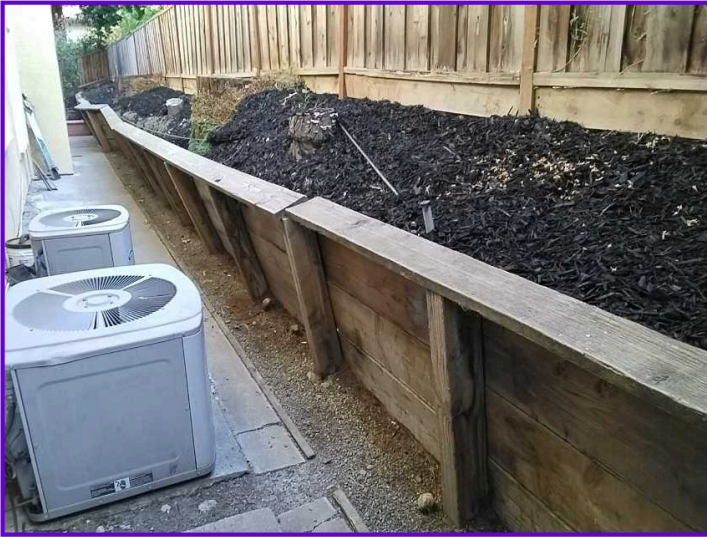
- **MONITOR:** The retaining wall at the side of the property has questionable or unknown structural value as a retaining wall in that it is not engineered as would normally be required for a wall over four feet high and will therefore need to be periodically monitored for movement/failure. These types of walls are far more prone to failure than walls that are engineered, and we cannot endorse them.

MONITOR: The retaining wall at the side of the property has questionable or unknown structural value.

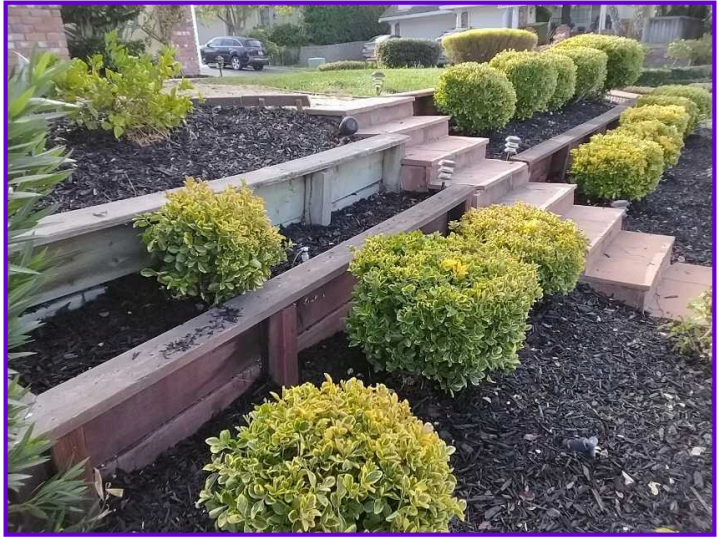
COMMENTS: The retaining walls in the front of the home appear to be functional and displayed no evidence of failure or damage.

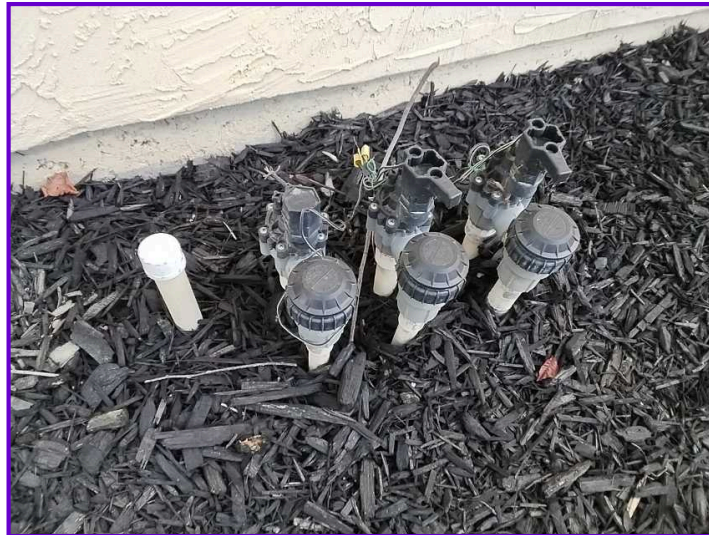
DEFERRED: The property is equipped with an automated watering system.

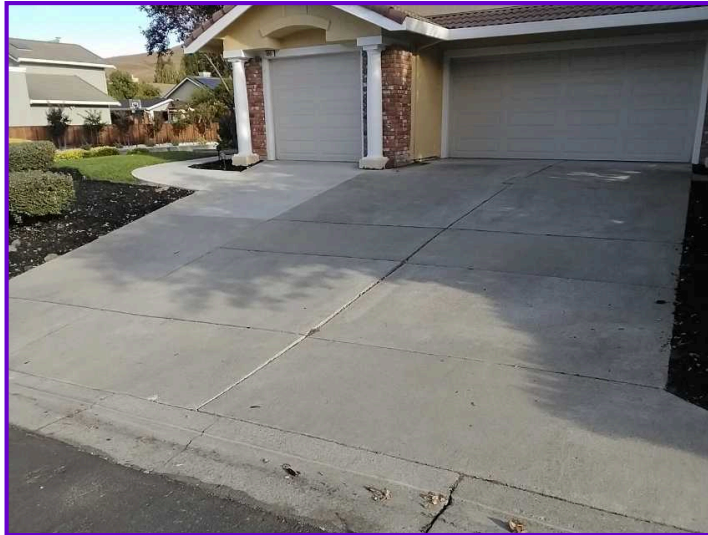
COMMENTS: The concrete driveway is functional but has some minor cracks.

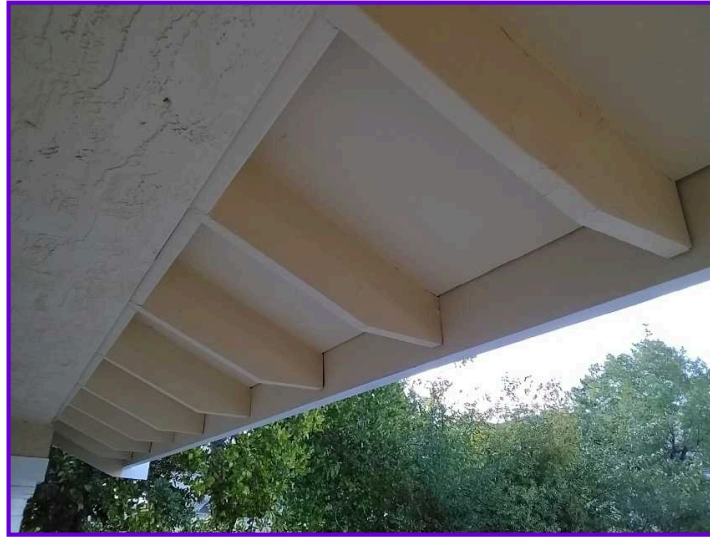
COMMENTS: The eaves and soffits appear to be in functional condition.

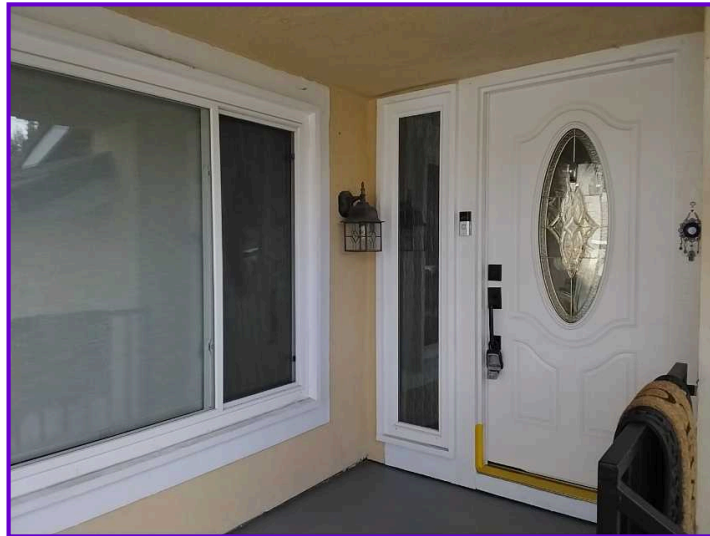
COMMENTS: The door and window exteriors appear to be in satisfactory condition.

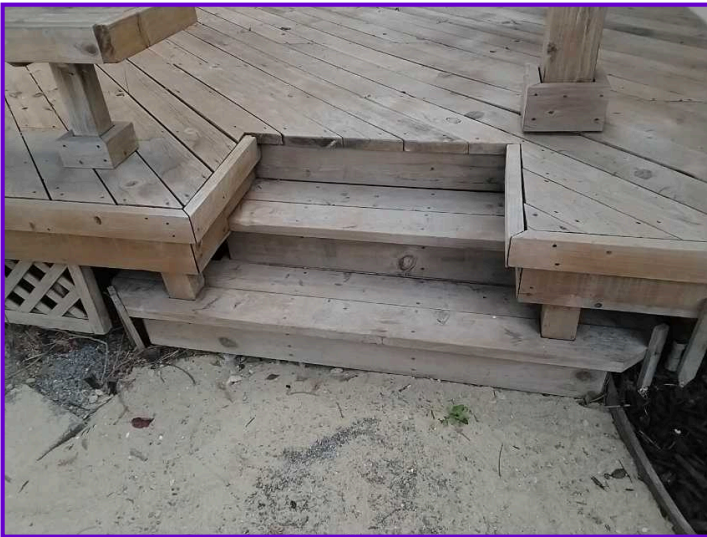
COMMENTS: The attached stairs and landing at the rear of the residence are in satisfactory condition.

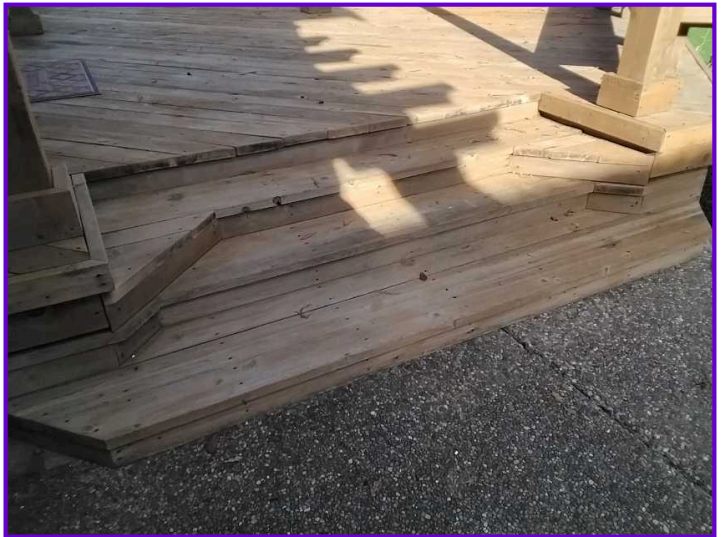
COMMENTS: The attached stairs at the rear of the residence are in satisfactory condition.

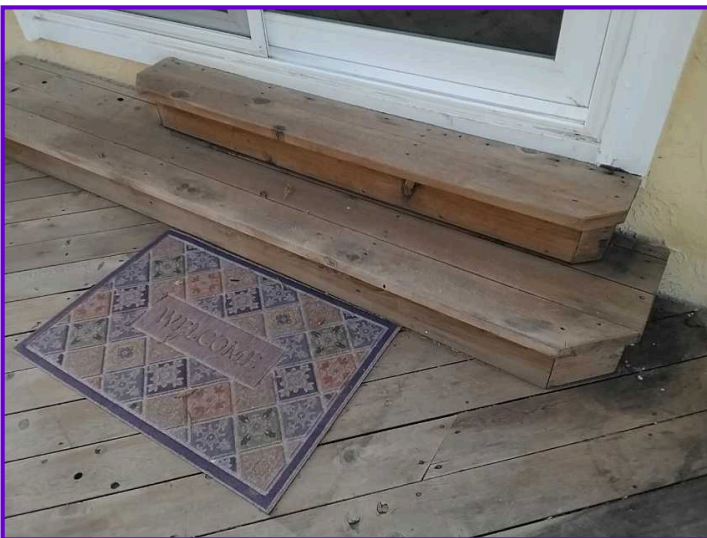
COMMENTS: The attached stairs at the rear of the residence are in satisfactory condition.

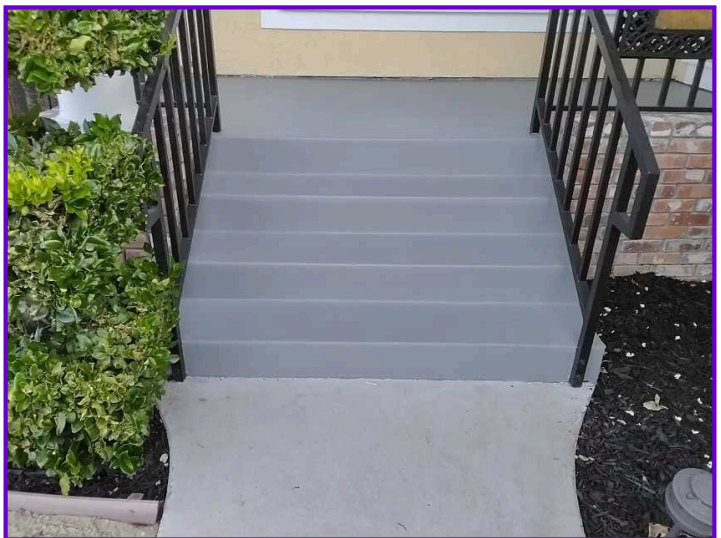
COMMENTS: The attached stairs at the front of the residence are in satisfactory condition.

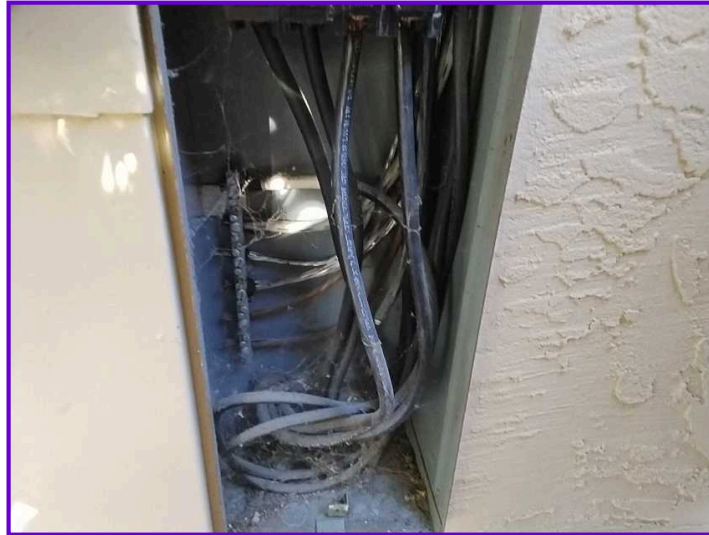
COMMENTS: We observed no deficiencies at the visible and accessible branch circuit wiring within the main panel.

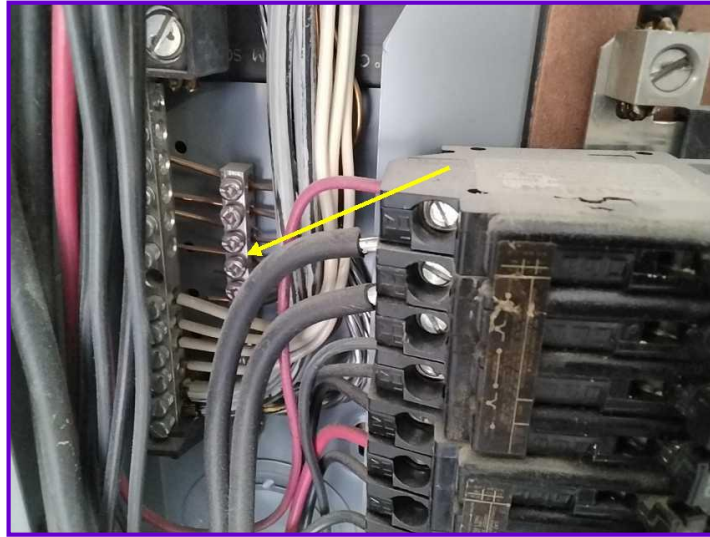
COMMENTS: The sub panel appears to be properly grounded.

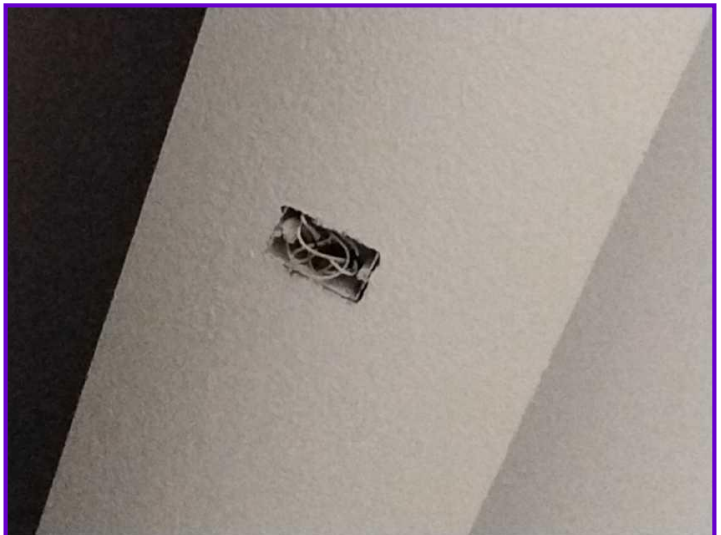
CAUTION: There are missing outlet covers that need to be replaced for safety reasons.

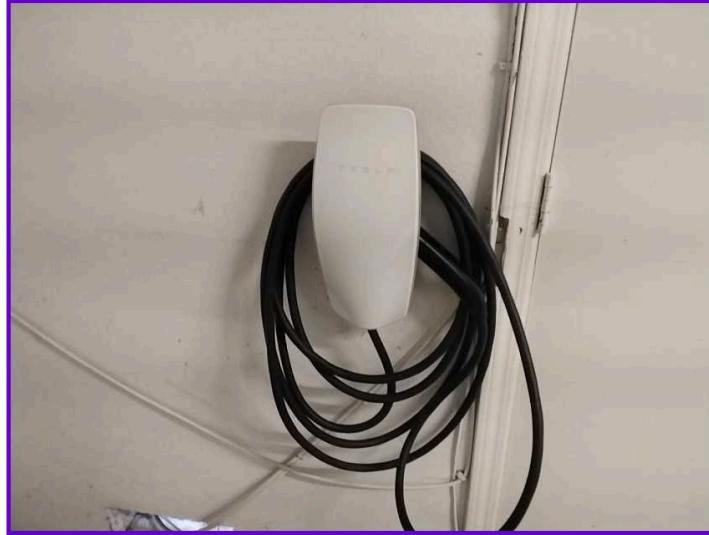
DEFERRED: The electrical system includes an electric vehicle charger (EVC) located in the garage.

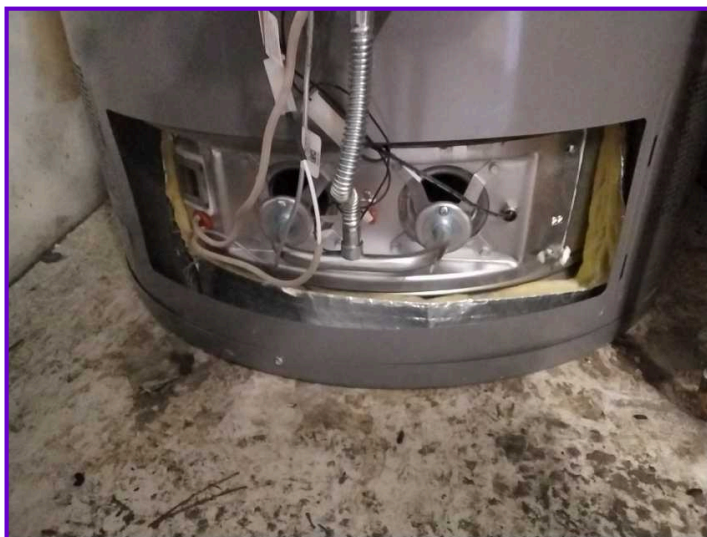
COMMENTS: The combustion chamber is free of leakage and excessive rust or corrosion.

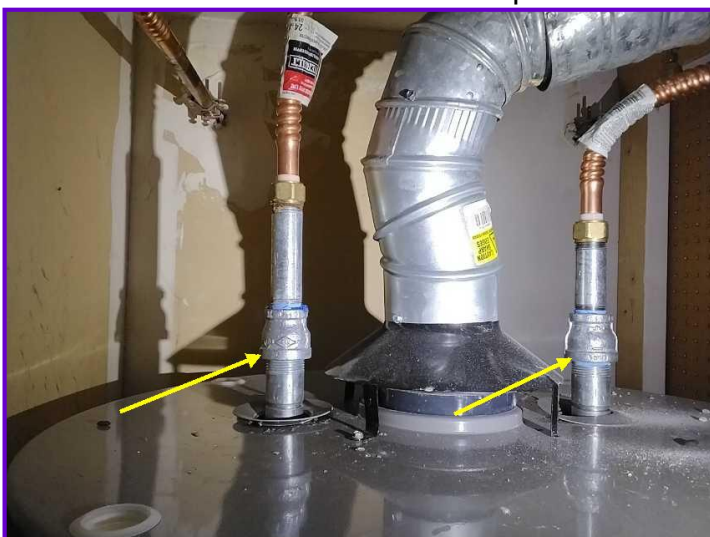
COMMENTS: The water supply lines and connectors appeared to be in satisfactory condition.

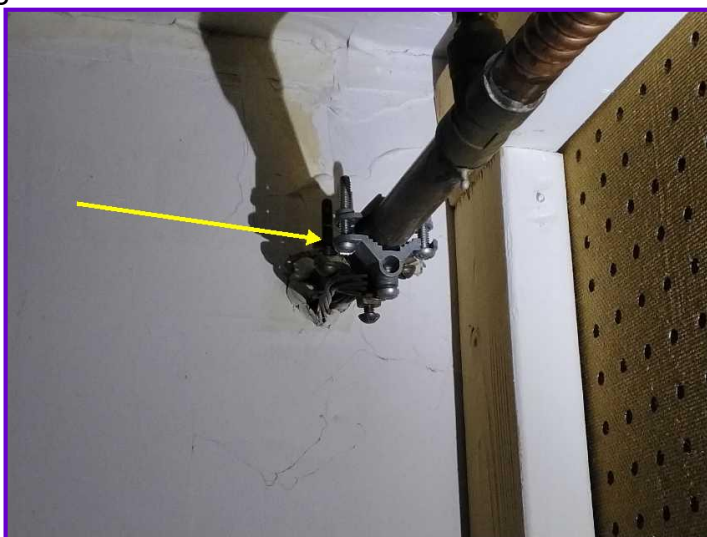
COMMENTS: The supply lines at the water heater are properly bonded.

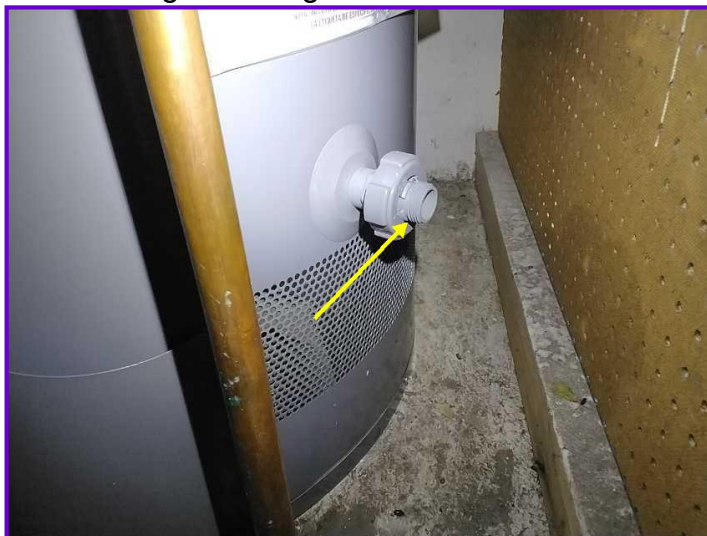
COMMENTS: A drain valve was installed on the water heater.

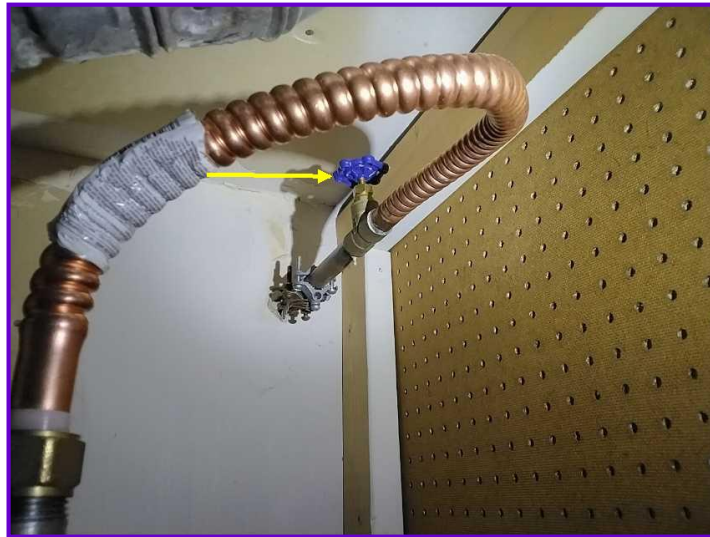
COMMENTS: The shut-off valve and water line connectors on the water heater appeared functional.

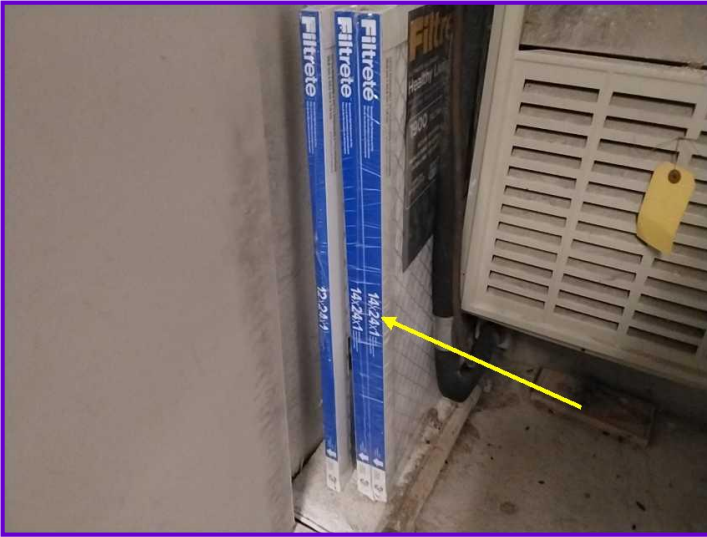
PREVENTIVE: Depending on filter type, it is important to replace or clean the filter every two or three months.

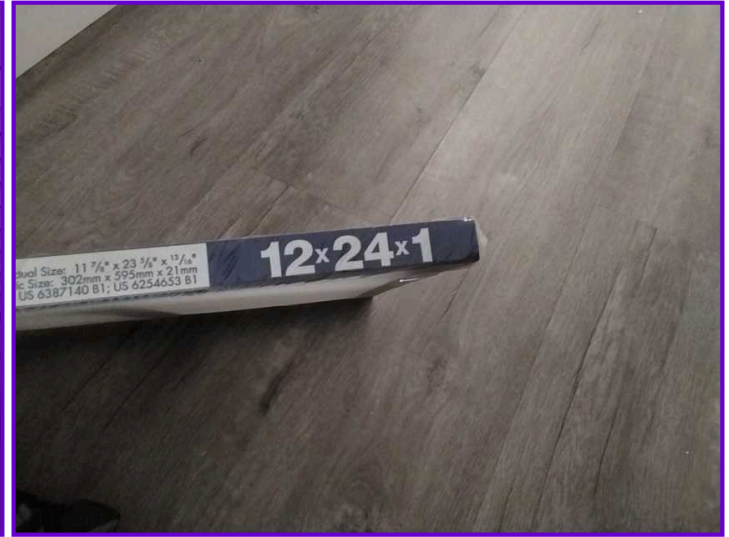
PREVENTIVE: Depending on filter type, it is important to replace or clean the filter every two or three months.

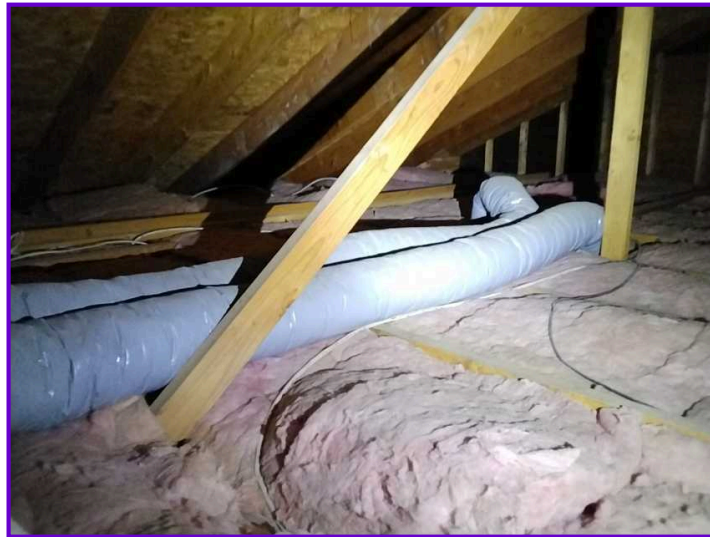
COMMENTS: Where visible and accessible, the supply ducts were in satisfactory condition.

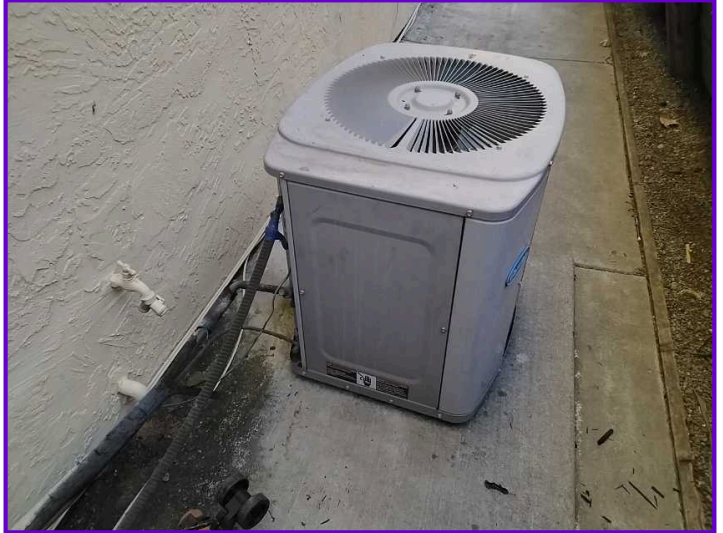
COMMENTS: All secondary condenser system components appeared to be functional and in satisfactory condition.

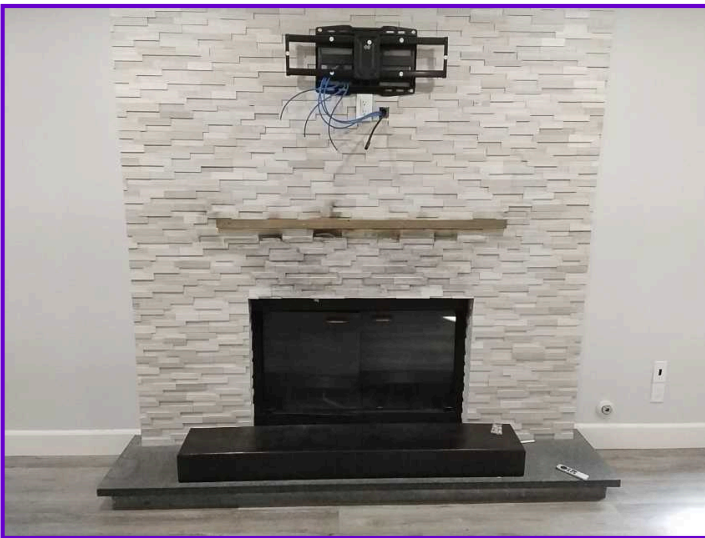
COMMENTS: The masonry fireplace appears to have no visible defects.

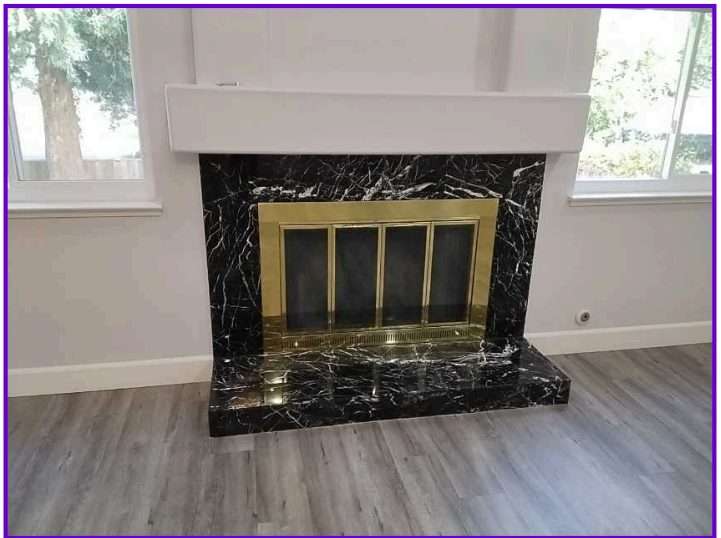
COMMENTS: The masonry fireplace appears to have no visible defects.

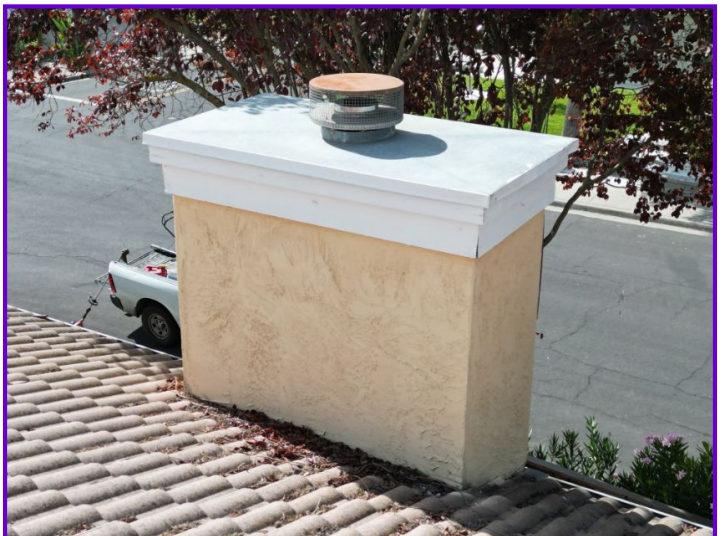
COMMENTS: The chimney structures had no visible defects.

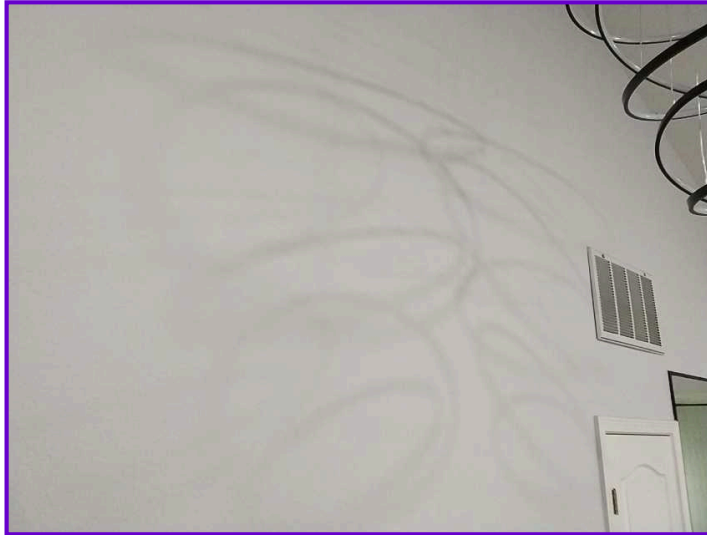
COMMENTS: The wall coverings may have some minor cosmetic damage but are functional.

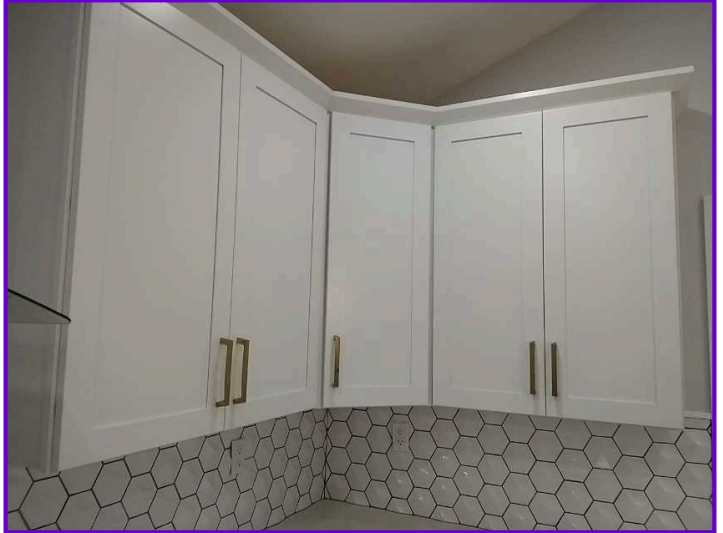
COMMENTS: The cabinetry is functional but may have minor wear that is commensurate with its age.

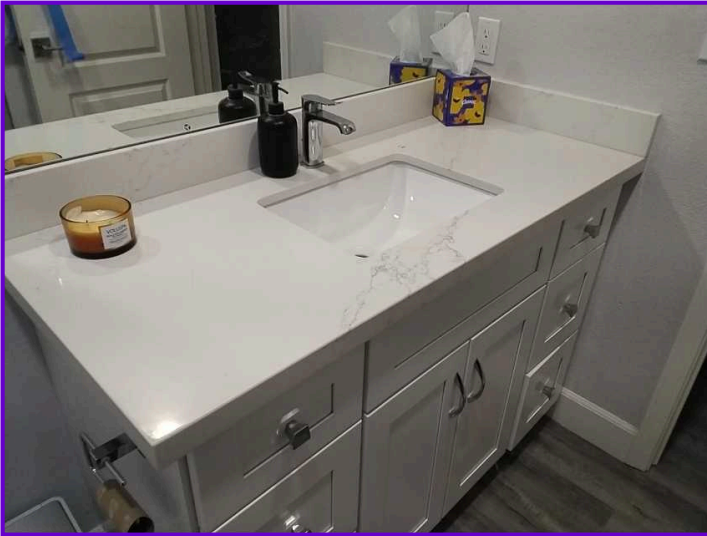
COMMENTS: The bathroom vanity tops are functional but may have minor wear that is commensurate with their age.

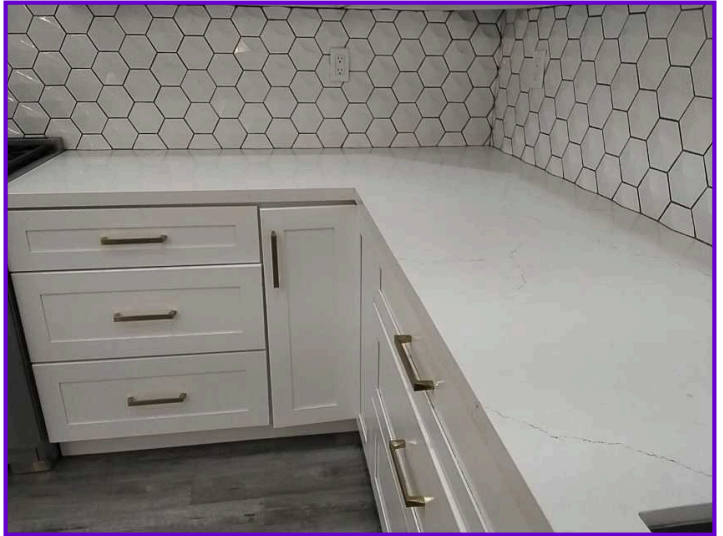
COMMENTS: The kitchen counter tops are functional but may have minor wear that is commensurate with their age.

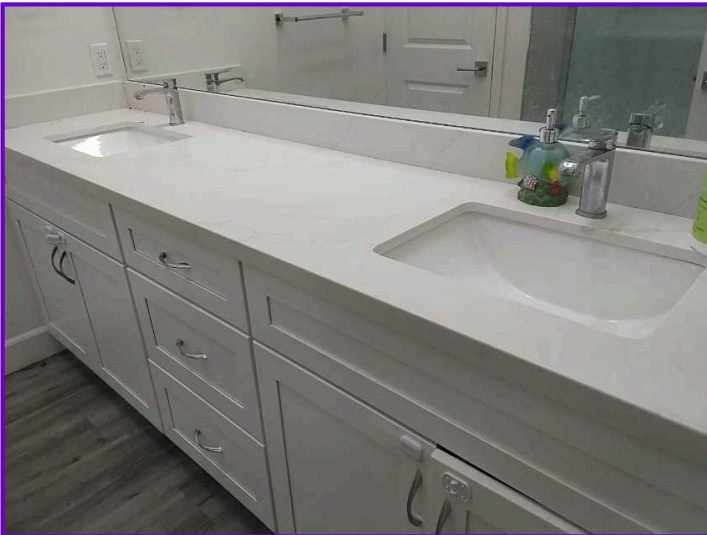
COMMENTS: The bathroom vanity tops are functional but may have minor wear that is commensurate with their age.

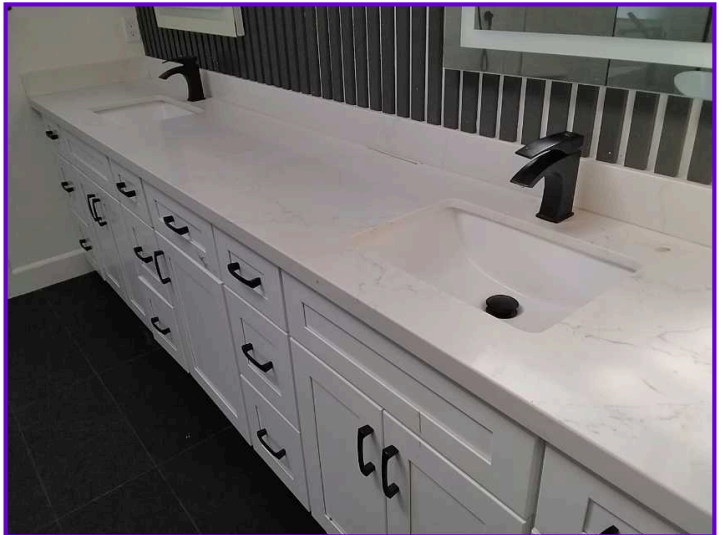
COMMENTS: The bathroom vanity tops are functional but may have minor wear that is commensurate with their age.

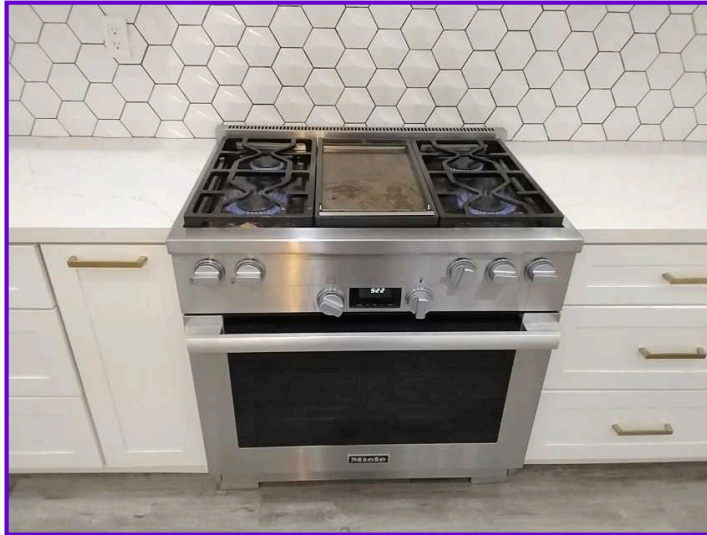
COMMENTS: The gas range (includes the stove burners, oven components, and primary controls) responded to normal user controls.

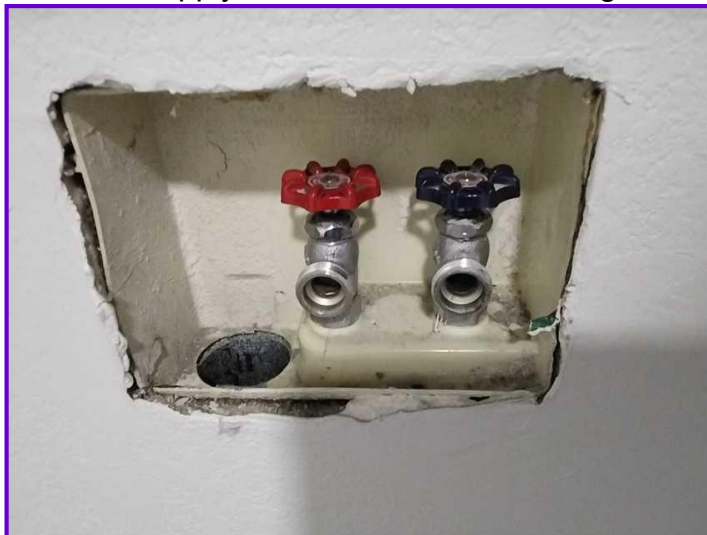
COMMENTS: The washer water supply valves were free of leakage but were not turned or tested.
