SEWER LATERAL REPORT

8000 Eastbrook Court, Danville, CA 94506

DATE OF INSPECTION: 1/1/2025

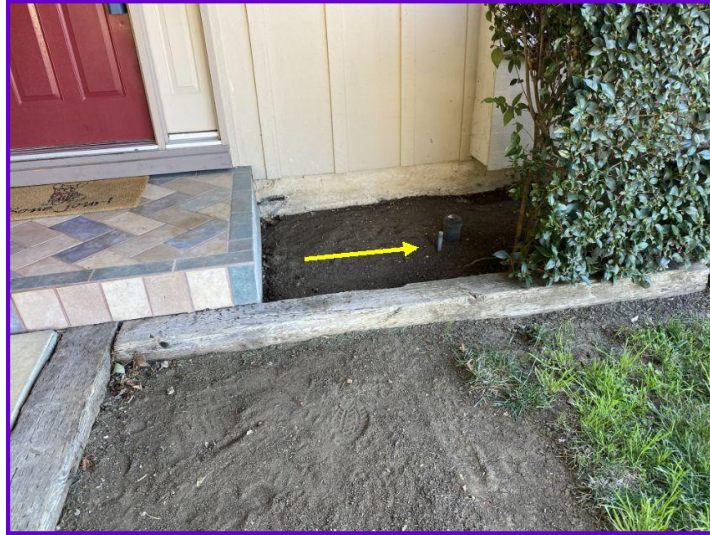
- **COMMENTS:** An exterior clean-out is located at the front of the home near the entry door. This clean-out provides essential access to the main drainpipe, allowing for inspection and facilitating the cleaning of the main waste line in the event of a blockage. It is important to be aware of the location of this exterior clean-out, as it will be beneficial should you ever need to clear the sewer lines.

COMMENTS: An exterior clean-out is located at the front of the home near the entry door.

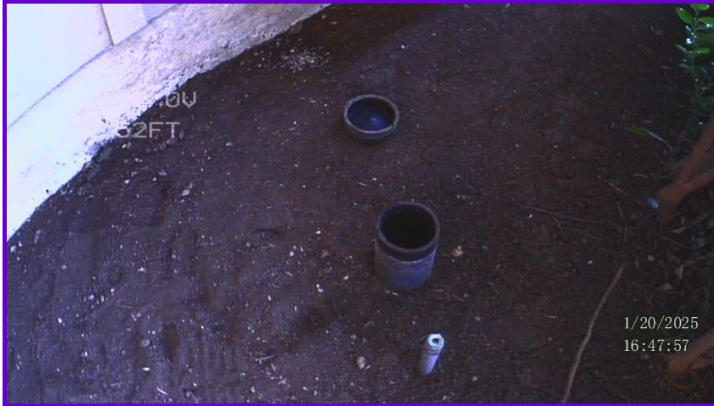
- **COMMENTS:** The sewer lateral access point is constructed of cast iron. Cast iron is a traditional material that is known for its strength and longevity; however, it can be susceptible to corrosion and deterioration over time. It is crucial to monitor the condition of the piping for any signs of rust, leaks, or structural weakness. Regular maintenance and inspections are recommended to mitigate potential issues, such as blockages or failures.
- **COMMENTS:** The sewer lateral access extends approximately 6 feet where it connects with the PVC section of the drain line.

COMMENTS: The sewer lateral access is constructed of cast iron.

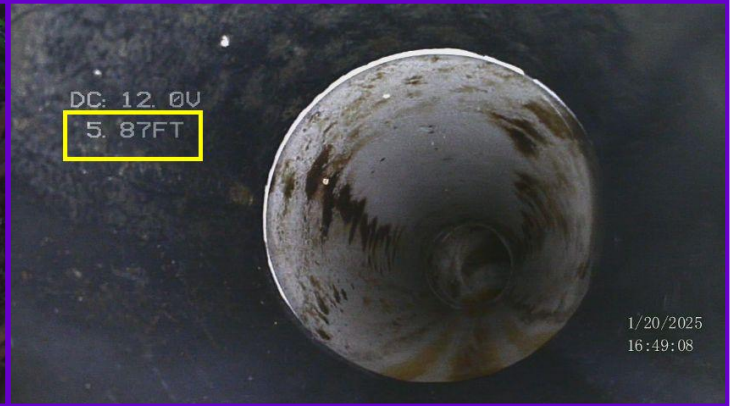
COMMENTS: The sewer lateral access extends approximately 6 feet where it connects with the PVC section of the drain line.

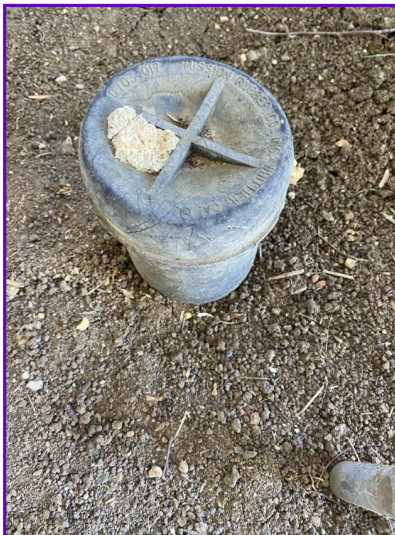
- COMMENTS: The sewer lateral access and cover were observed to be in good condition at the time of inspection. This indicates that the access point is functioning properly and is free from any visible defects or damage. Regular monitoring and maintenance are still advised to ensure ongoing functionality and to prevent potential issues in the future.

COMMENTS: The sewer lateral access and cover were observed to be in good condition at the time of inspection.

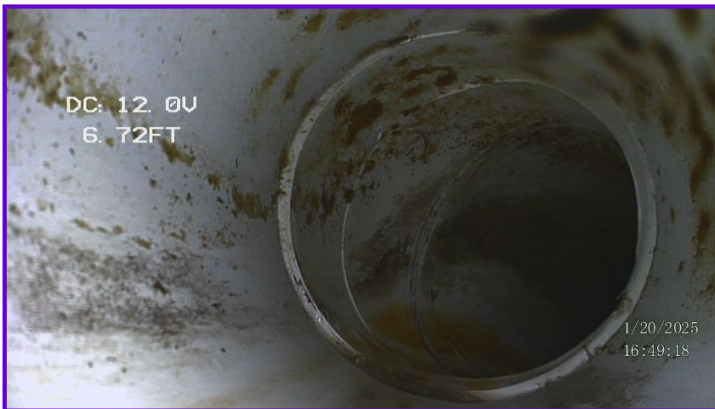
- **COMMENTS:** The first 51 feet of the sewer lateral drain line appears to be constructed of Polyvinyl Chloride (PVC). While PVC is commonly used for sewer lines due to its durability and resistance to corrosion, it is important to ensure that there are no obstructions or damage to the piping. Regular maintenance and inspection are advised to prevent any potential issues, such as clogs or leaks. A professional should be consulted to assess the condition of the sewer lateral and address any concerns regarding its functionality on an annual basis.

COMMENTS: The first 51 feet of the sewer lateral drain line appears to be constructed of Polyvinyl Chloride (PVC).

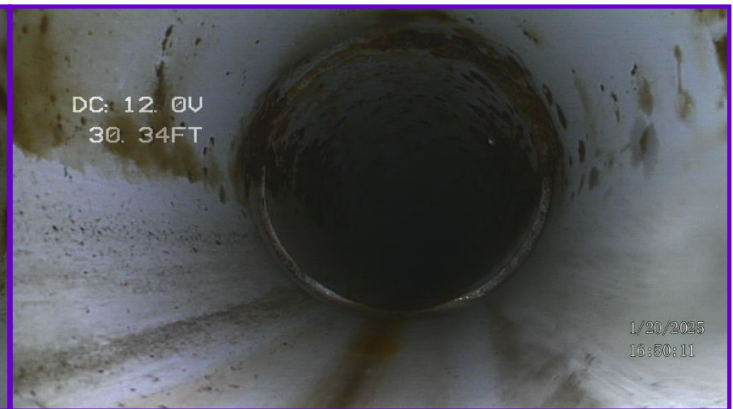
COMMENTS: The first 51 feet of the sewer lateral drain line appears to be constructed of Polyvinyl Chloride (PVC).

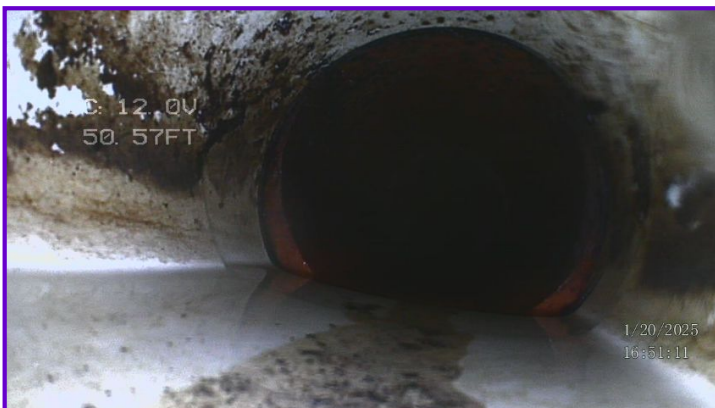
- **COMMENTS:** At approximately 51 feet from the entrance, the sewer lateral drain line transitions to vitrified clay. This material is commonly used for sewer lines due to its durability and resistance to chemical corrosion and root infiltration. While vitrified clay can provide a long service life, it is important to regularly inspect the piping for any signs of cracking, shifting, or blockage, which can compromise its functionality. To ensure optimal performance and prevent potential issues, regular maintenance and inspections are recommended.

COMMENTS: At approximately 51 feet from the entrance, the sewer lateral drain line transitions to vitrified clay.

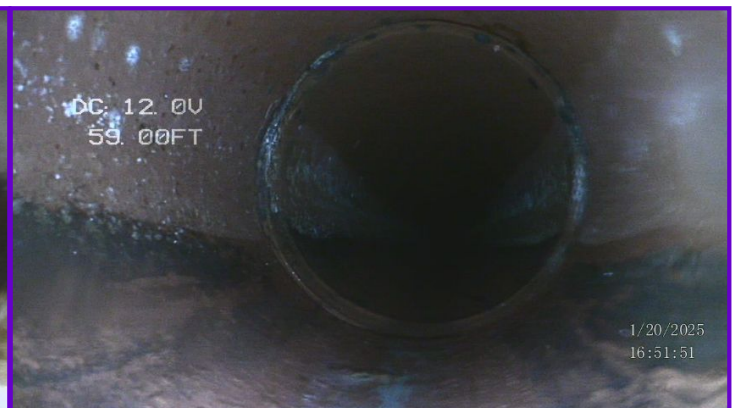
COMMENTS: At approximately 51 feet from the entrance, the sewer lateral drain line transitions to vitrified clay.

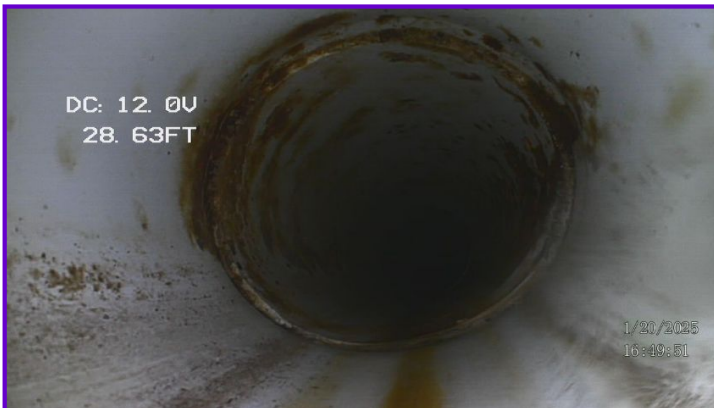
• **COMMENTS:** The overall condition of the sewer lateral system appears to be clear and in satisfactory condition. There are no visible breaks, leaks, offsets, or blockages. These sewer lateral lines, when properly installed and maintained, typically have an expected lifespan of around 50 years or more. Given its current status, and with appropriate maintenance and regular professional inspections, this system is expected to function effectively and reliably for many decades to come.

COMMENTS: The overall condition of the PVC sewer lateral system appears to be clear and in satisfactory condition.

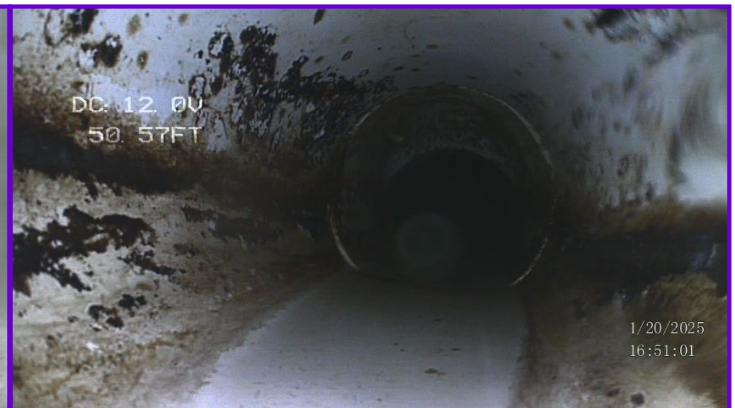
COMMENTS: The overall condition of the PVC sewer lateral system appears to be clear and in satisfactory condition.

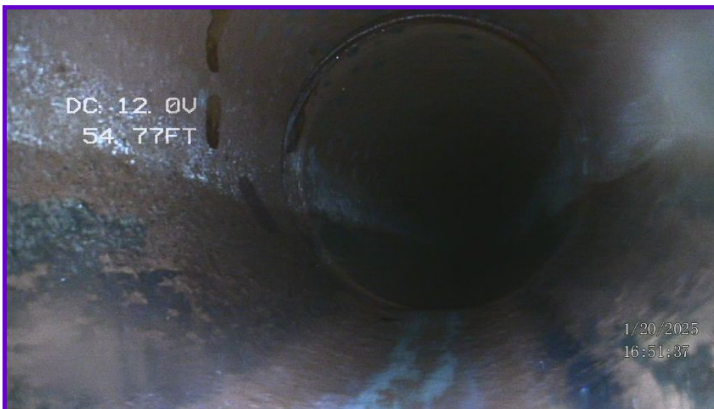
COMMENTS: The overall condition of the clay sewer lateral system appears to be clear and in satisfactory condition.

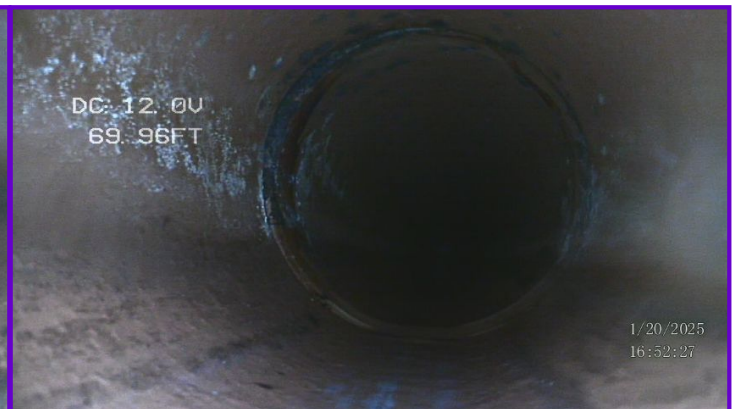
COMMENTS: The overall condition of the clay sewer lateral system appears to be clear and in satisfactory condition.

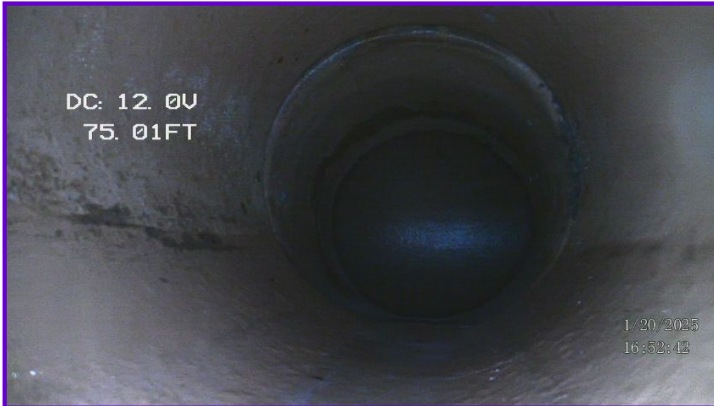
• **COMMENTS:** The private residential sewer lateral connects with the public utility system at approximately 75 feet from the private access point.

COMMENTS: The private sewer lateral connects with the public utility system at approximately 75 feet from the clean out entrance.

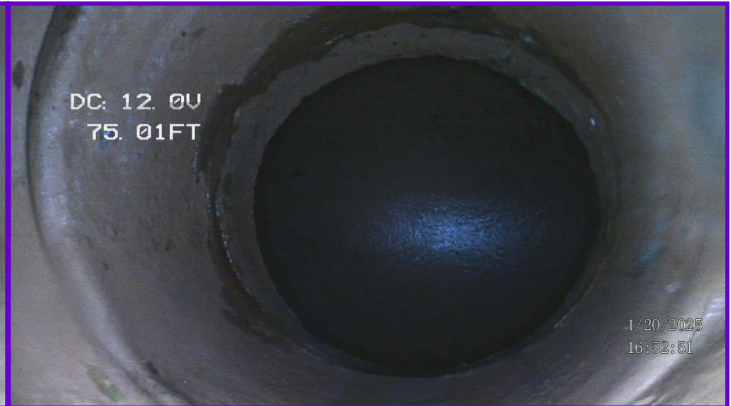
COMMENTS: The private sewer lateral connects with the public utility system at approximately 75 feet from the clean out entrance.
