# ROOF INSPECTION REPORT

**805 Eastbrook Court, Danville, CA**

DATE OF INSPECTION: 1/1/2025

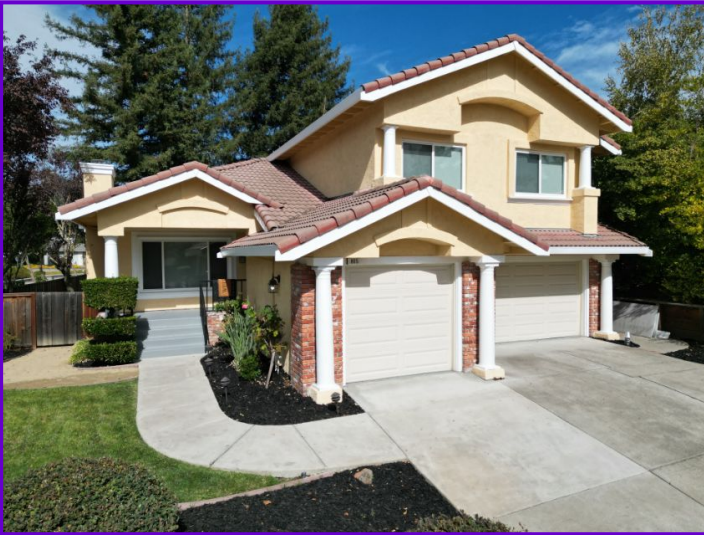
**COMMENTS:** The residence features a sloped or pitched roof.

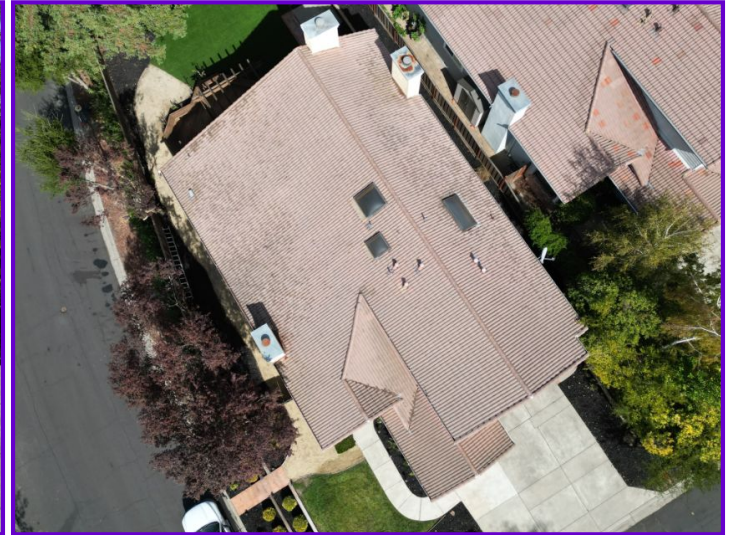
**COMMENTS:** The residence features a sloped or pitched roof.

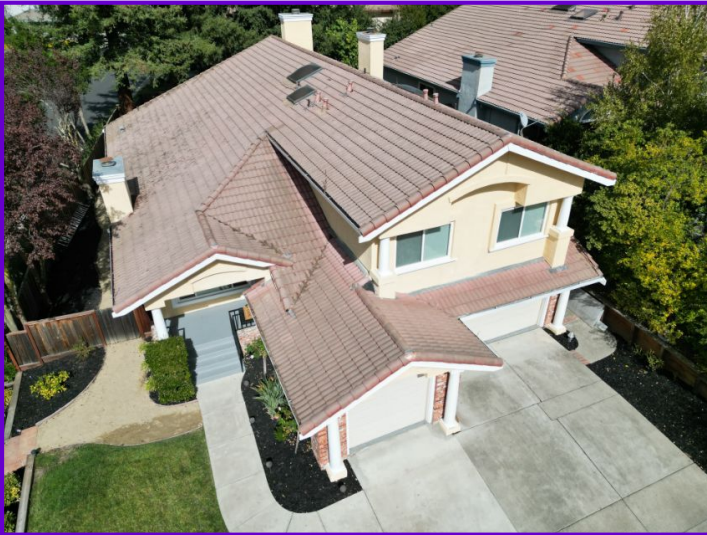
COMMENTS: The composite tile roofing material appears to be in satisfactory condition relative to its age.

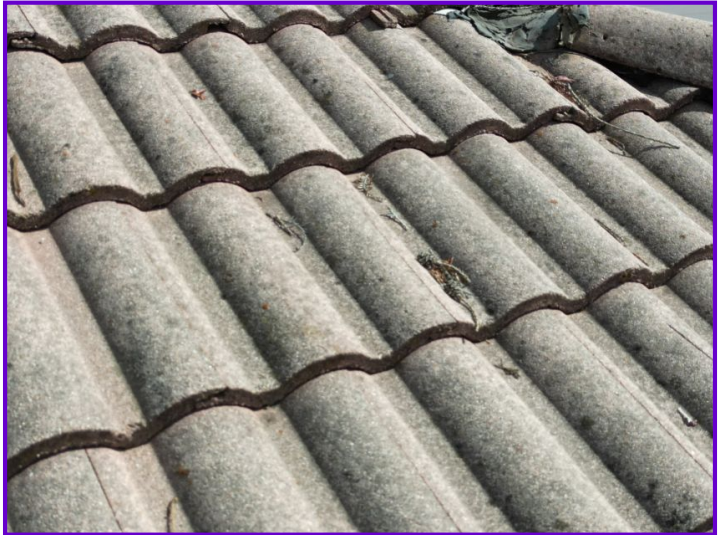
COMMENTS: The composite tile roofing material appears to be in satisfactory condition relative to its age.

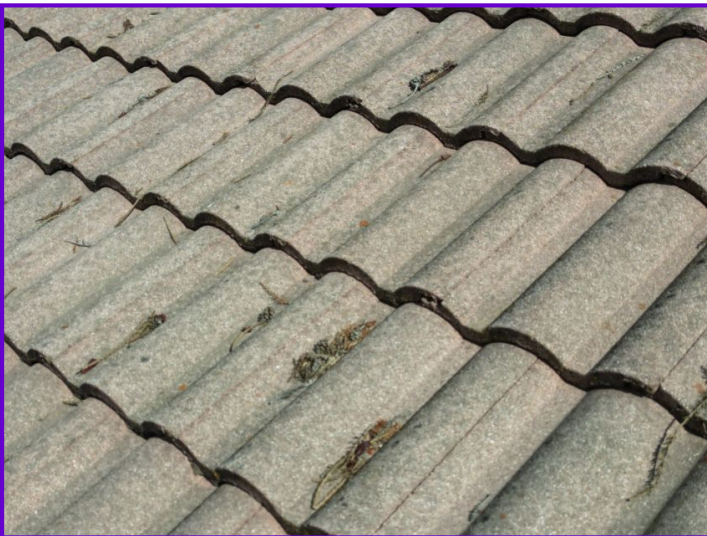
COMMENTS: The composite tile roofing material appears to be in satisfactory condition relative to its age.

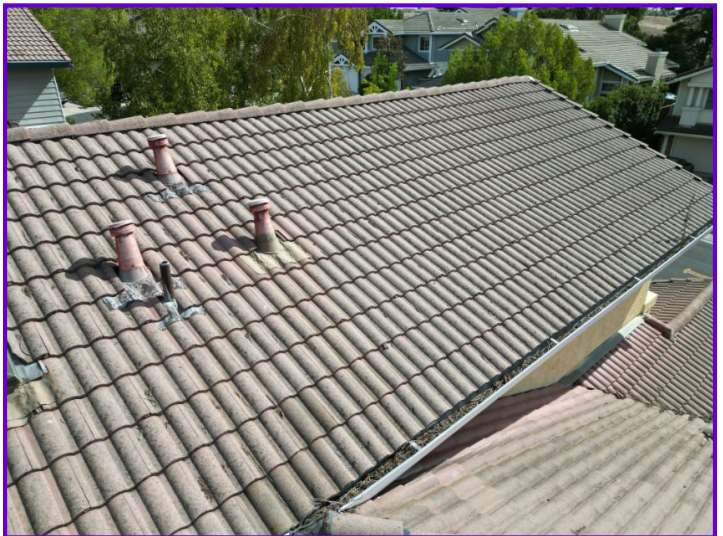
COMMENTS: The composite tile roofing material appears to be in satisfactory condition relative to its age.

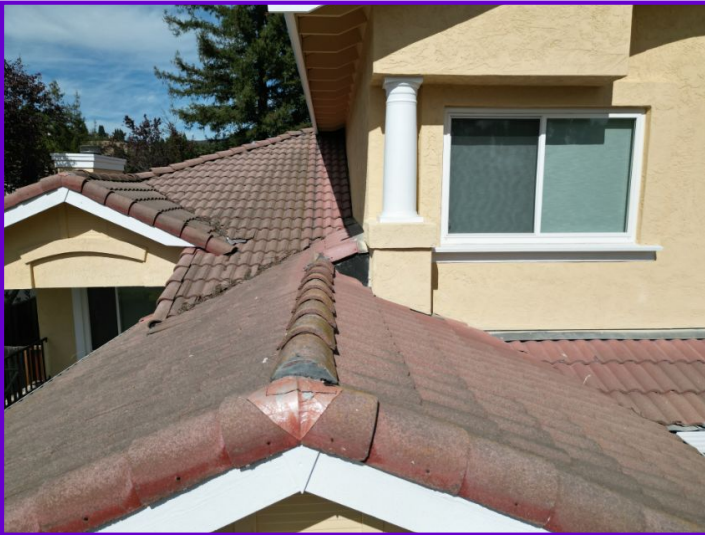
COMMENTS: The composite tile roofing material appears to be in satisfactory condition relative to its age.

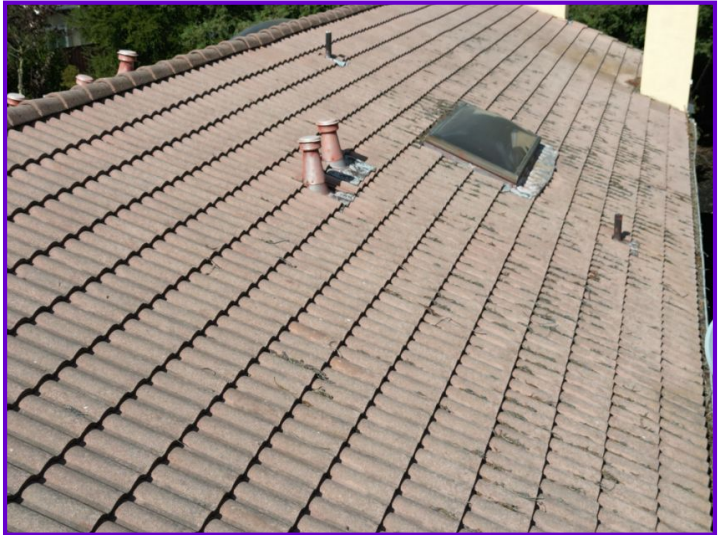
COMMENTS: The composite tile roofing material appears to be in satisfactory condition relative to its age.

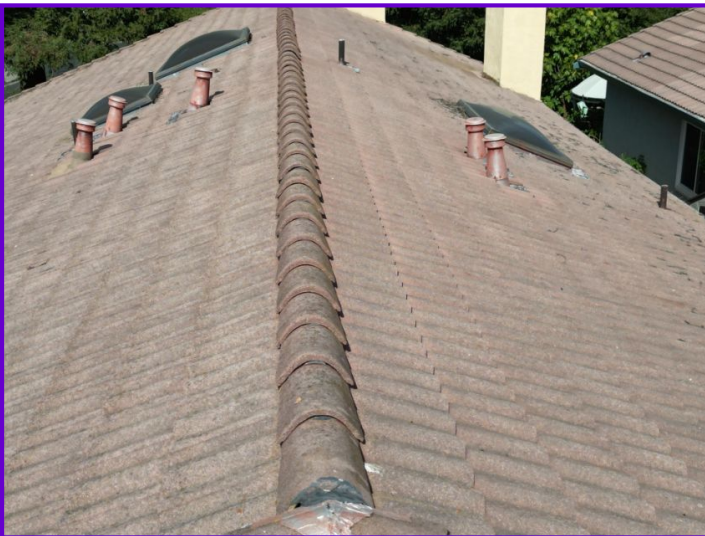
COMMENTS: The composite tile roofing material appears to be in satisfactory condition relative to its age.

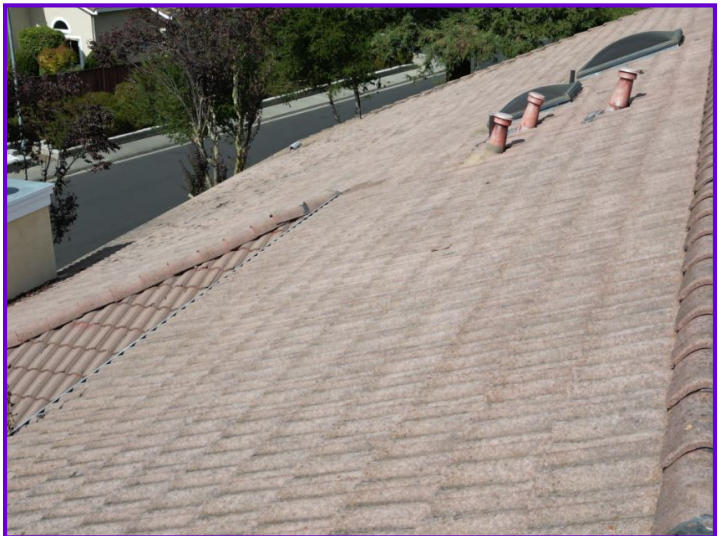
COMMENTS: The composite tile roofing material appears to be in satisfactory condition relative to its age.

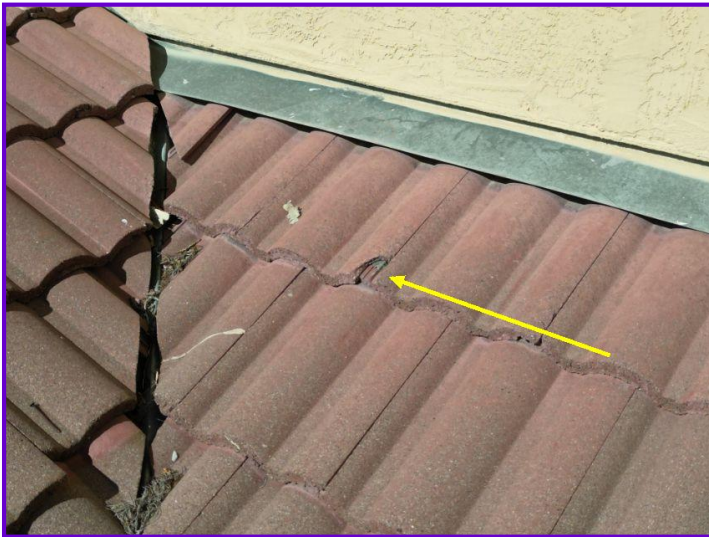
• **COMMENTS:** There may be the occasional cracked or chipped tiles, but none that would appear to warrant replacement of the tiles. This is common on tile roofs and is normally not a concern.

COMMENTS: There may be the occasional cracked or chipped tiles, but none that would appear to warrant replacement of the tiles.

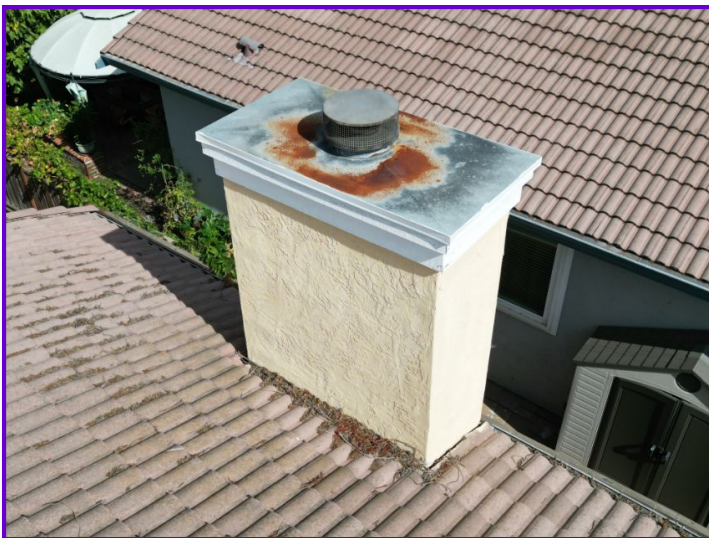
- **MONITOR:** There are two chimneys that are over 30 inches wide and do not have diverter flashings to help prevent water from pooling at the roof area directly behind them. This area is a common point for damming and leakage. Concerned parties may wish to monitor this area regularly and keep clear of debris.

**MONITOR:** There are two chimneys that are over 30 inches wide and do not have diverter flashings.

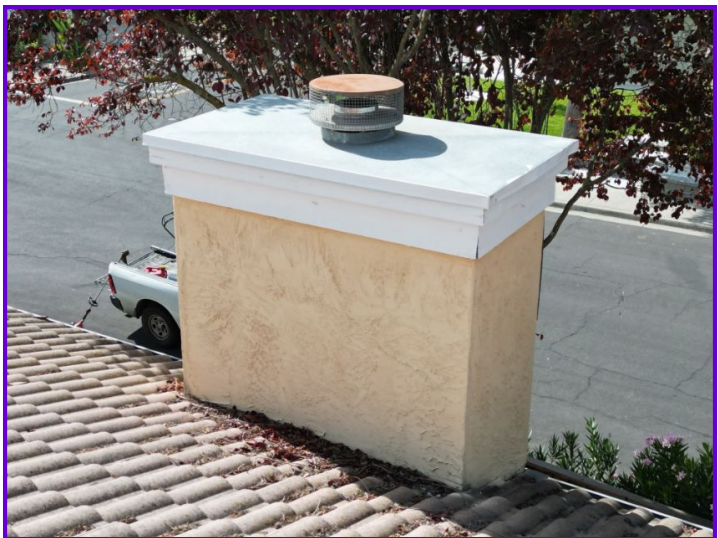
**MONITOR:** There are two chimneys that are over 30 inches wide and do not have diverter flashings.

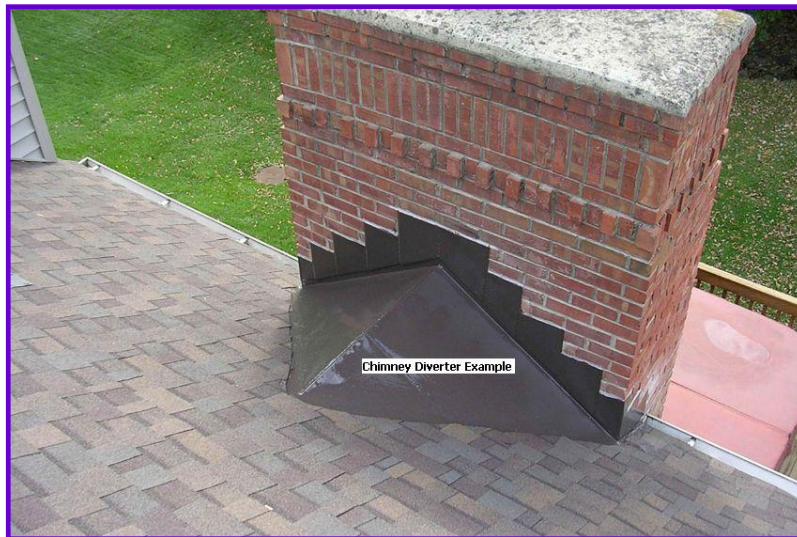
MONITOR: There are two chimneys that are over 30 inches wide and do not have diverter flashings.

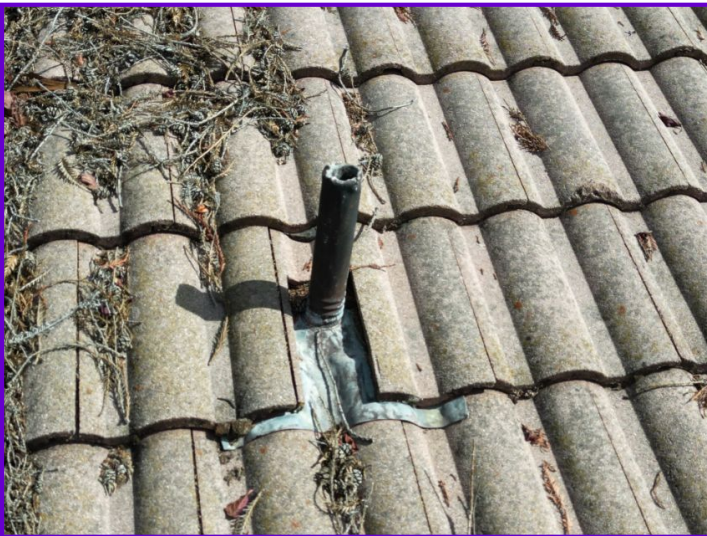
COMMENTS: The plumbing vent protrusions appeared to be well sealed, properly flashed and in satisfactory condition.

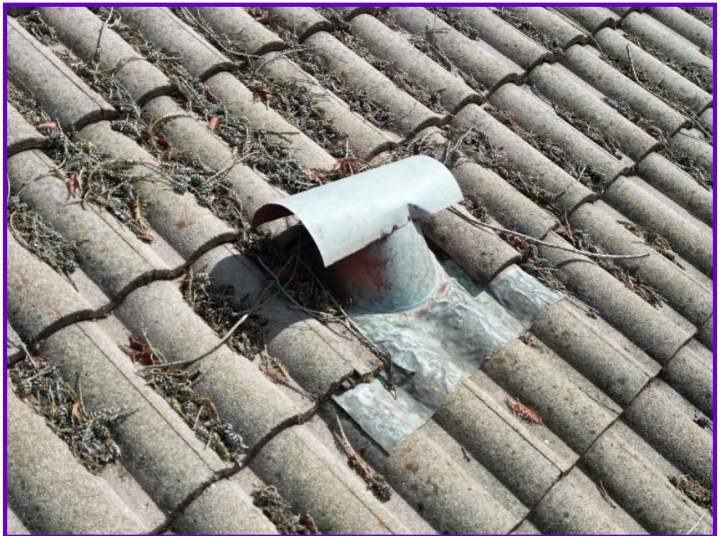
COMMENTS: The exhaust vent protrusions appeared to be well sealed, properly flashed and in satisfactory condition.

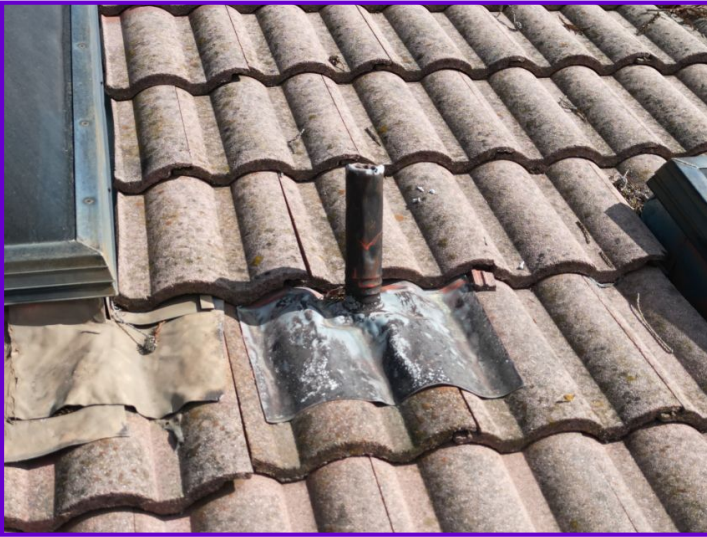
COMMENTS: The plumbing vent protrusions appeared to be well sealed, properly flashed and in satisfactory condition.

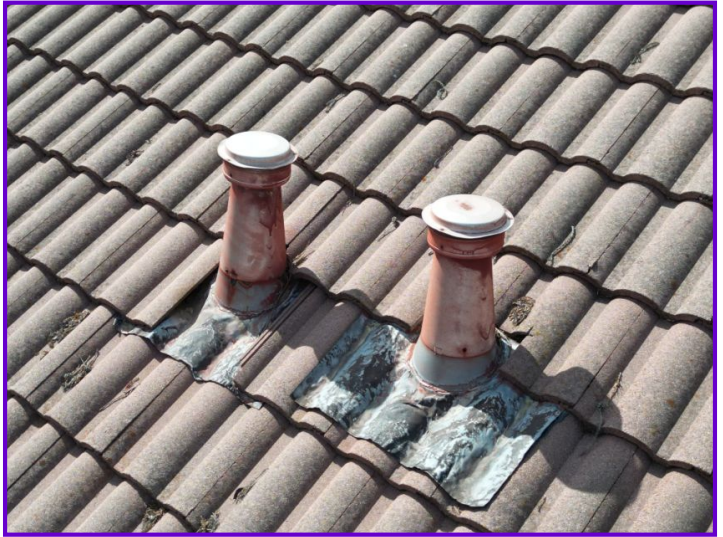
COMMENTS: The exhaust vent protrusions appeared to be well sealed, properly flashed and in satisfactory condition.

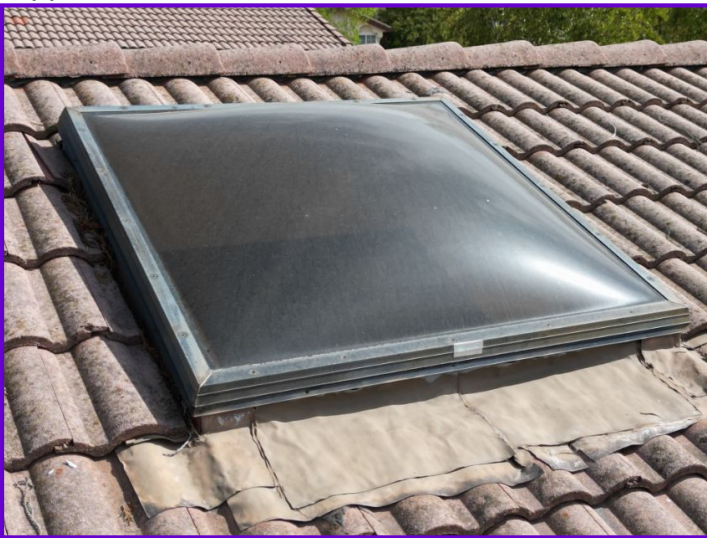
COMMENTS: The roof includes skylights which appeared to be in satisfactory condition.

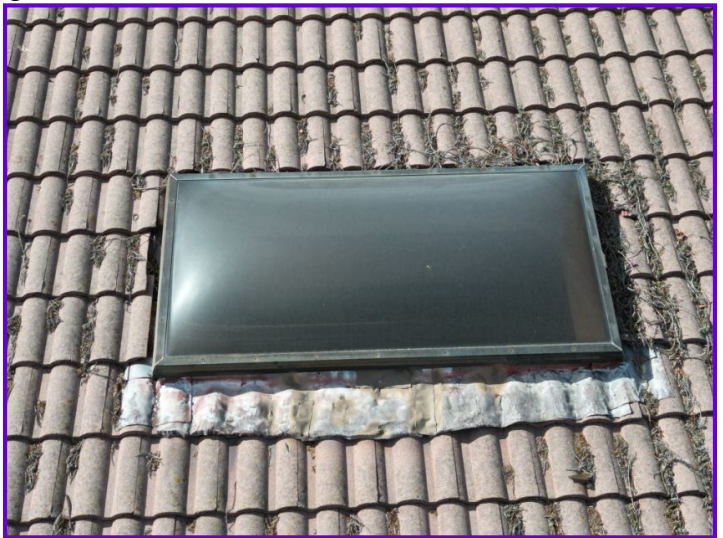
COMMENTS: The roof includes skylights which appeared to be in satisfactory condition.

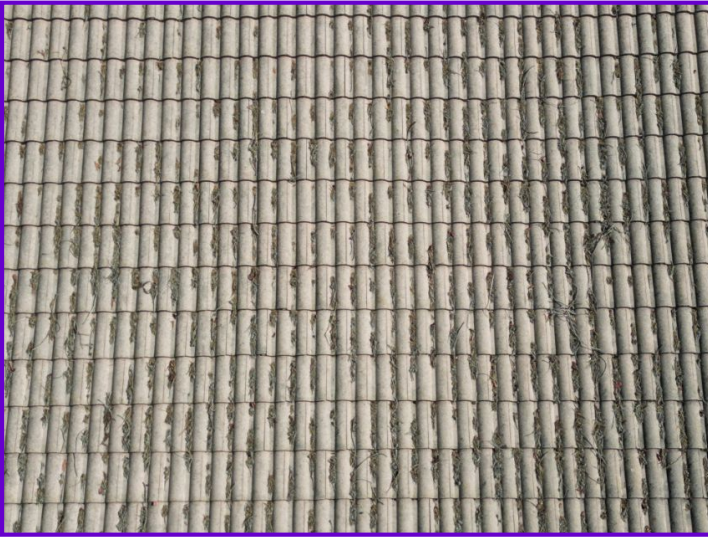
PREVENTIVE: Regular cleaning and maintenance of the roof are essential.

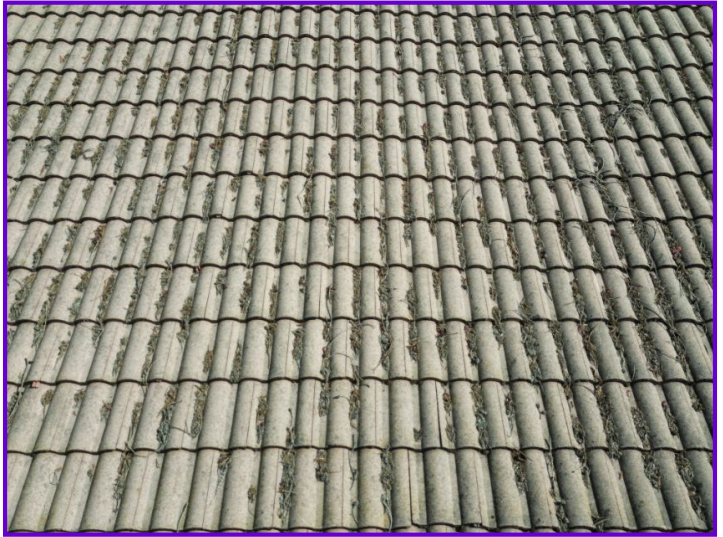
PREVENTIVE: Regular cleaning and maintenance of the roof are essential.

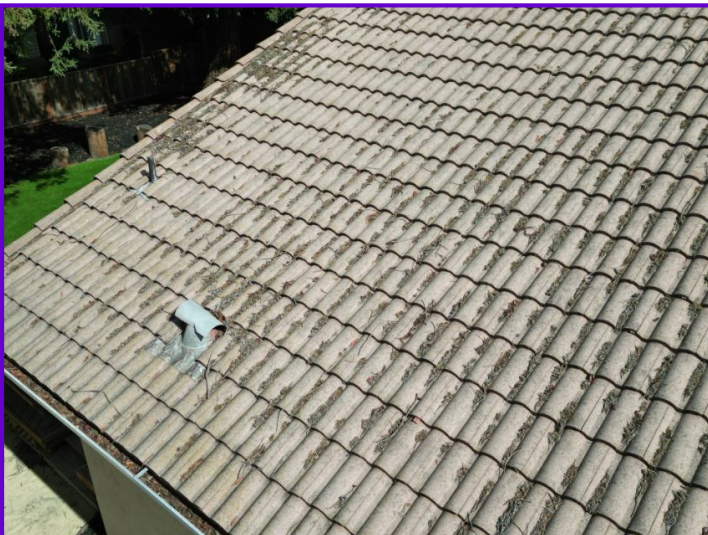
PREVENTIVE: Regular cleaning and maintenance of the roof are essential.

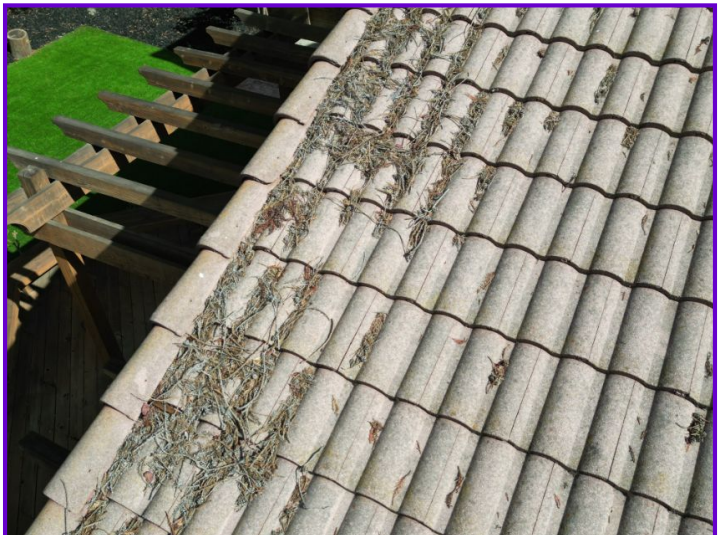
PREVENTIVE: Regular cleaning and maintenance of the roof are essential.

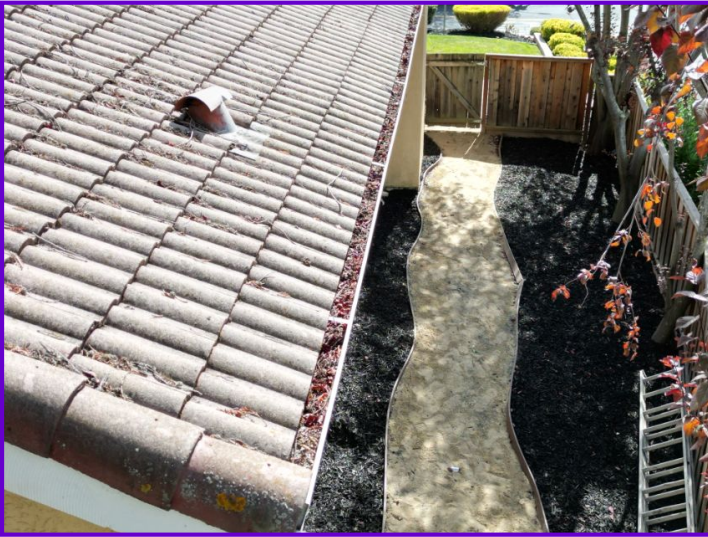
**MAINTENANCE:** The roof gutters need to be cleaned, sealed and serviced to perform properly.

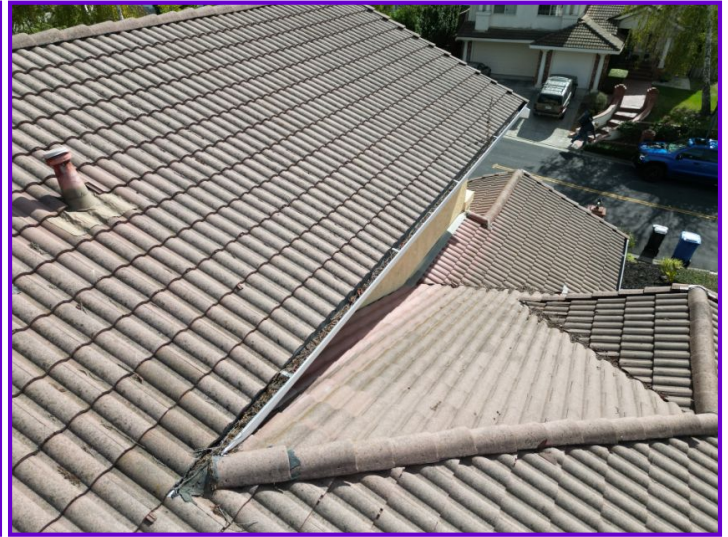
**MAINTENANCE:** The roof gutters need to be cleaned, sealed and serviced to perform properly.

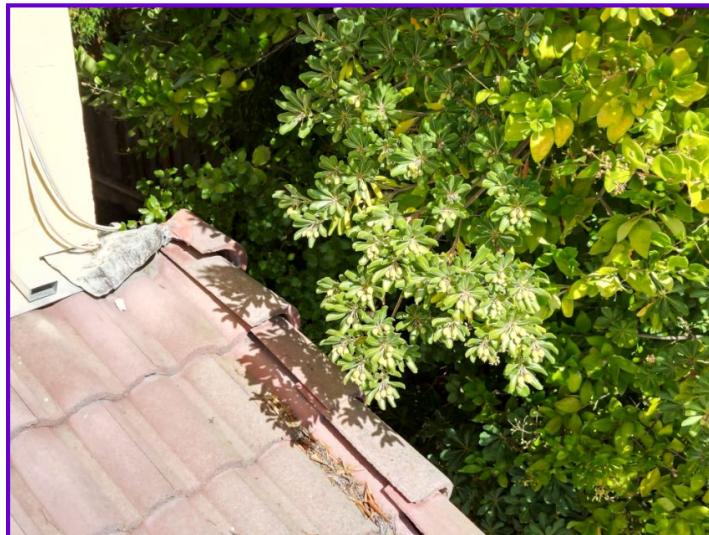
**PREVENTIVE:** The roof needs any foliage trimmed away and maintained to prevent damage to the roof covering and to facilitate proper drainage.

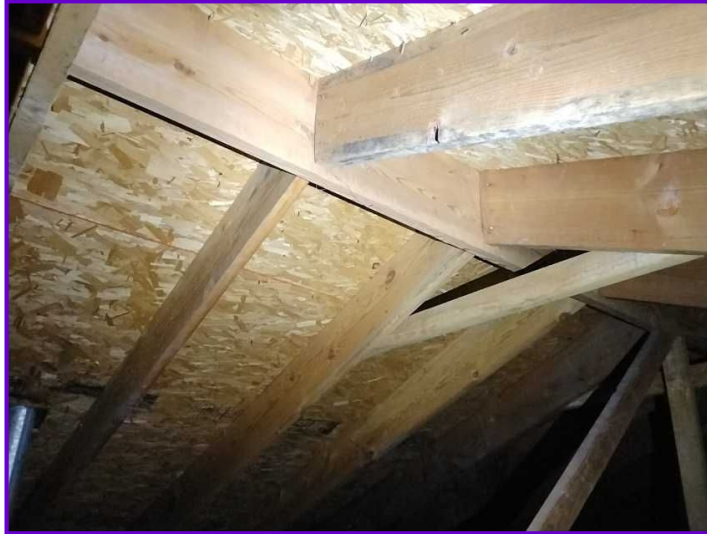
COMMENTS: The roof structure appeared functional.
