# BUYER ADVISORY SUMMARY

TINCHER CONSULTING &  
INSPECTION SERVICES

PROPERTY:  
456 Oak Lane,  
Bay Area, California 94050

DATE:  
10-01-2026

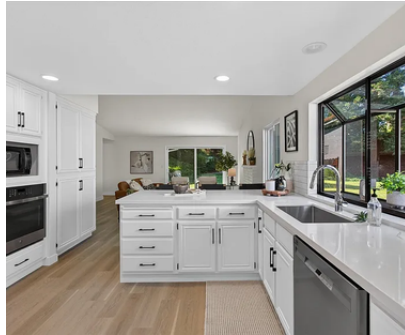
Kitchen presentation; verify work records.

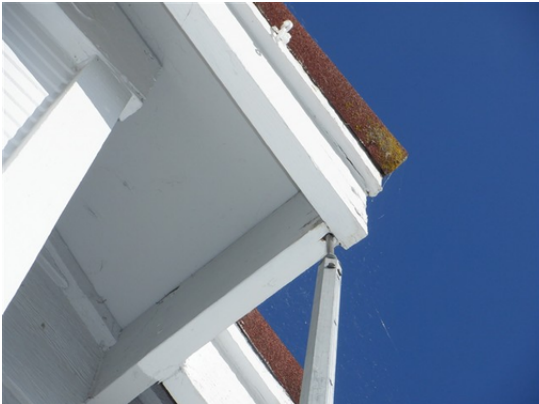
Home-report photograph: fascia / eave deterioration.  
Coordinate the wood and roof trades.

**Scope gap to close**  
GNG excludes repairs to the roof after wood work. Timberline's \$1,685 scope does not expressly price removal/reinstallation for GNG's sheathing and trim repairs. Obtain a written combined sequence and price.

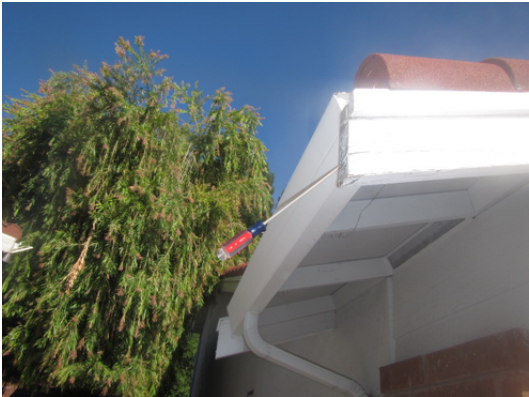
Pest-report photograph: damaged roof-edge wood.

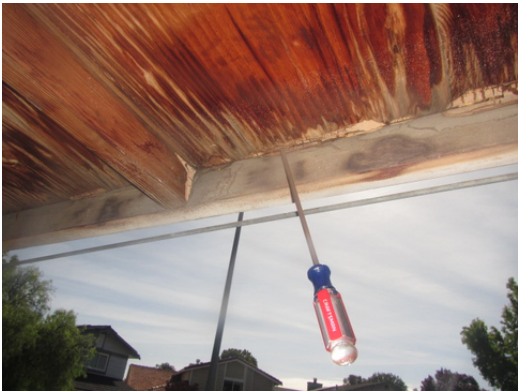
Pest-report photograph: garage-door damage; other trade.

**Not in the wood quote:** garage door; roof restoration after coverings are disturbed; final paint; Section II other-trade work; further inspections and concealed extensions. Obtain supplemental scope and completion documentation.
