POOL & SPA INSPECTION REPORT

1111 Salvadorean Blvd, Alameda, CA 94501

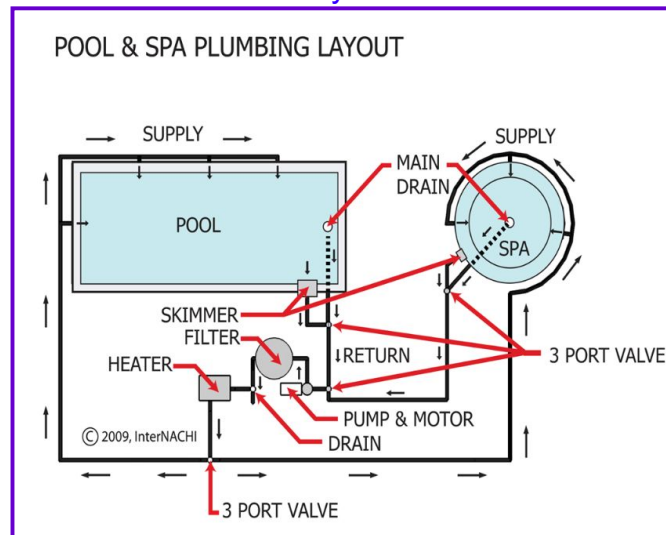
INSPECTION SCOPE: A pool inspection involves a comprehensive evaluation of the pool's structural integrity, equipment operation, safety features, and surrounding environment to ensure functionality and compliance with safety and health regulations.

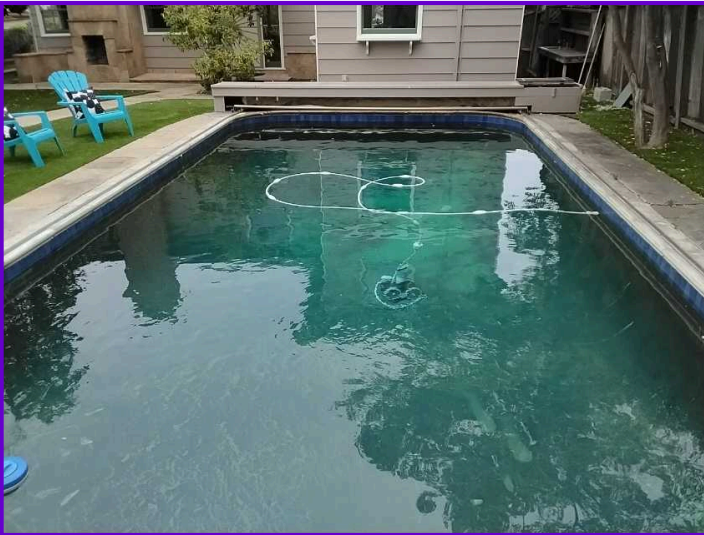
COMMENTS: The pool appeared to be reasonably level, as was evident from the water line on the tiles.

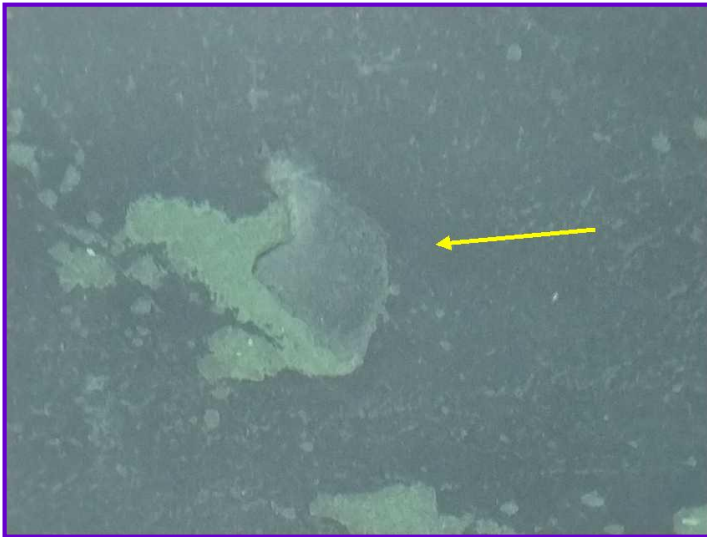
DEFERRED: There are areas of the pool body surfaces that are showing signs of deterioration.

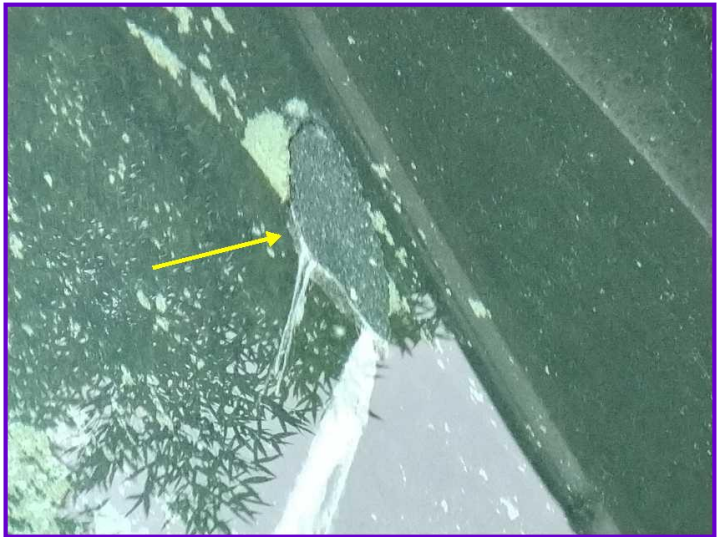
DEFERRED: There are areas of the pool body surfaces that are showing signs of deterioration.

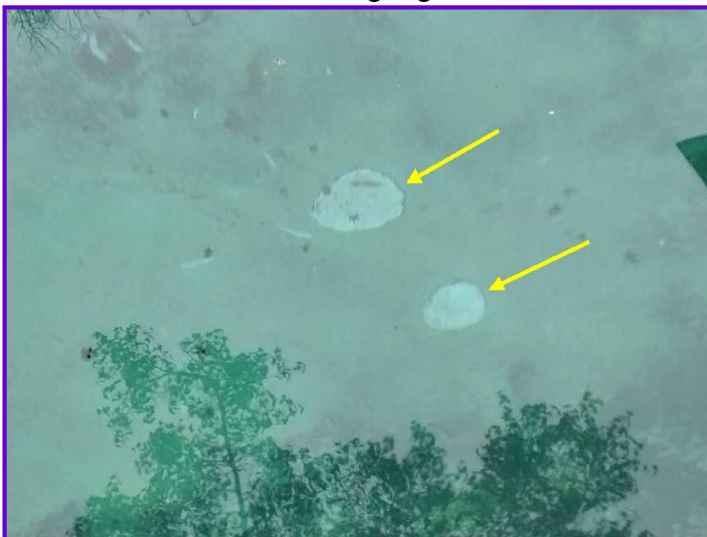
DEFERRED: There are areas of the pool body surfaces that are showing signs of deterioration.

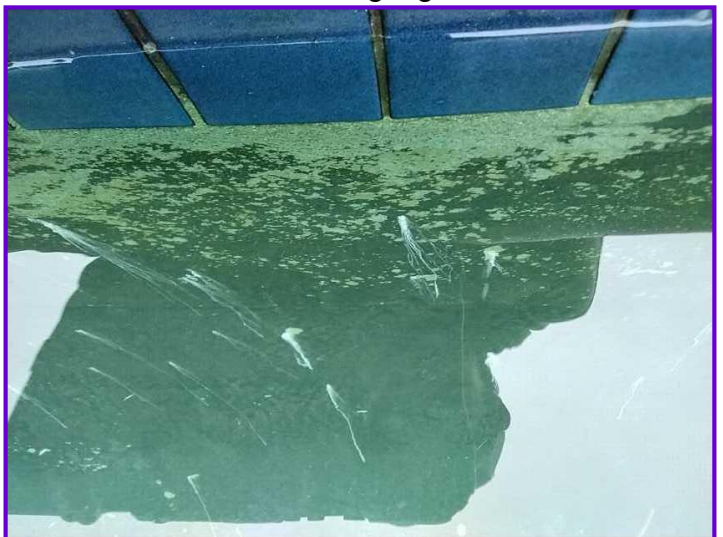
DEFERRED: There are areas of the pool body surfaces that are showing signs of deterioration.

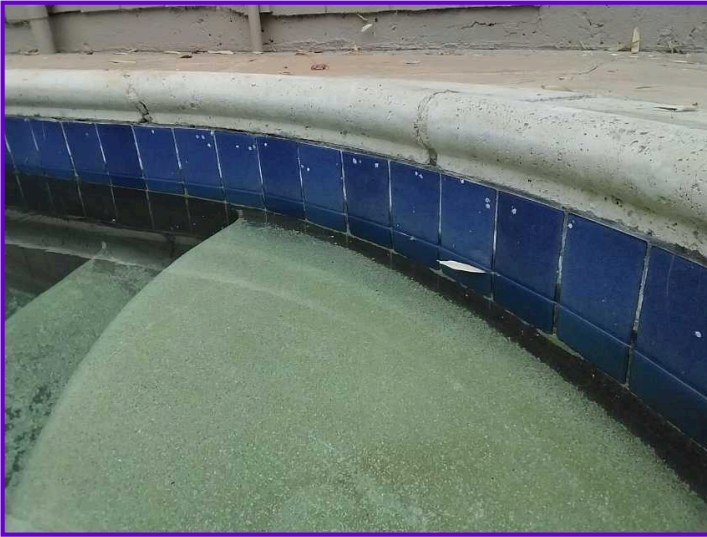
COMMENTS: The pool and spa tiles at the water line appear functional.

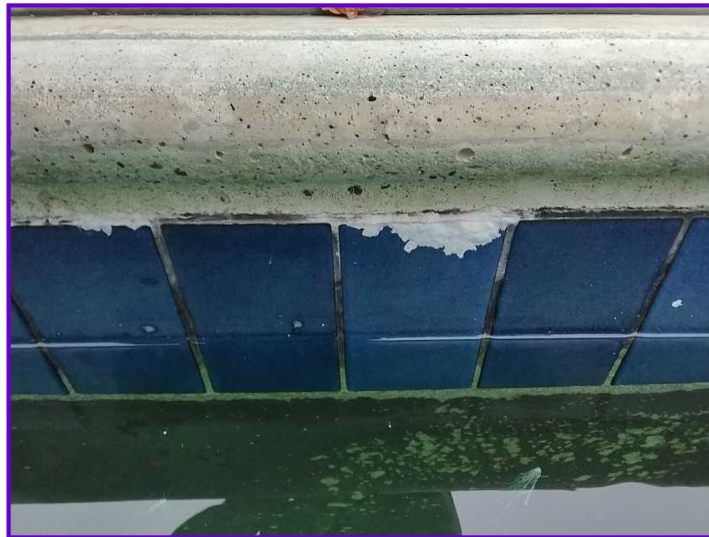
MONITOR: Calcium buildup on pool tiles was observed during the inspection.

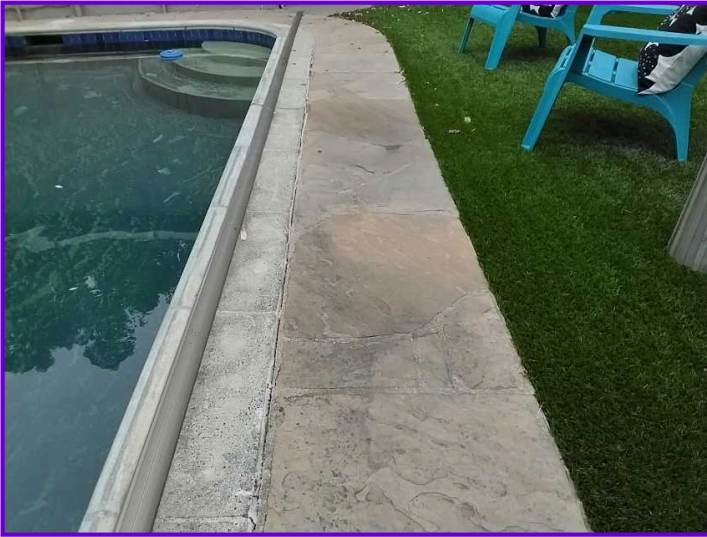
COMMENTS: The majority of the decking and coping appeared functional at the time of the inspection.

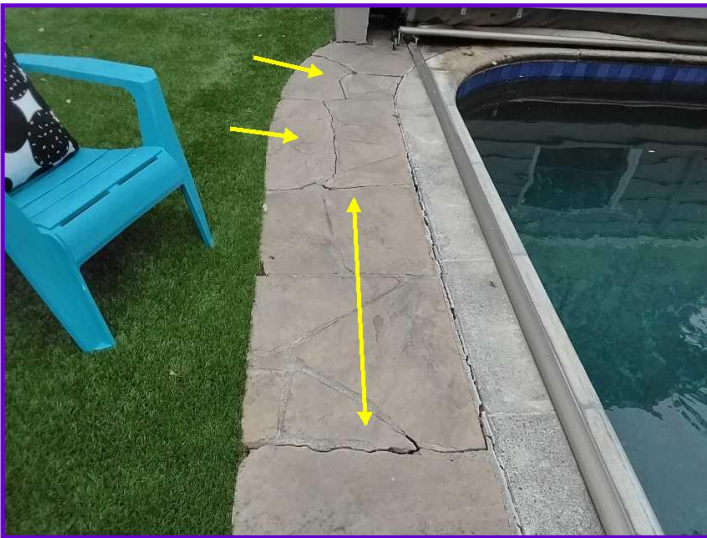
DEFERRED: The pool deck is cracked at multiple location.

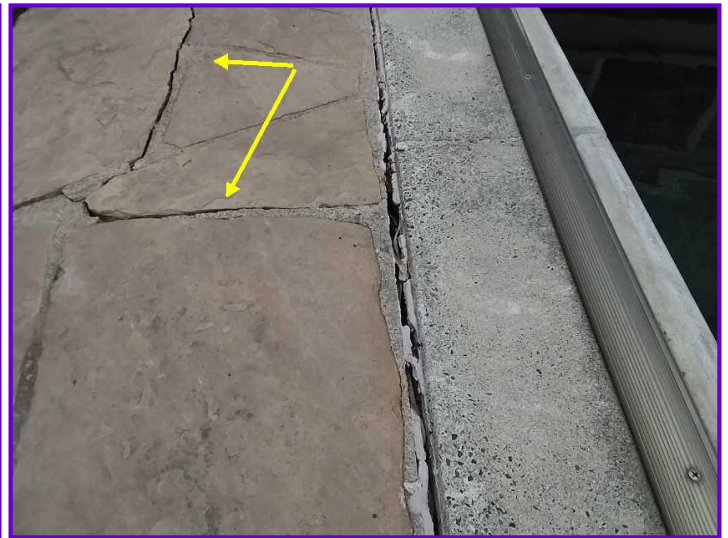
DEFERRED: The pool deck is cracked at multiple location.

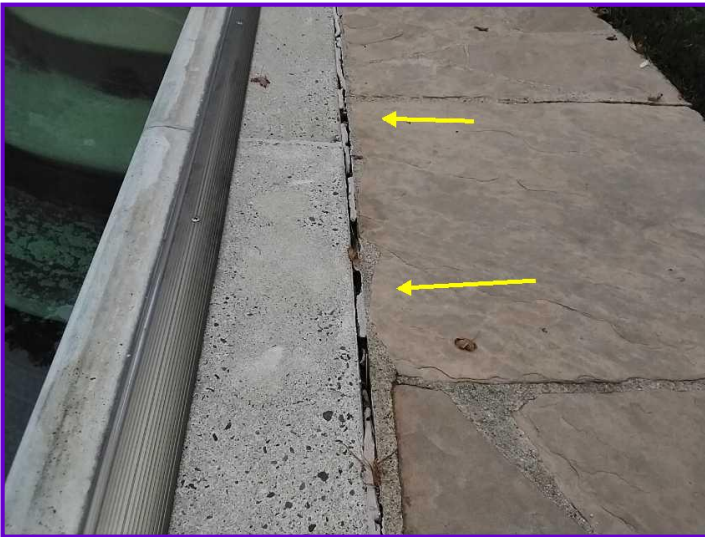
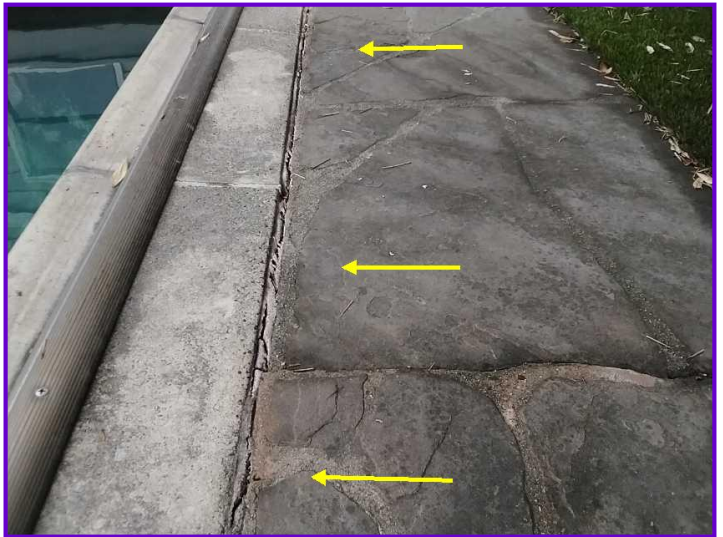
PREVENTIVE: The caulk in the expansion joint of the pool deck has deteriorated and cracked.

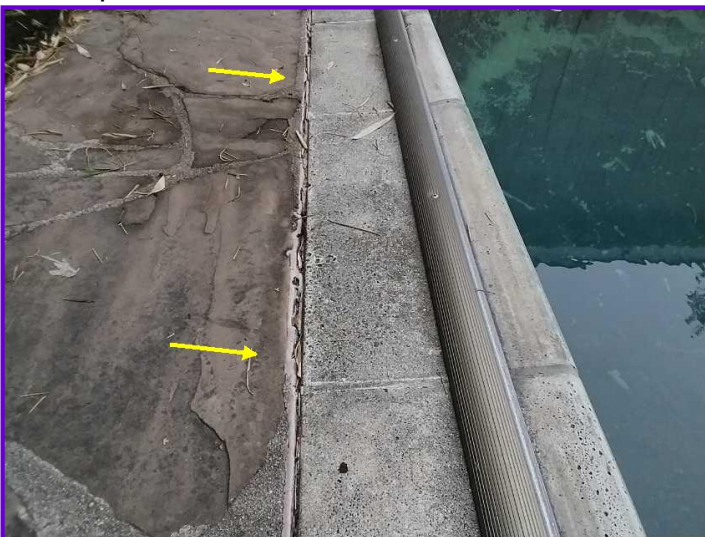
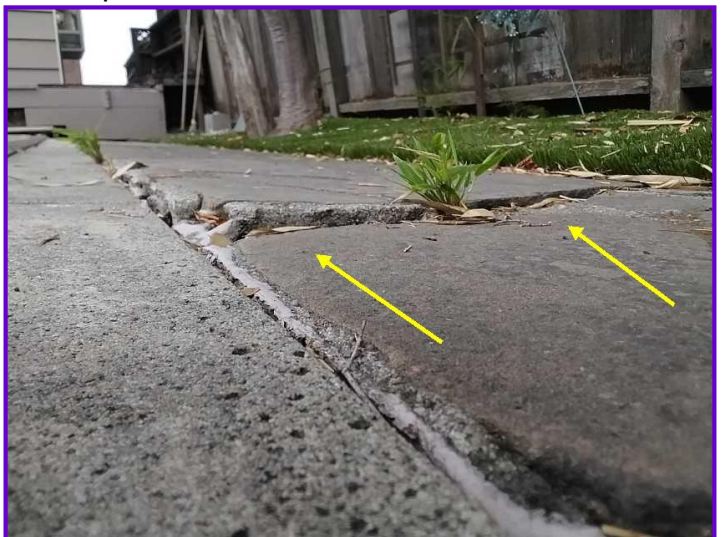
PREVENTIVE: The caulk in the expansion joint of the pool deck has deteriorated and cracked.

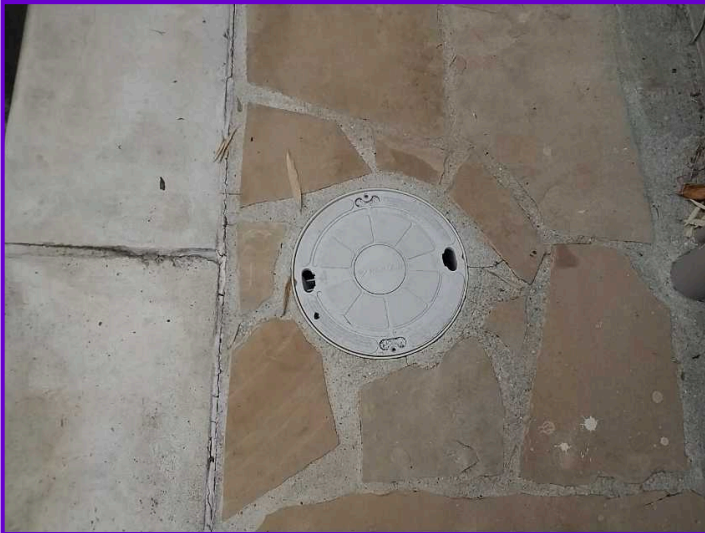
COMMENTS: The skimmers and covers are functional.

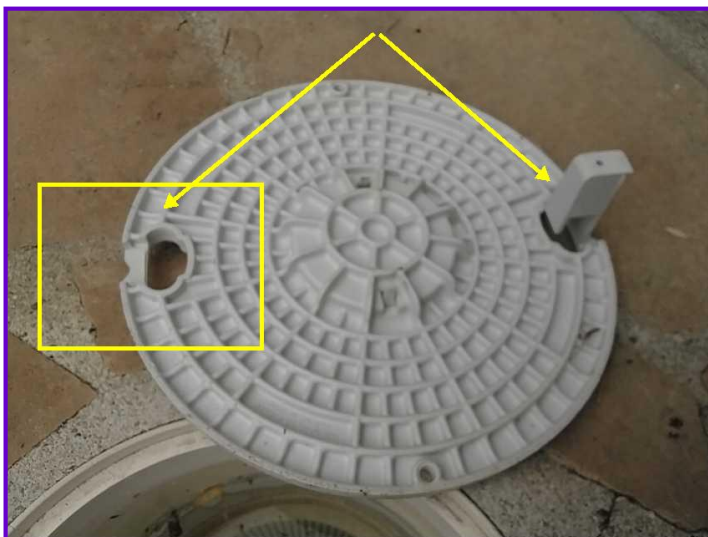
PREVENTIVE: The skimmer cover latching system is damaged. Concerned parties may wish having the cover replaced.

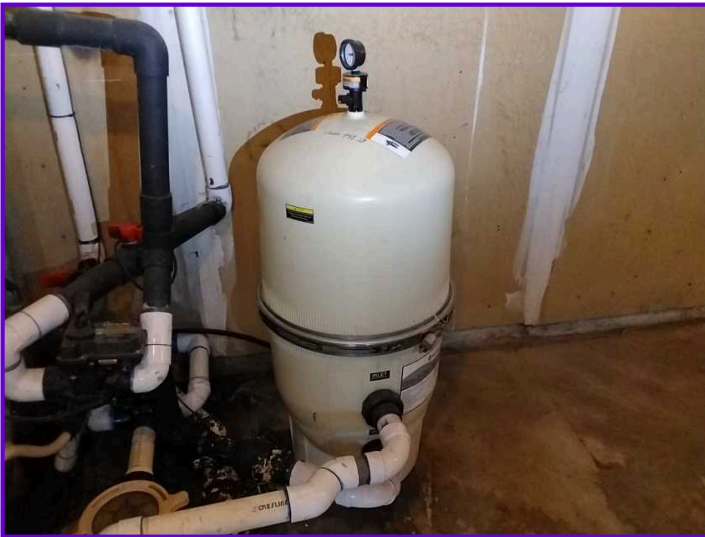
COMMENTS: The casing and filter system appears functional.

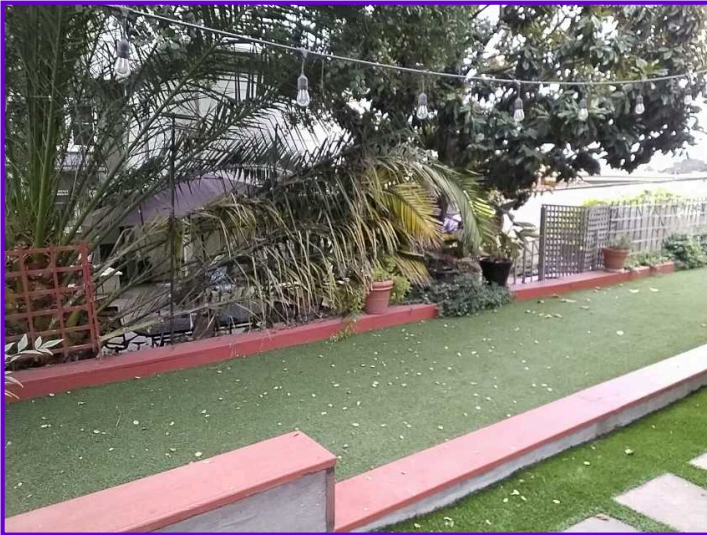
SAFETY: The property does not meet with minimum pool safety requirements.

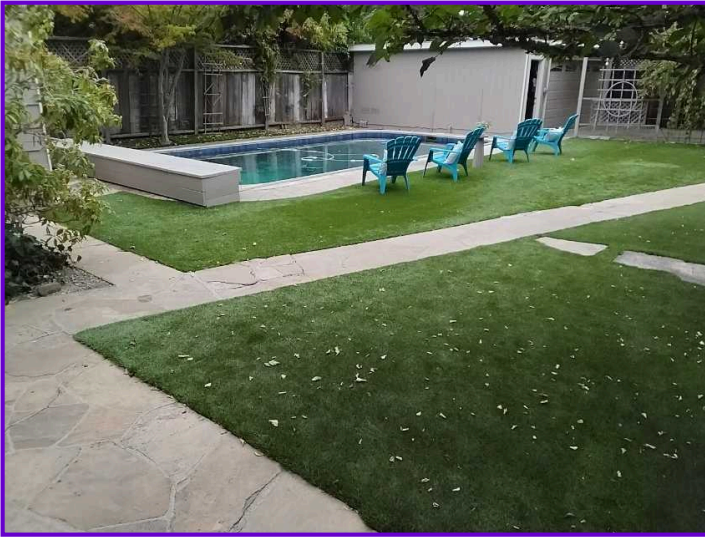
SAFETY: We recommend you install a separate enclosure around the pool.

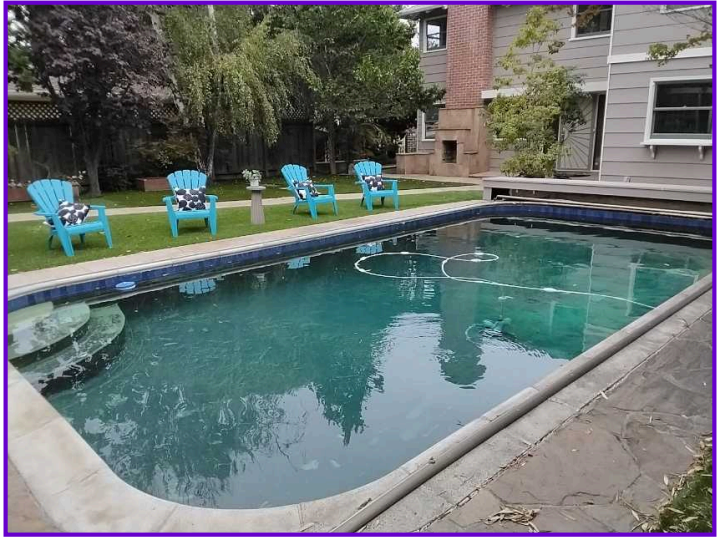
SAFETY: We recommend you install a separate enclosure around the pool.

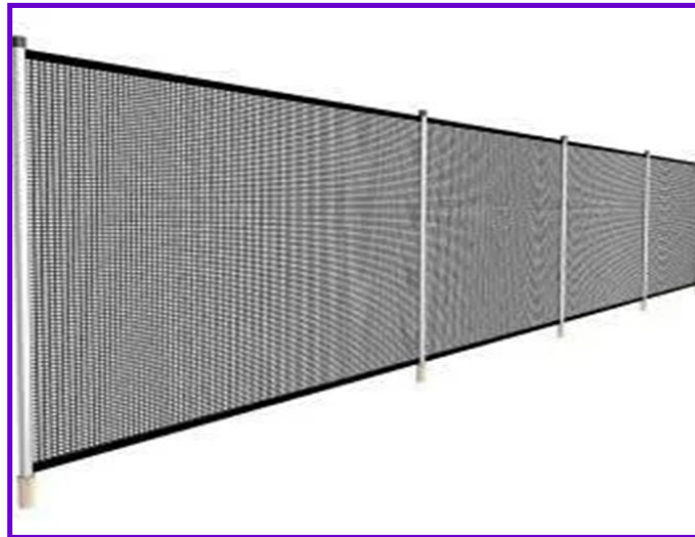
SAFETY: We recommend you install a separate enclosure around the pool and spa.

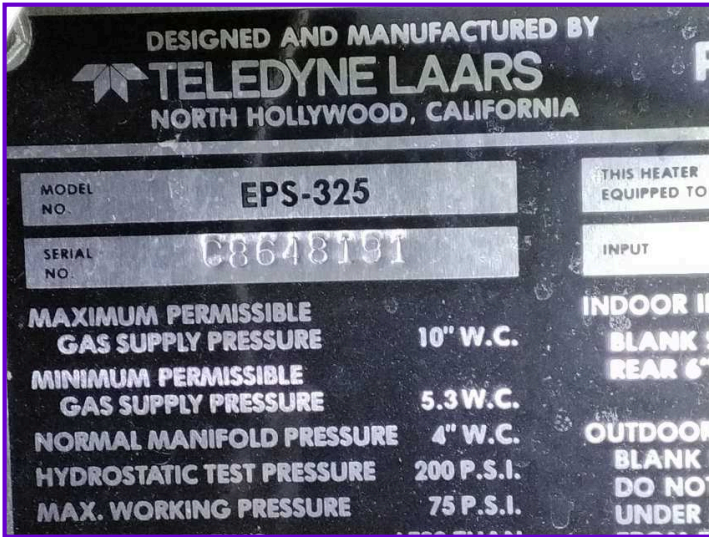
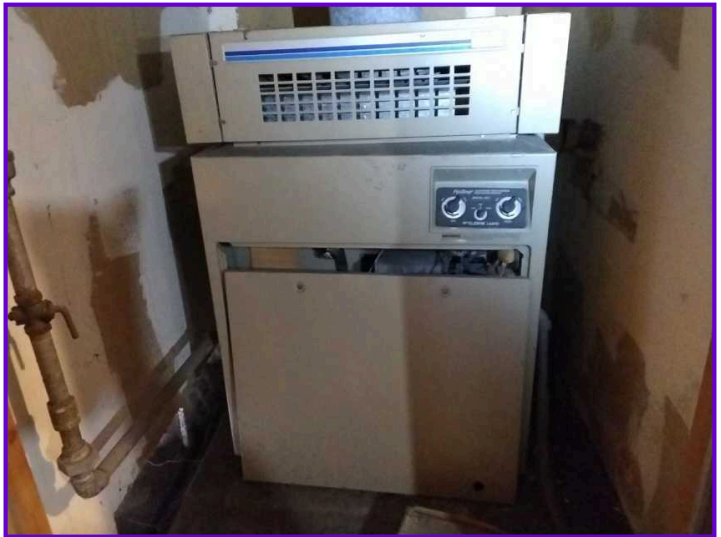
COMMENTS: There is a 39-years old heater located in the garage.

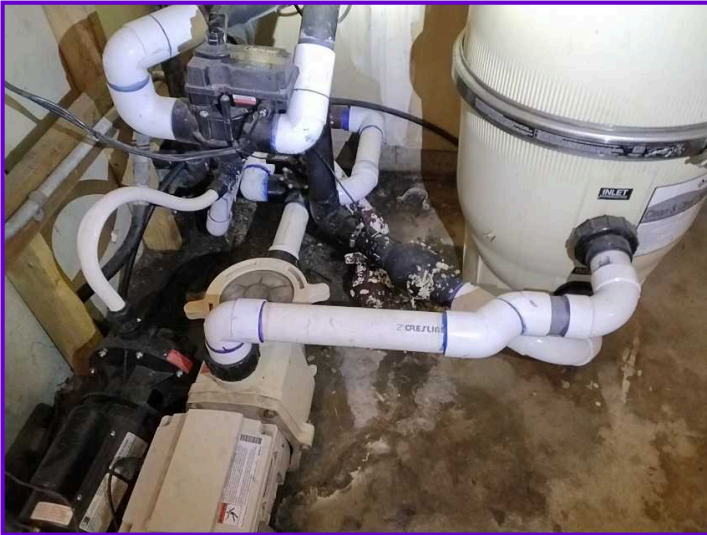
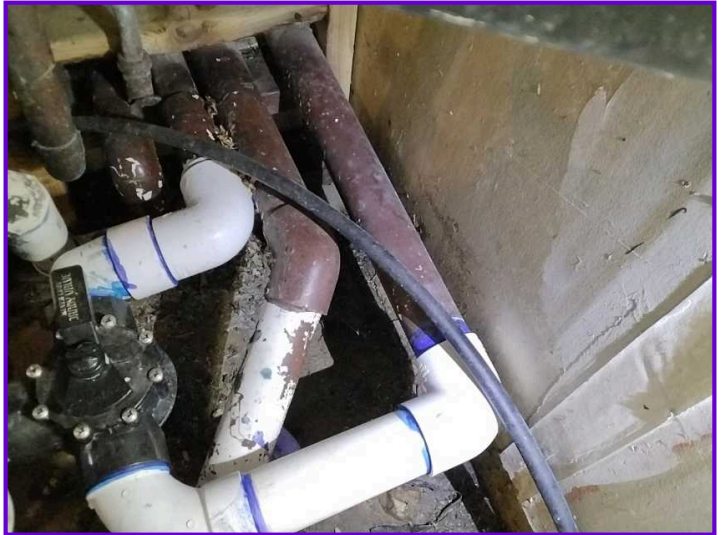
COMMENTS: The visible pool plumbing lines and valves appeared to be functional.

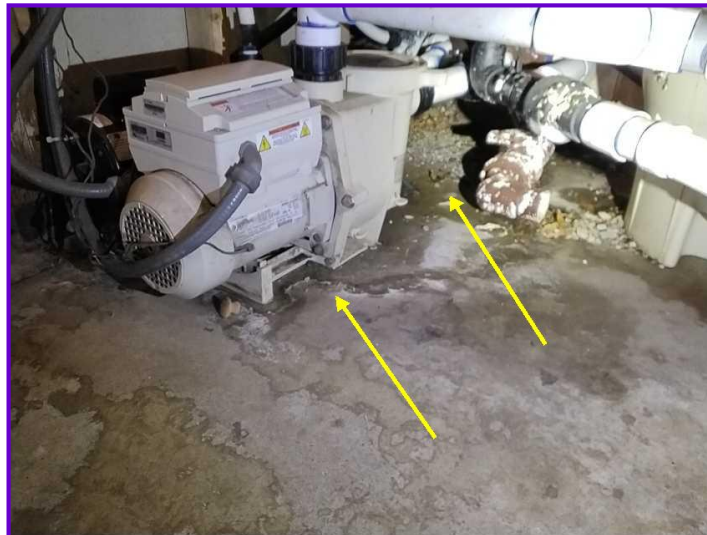
MAINTENANCE: There is a minor leak at the supply line and/or the motor pump.

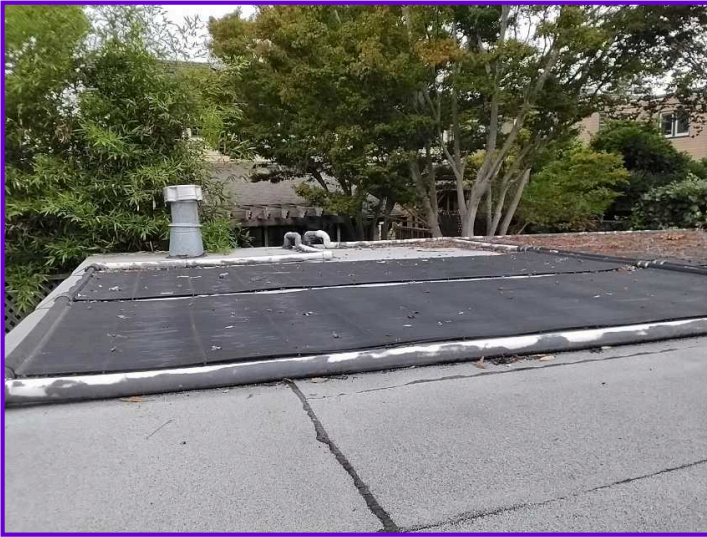
DEFERRED: The pool plumbing includes a hydronic solar panel water heating system located on the garage roof.

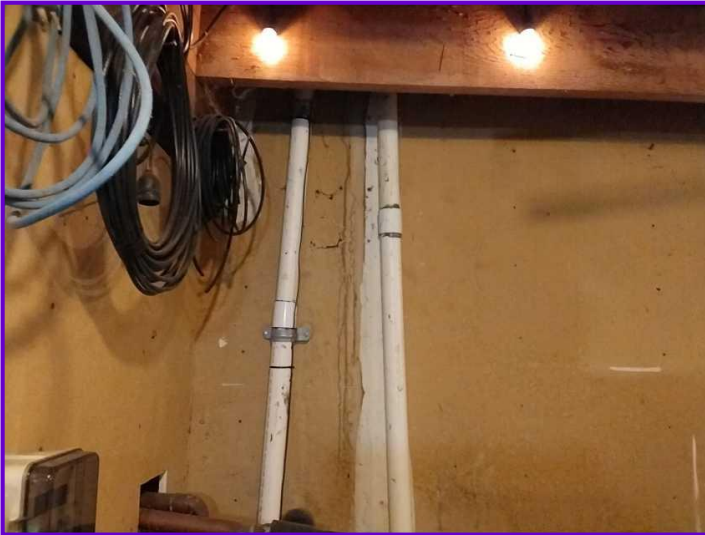
MONITOR: Water stains were observed near the hydronic solar system water line coming from the roof.

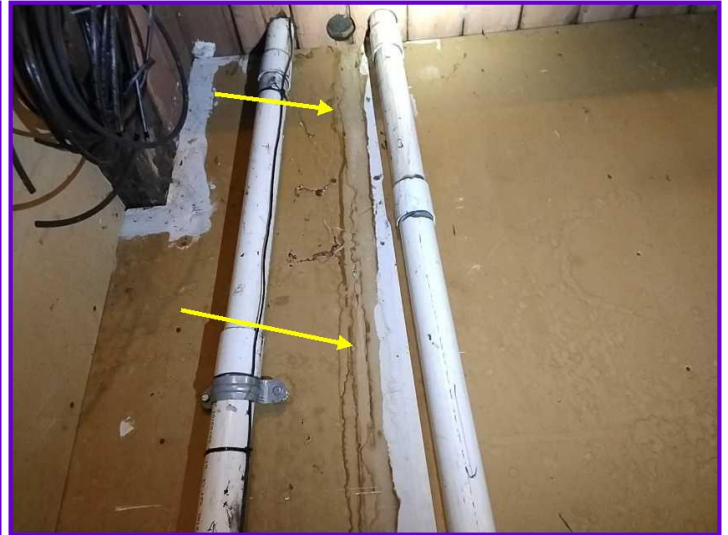
MONITOR: Water stains were observed near the hydronic solar system water line coming from the roof.
