## MOLD & IAC TESTING & INSPECTIONS

**102 Rolling Green Circle, Pleasant Hill, CA 94523**

DATE OF INSPECTION: 8/19/2025

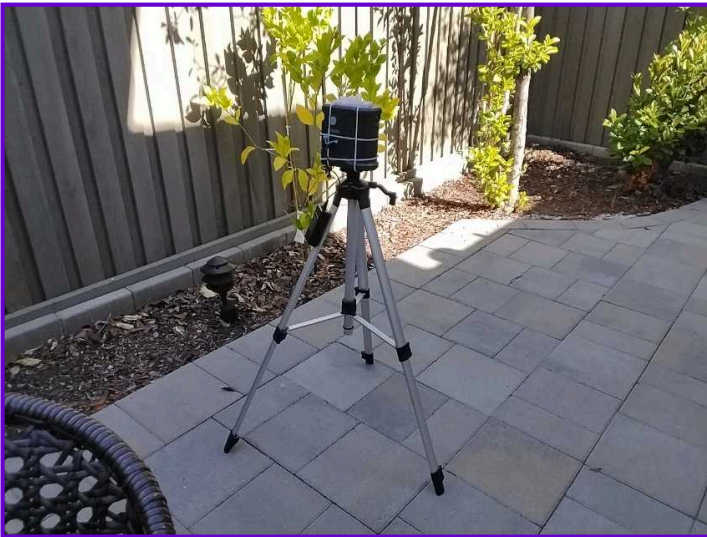
**COMMENTS:** Your inspector took an air samples outside.

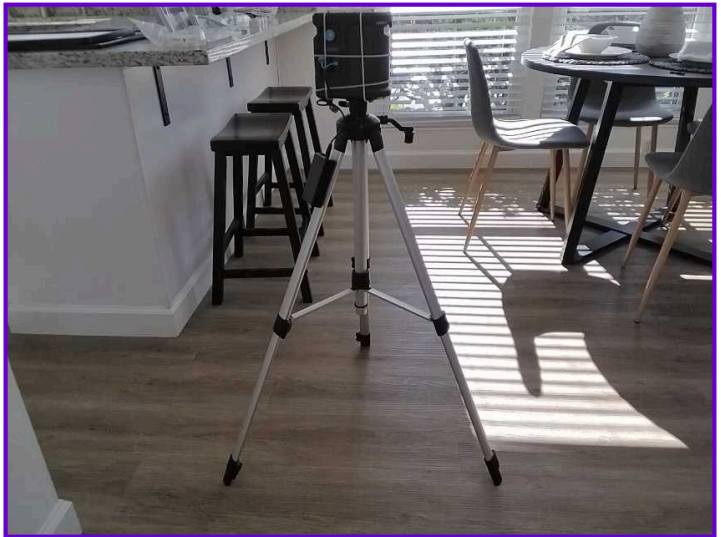
**COMMENTS:** Your inspector took an air sample in the kitchen.

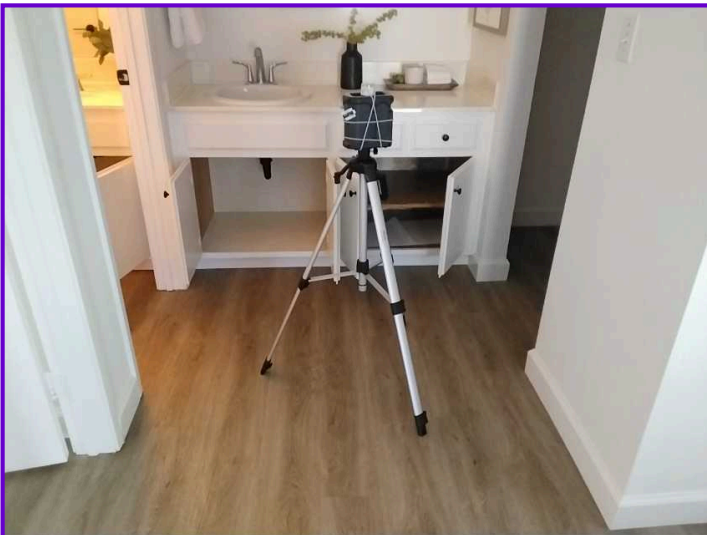
**COMMENTS:** Your inspector took an air sample in the primary bathroom.

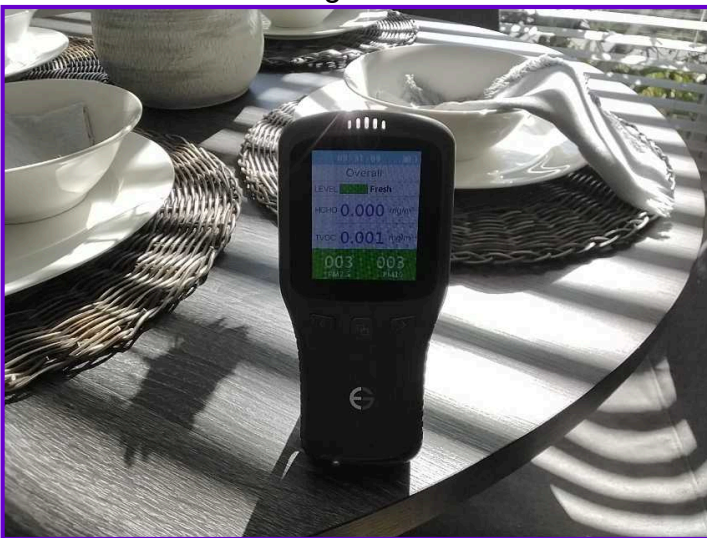
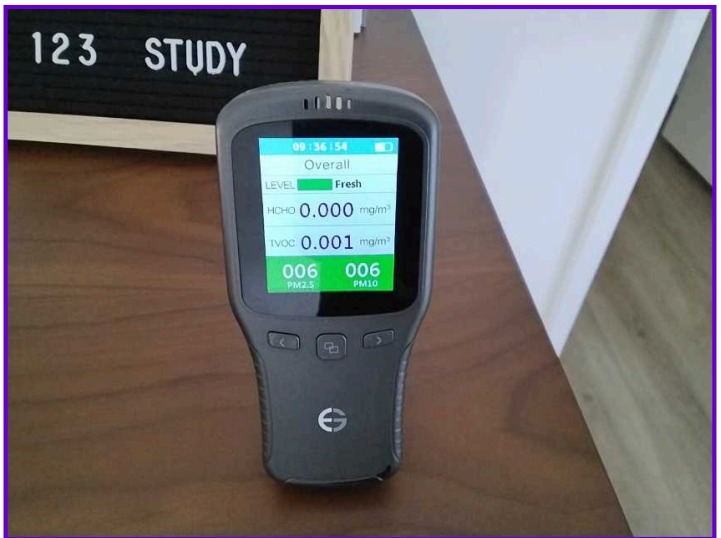
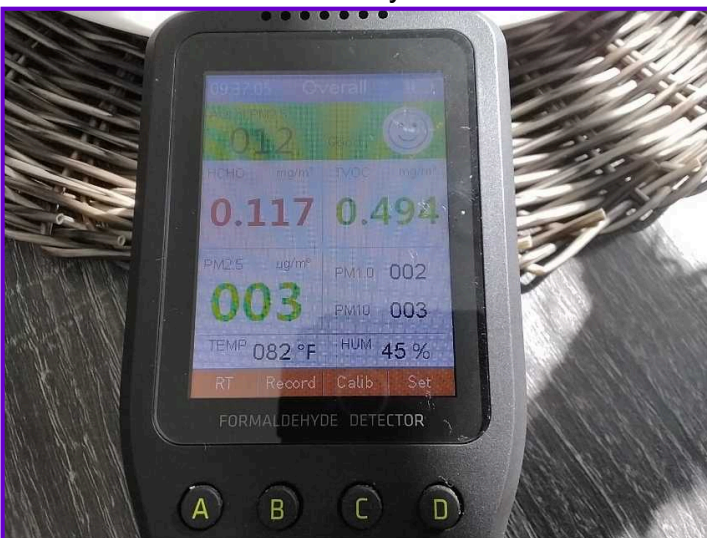
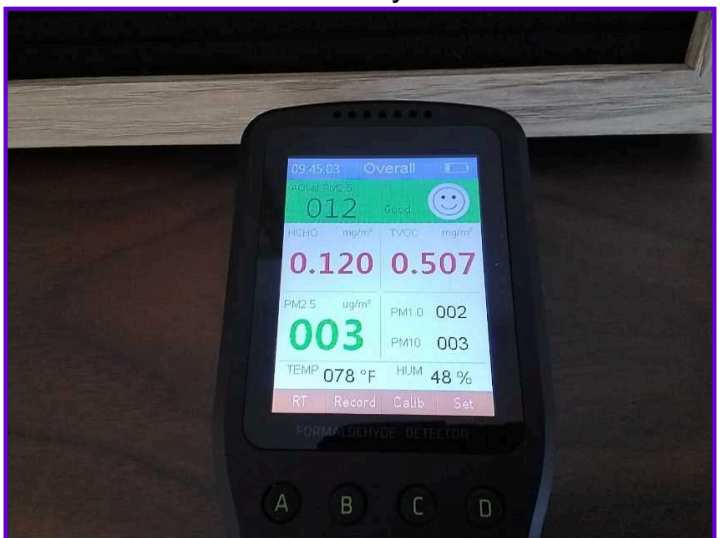
- **COMMENTS:** The air quality was excellent and healthy. We conducted an air quality test in the interior areas. Indoor air quality monitors use a range of sensors to track various pollutants in your home. These sensors detect and measure levels of pollutants such as particulate matter (PM<sub>2.5</sub>), volatile organic compounds (VOCs), carbon dioxide (CO<sub>2</sub>) The diagram will help you better understand the readings.

**COMMENTS:** The air quality was excellent and healthy.

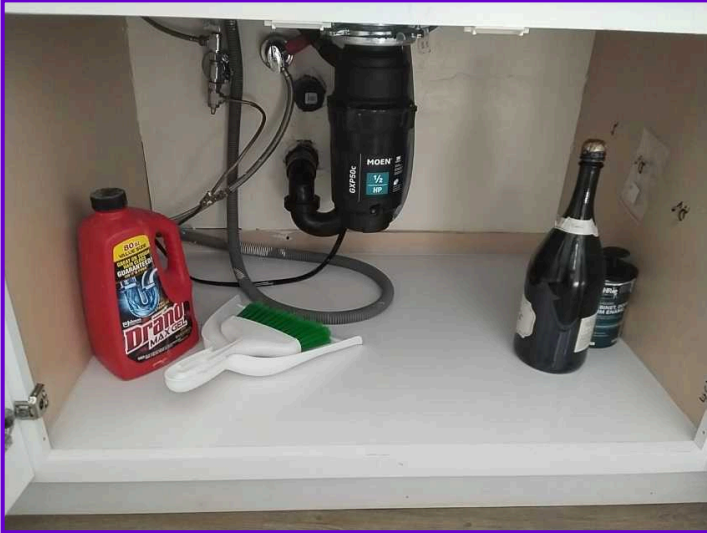
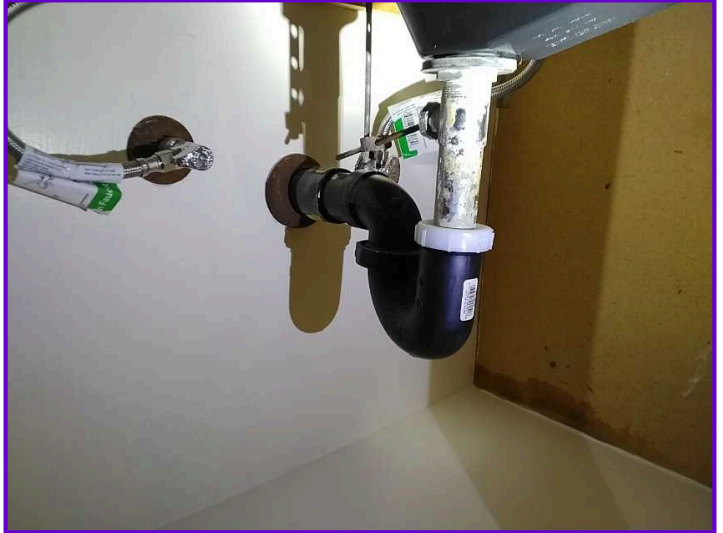
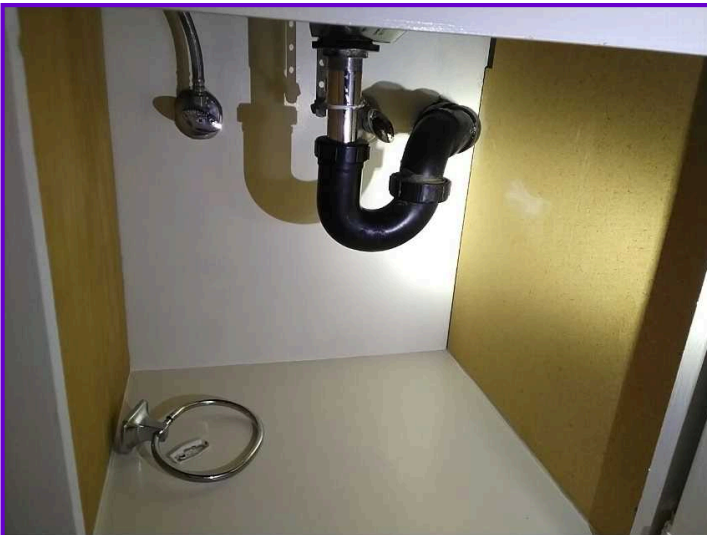
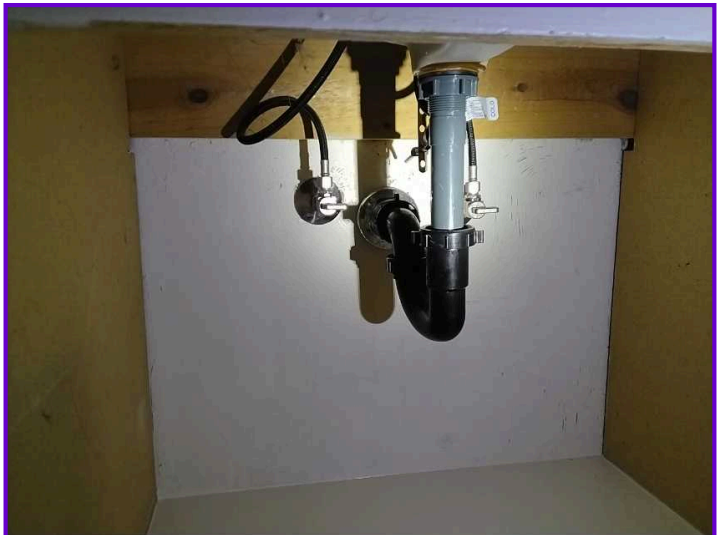
- COMMENTS: The fixture drain and vent pipes within the property were functional at the time of the inspection.

COMMENTS: The fixture drain and vent pipes within the property were functional.

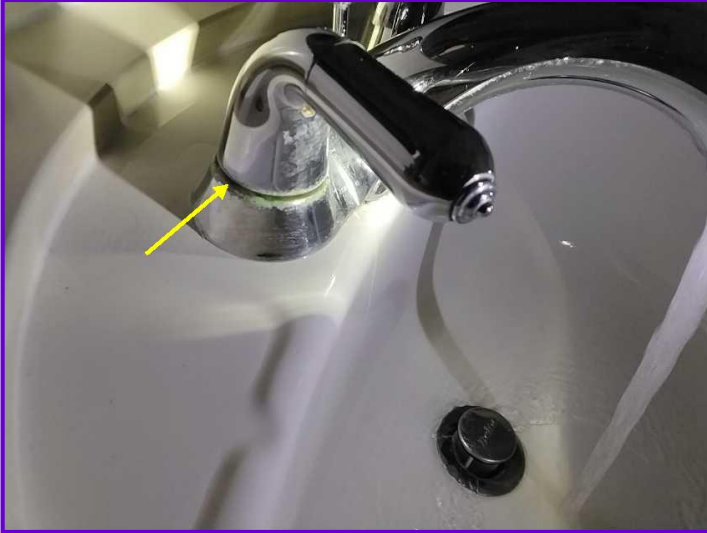
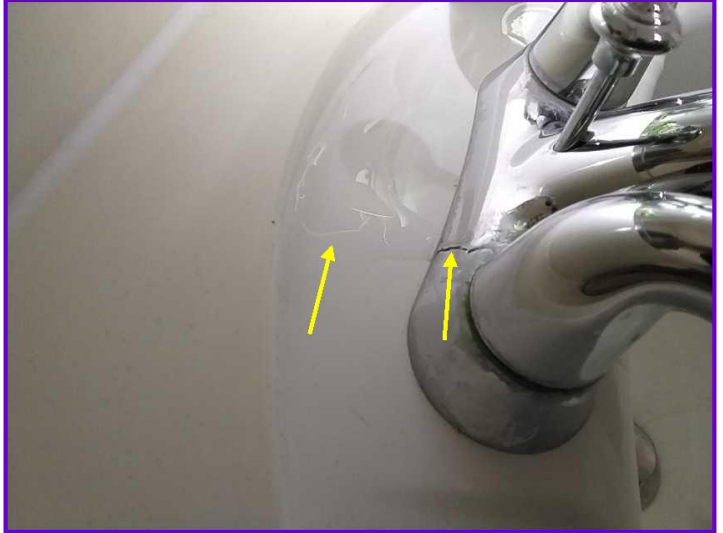
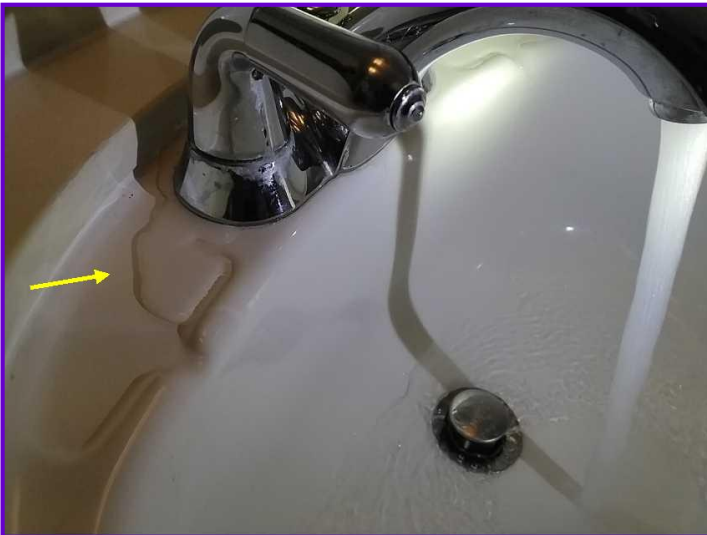
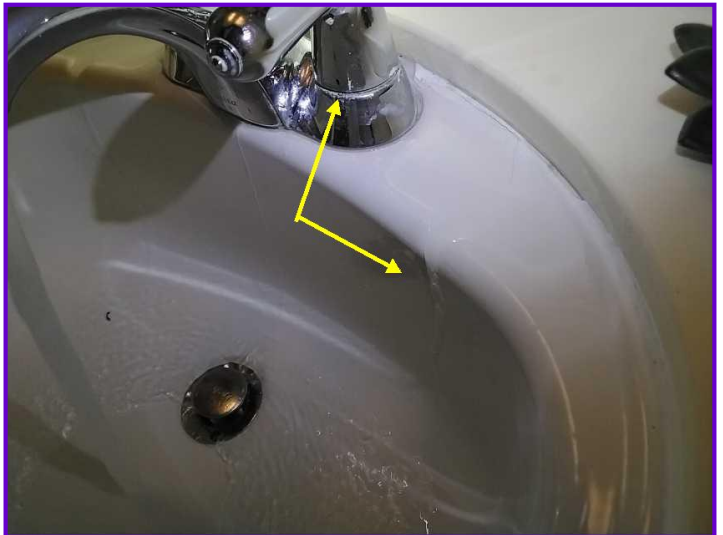
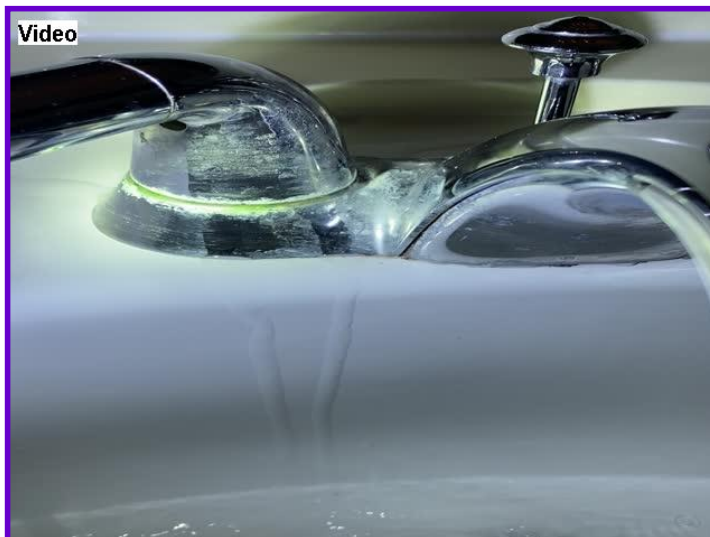
- **DEFICIENT:** The faucet valves handle were leaking when in use at the primary bathroom sink, secondary bathroom sink. Concerned parties may wish having the faucet repaired or replaced.

DEFICIENT: The faucet valves handle were leaking when in use.

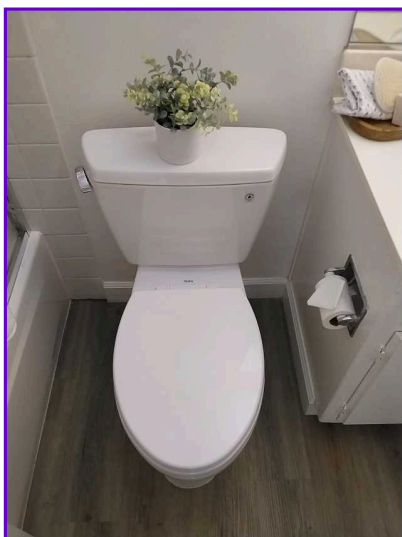
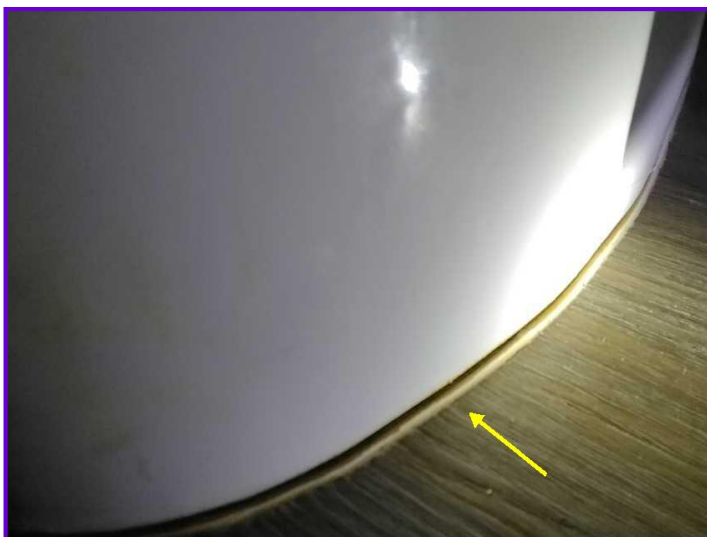
- **MAINTENANCE:** The toilets are functional but need to be firmly anchored to the floor or leakage may result. Replacing the wax rings is also suggested at this time as an additional precaution against leakage.

MAINTENANCE: The toilets need to be firmly anchored to the floor or leakage may result.

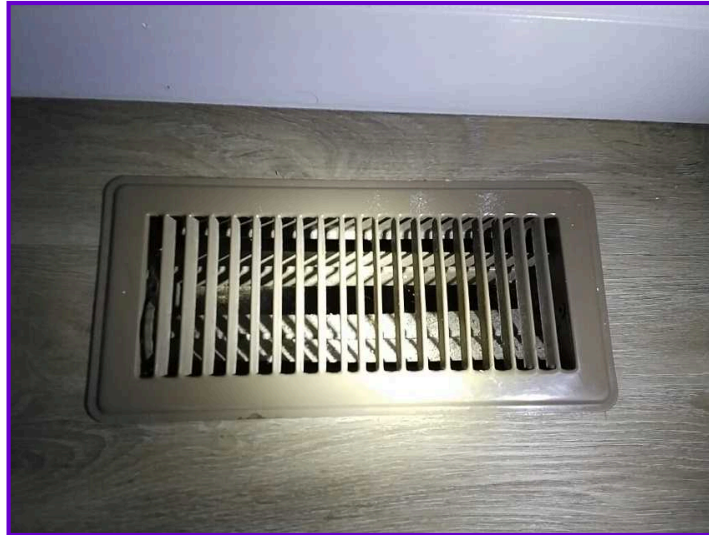
**PREVENTIVE:** The heating distribution system in the property if not cleaned regularly, can accumulate dust and promote mold growth, posing health risks.

- **PREVENTIVE:** The heating distribution system in the property if not cleaned regularly, can accumulate dust and promote mold growth, posing health risks. Regular cleaning and maintenance are recommended to ensure proper ventilation and maintain a healthy environment.

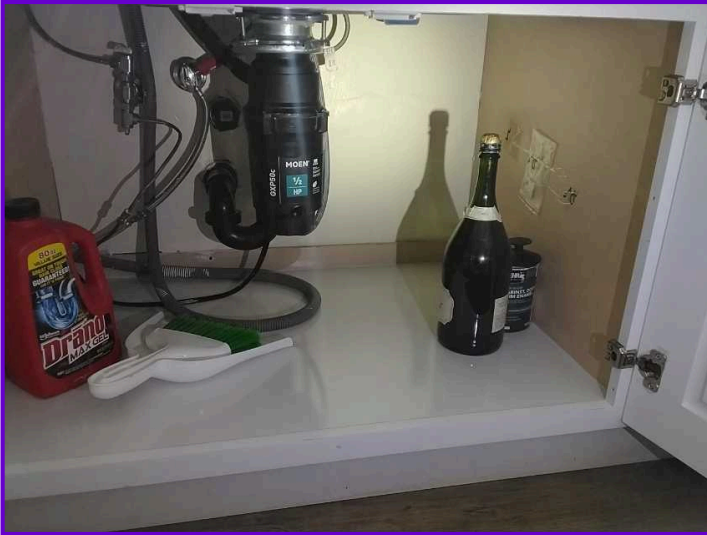
**COMMENTS:** The cabinetry is functional but may have minor wear that is commensurate with its age.

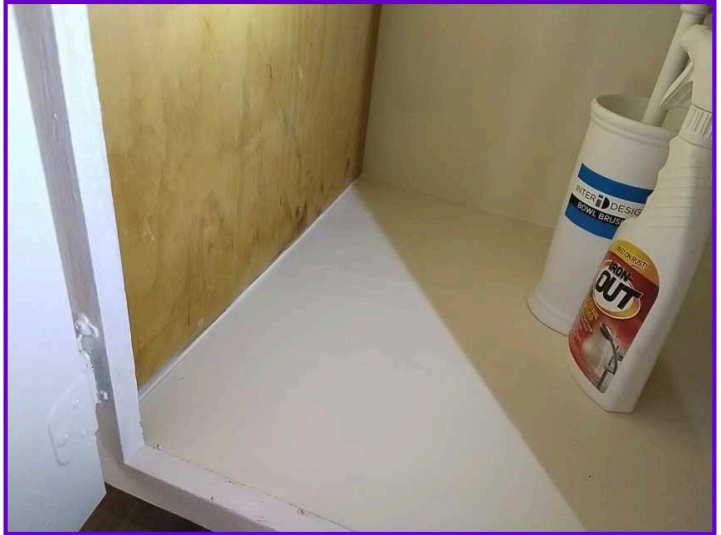
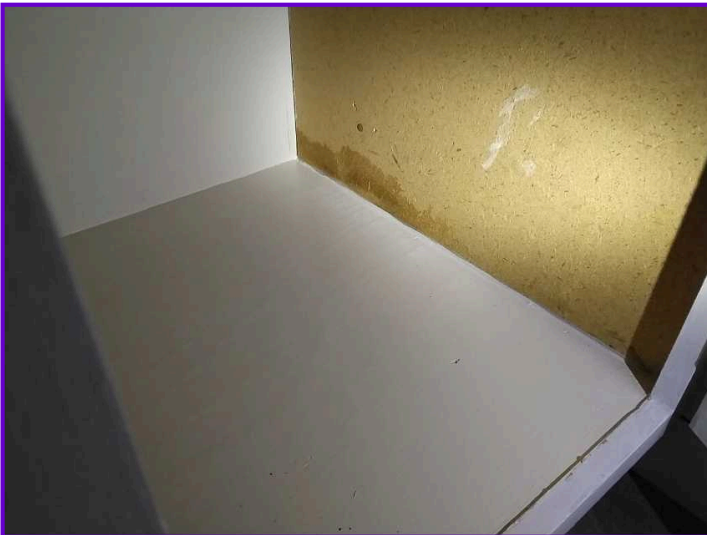
**DEFERRED:** Moisture stains were observed in the bathroom cabinet, likely caused by a previous leak under the sink.

- **COMMENTS:** The cabinetry is functional but may have minor wear that is commensurate with its age.
- **DEFERRED:** Moisture stains were observed in the bathroom cabinet, likely caused by a previous leak under the sink. During the inspection, moisture content was tested and found not to be a concern at this time. It is recommended to monitor the area and address any ongoing issues to prevent future damage.

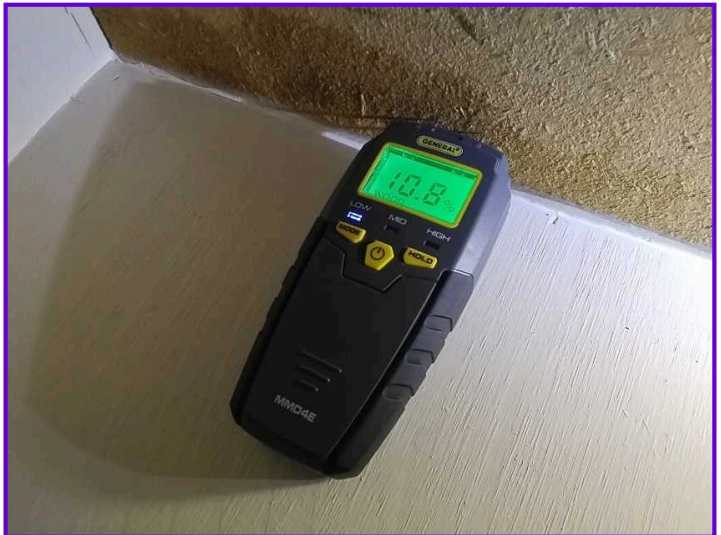
**DEFERRED:** During the inspection, moisture content was tested and found not to be a concern at this time.

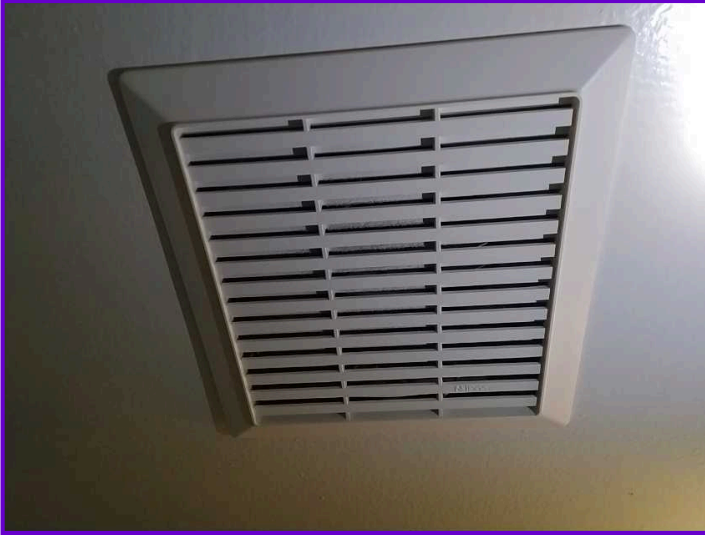
**COMMENTS:** The bathroom exhaust fans are functional.

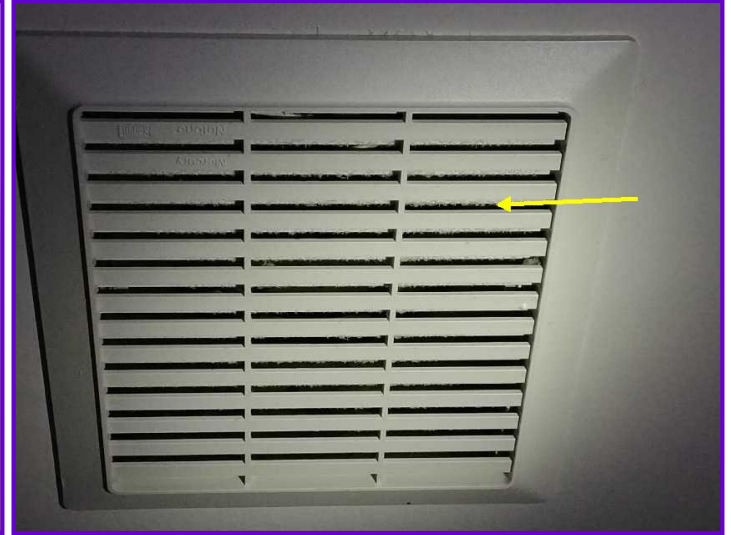
**PREVENTIVE:** The exhaust fan in the bathroom, if not cleaned regularly, can accumulate dust and promote mold growth.

- **COMMENTS:** The bathroom exhaust fans are functional.
- **PREVENTIVE:** The exhaust fan in the bathroom, if not cleaned regularly, can accumulate dust and promote mold growth, posing health risks. Regular cleaning and maintenance are recommended to ensure proper ventilation and maintain a healthy environment.
