PROPERTY INSPECTION REPORT

805 Eastbrook Court, Danville, CA 94506

DATE OF INSPECTION: 1/1/2025

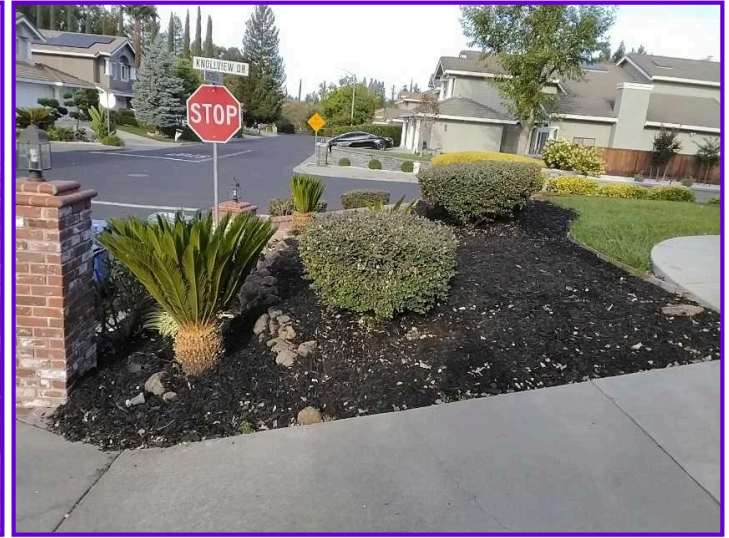
VEGETATION: There are trees and/or vegetation on or adjacent to the property.

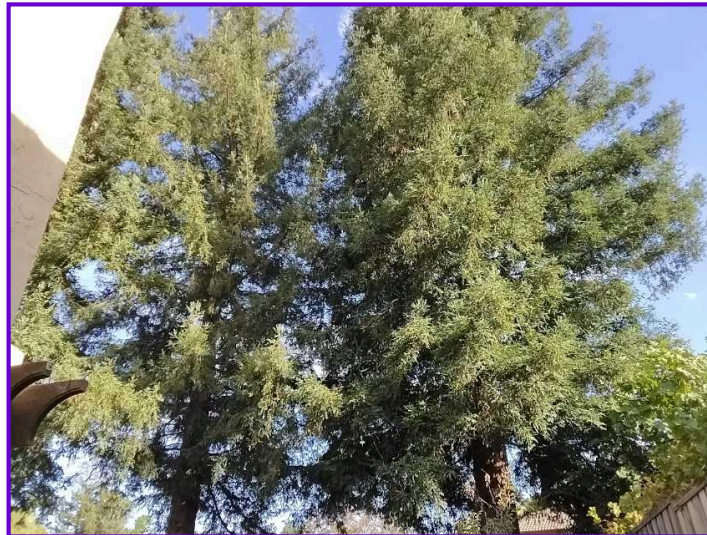
VEGETATION: There are trees and/or vegetation on or adjacent to the property.

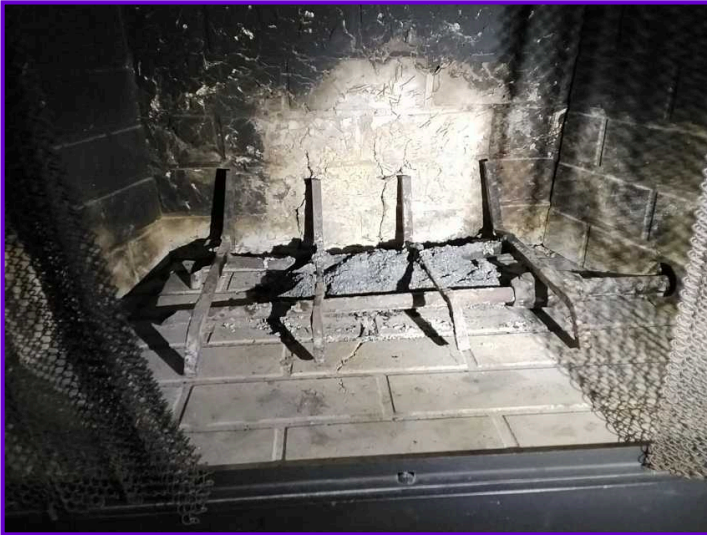
COMMENTS: The log grate appeared functional.

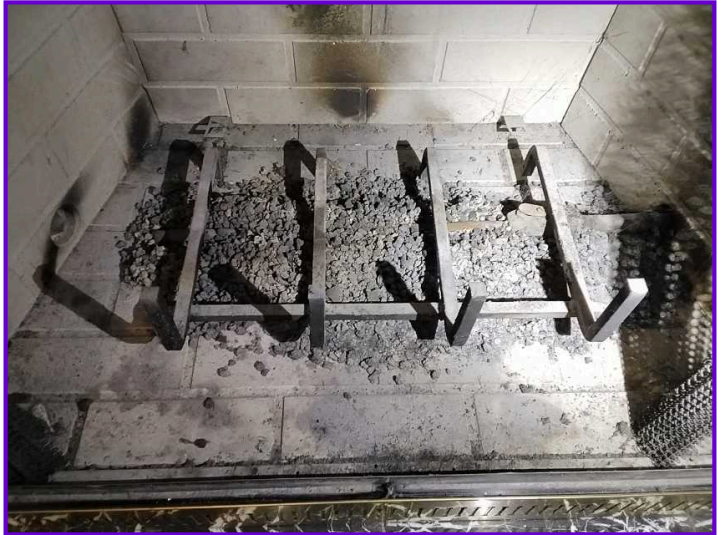
COMMENTS: The log grate appeared functional.

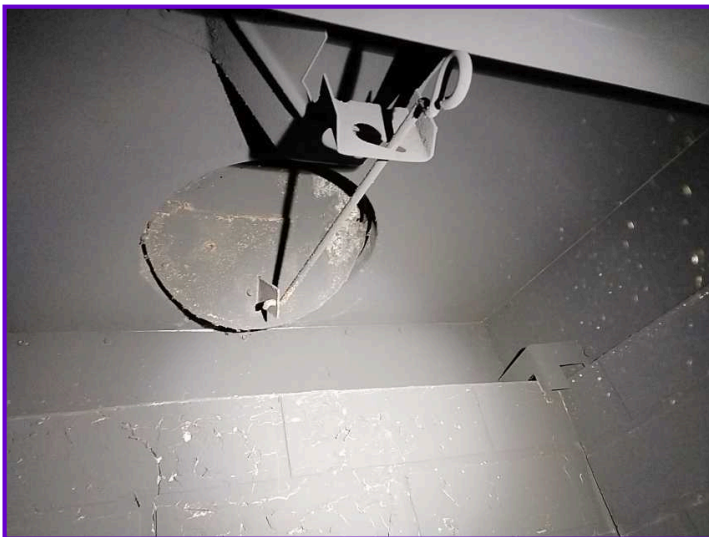
COMMENTS: The damper is functional.

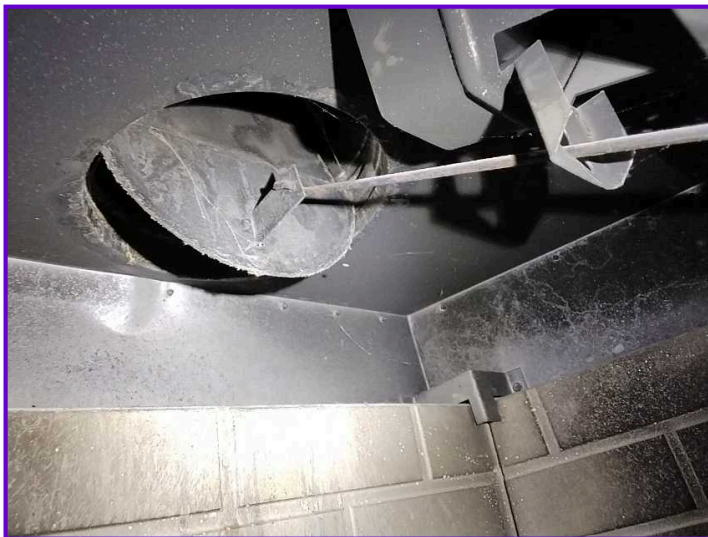
COMMENTS: The damper is functional.

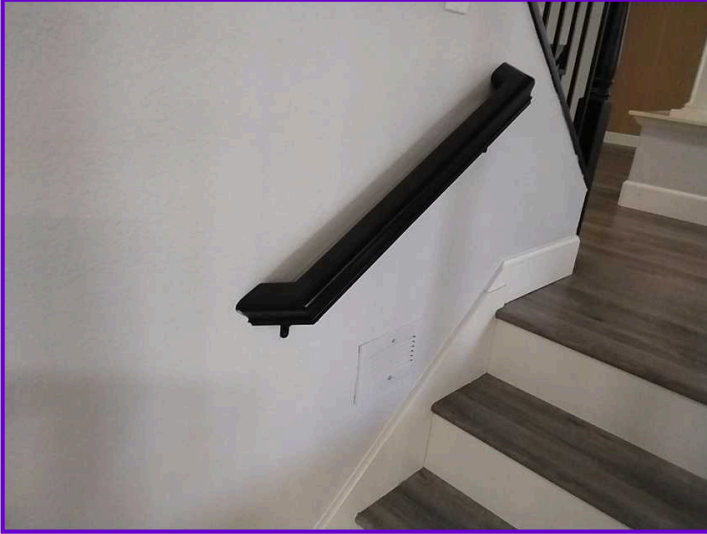
COMMENTS: The handrails appear to be functional and secure.

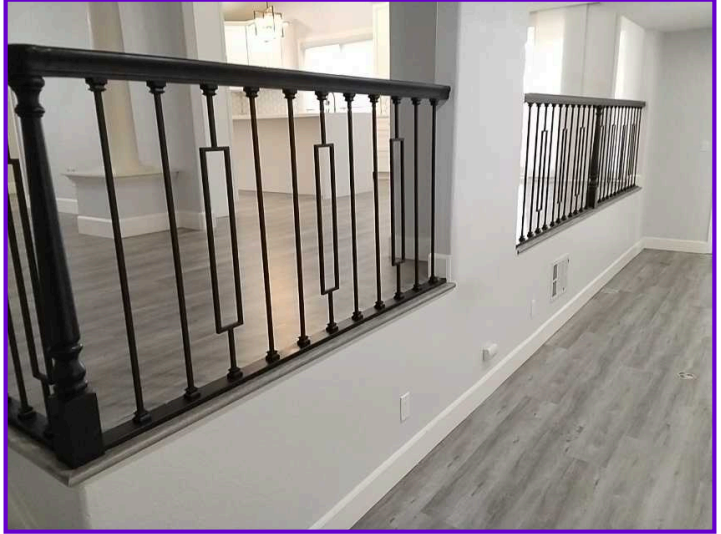
COMMENTS: The balusters rails appear to be functional and secure.
