PROPERTY INSPECTION REPORT

805 Eastbrook Court, Danville, CA 94506

DATE OF INSPECTION: 1/1/2025

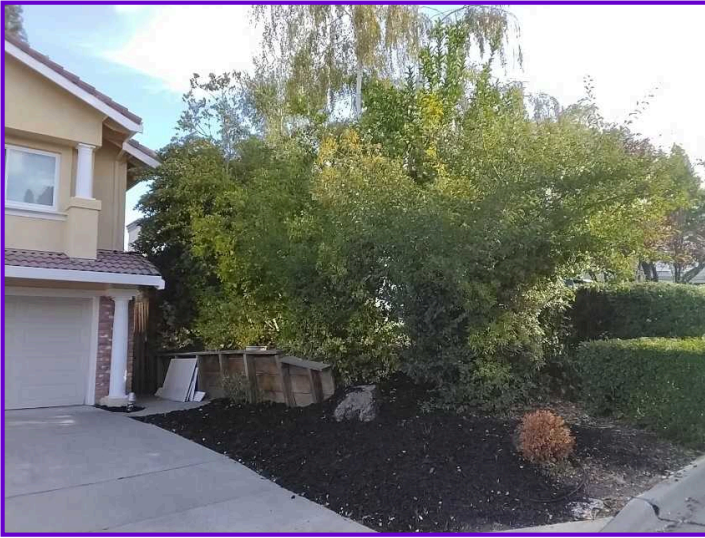
VEGETATION: There are trees and/or vegetation on or adjacent to the property.

- **VEGETATION:** There are trees and/or vegetation on or adjacent to the property. Evaluation of trees and vegetation falls outside the scope of a home inspection. Concerned parties may wish to have the trees and/or other vegetation examined by an appropriate specialist. An arborist is normally considered best qualified.

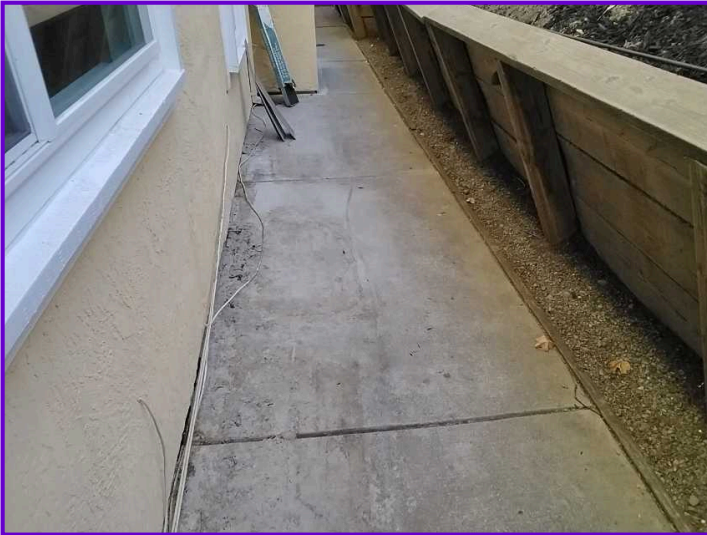
COMMENTS: The walkways at various locations around the residence are functional.

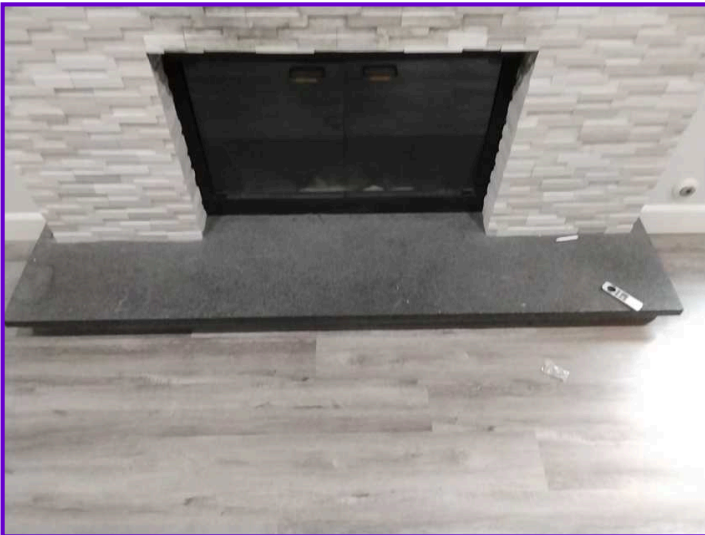
COMMENTS: The hearth extension is in satisfactory condition.

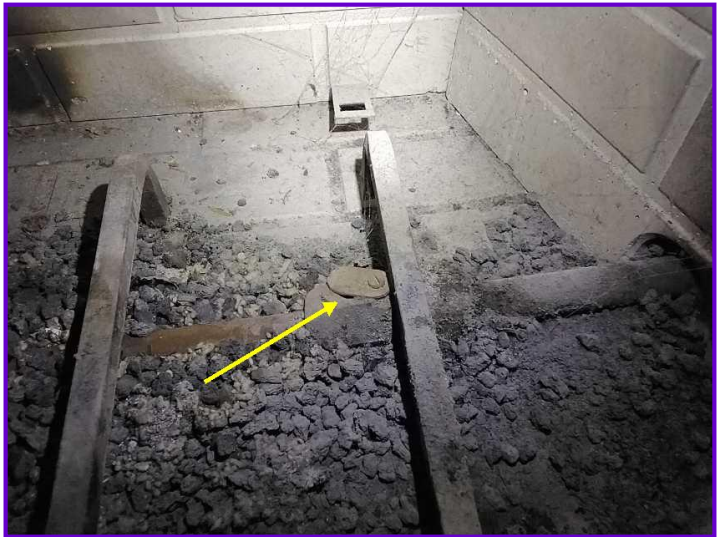
COMMENTS: The gas log starter in the fireplace appeared functional.

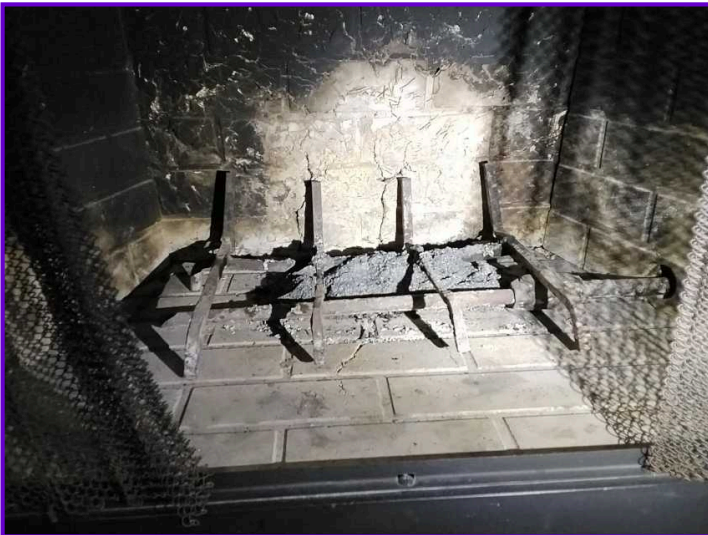
COMMENTS: The log grate appeared functional.

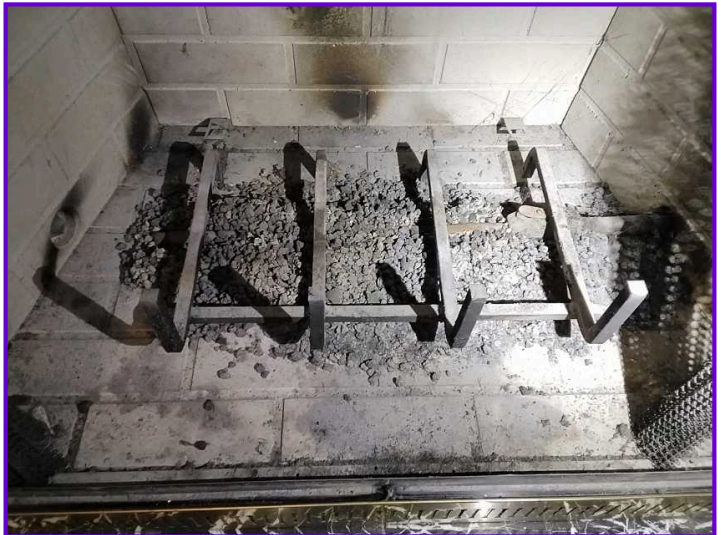
COMMENTS: The log grate appeared functional.

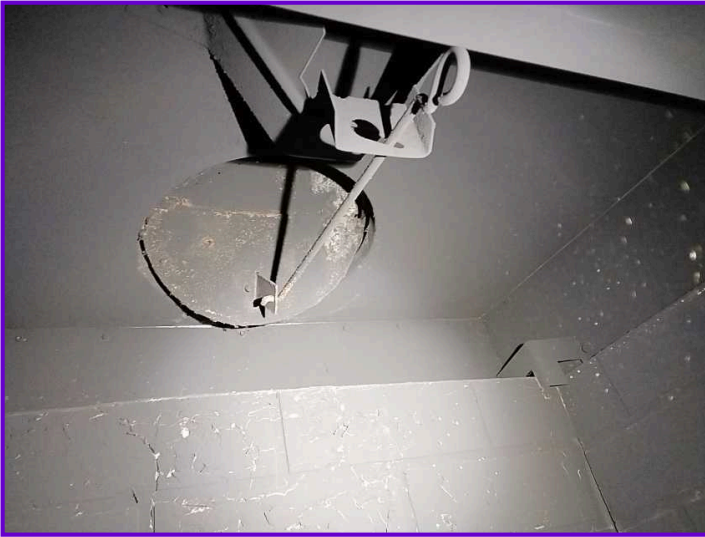
COMMENTS: The damper is functional.

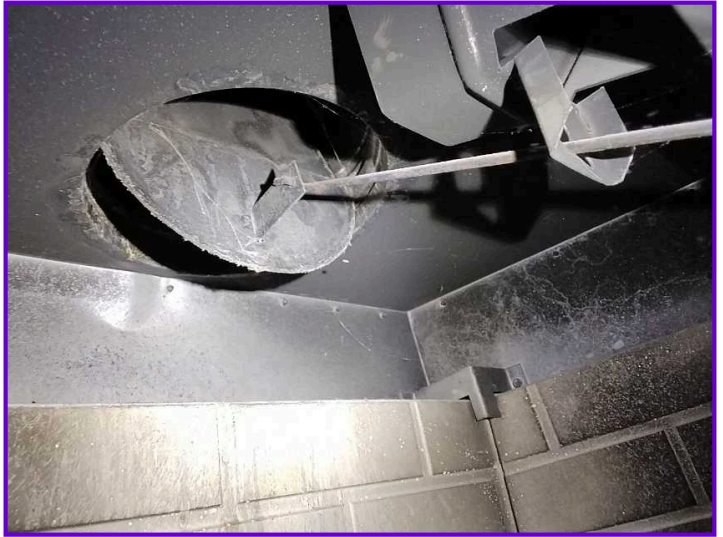
COMMENTS: The damper is functional.

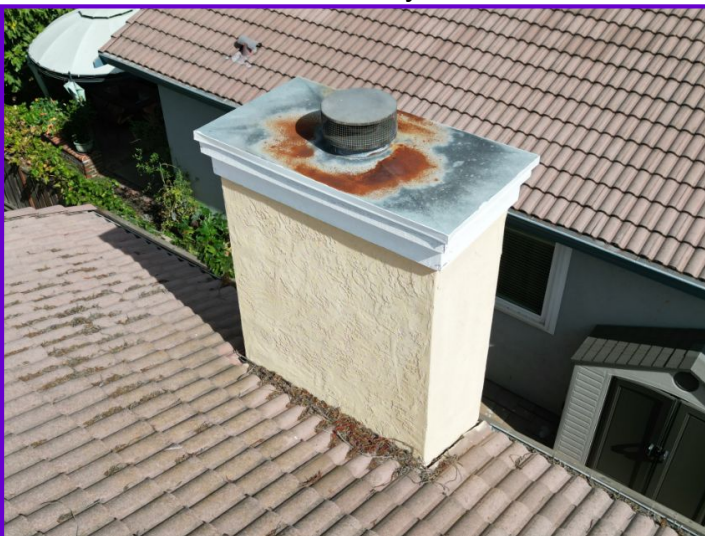
COMMENTS: The chimney structures had no visible defects.
