PROPERTY INSPECTION REPORT

805 Eastbrook Court, Danville, CA 94506

DATE OF INSPECTION: 1/1/2025

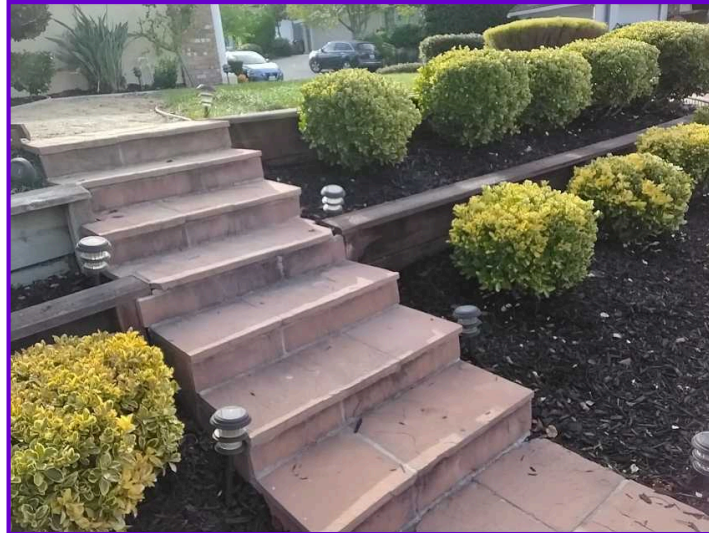
- **CAUTION:** Handrails were not provided for the stairs at front of the property. Standards require stairs with three or more risers have handrails that are grippable, a minimum of thirty-four inches high and with vertical pickets no more than four inches apart.

CAUTION: Handrails were not provided for the stairs at front of the property.

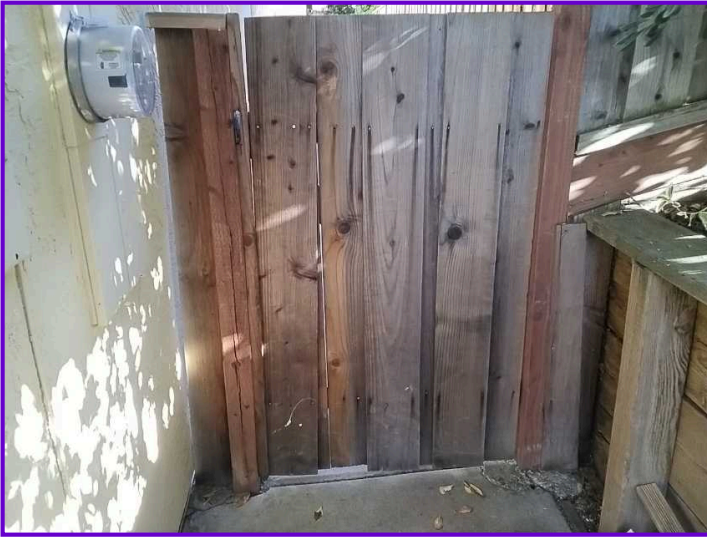
COMMENTS: The gating of the property is functional.

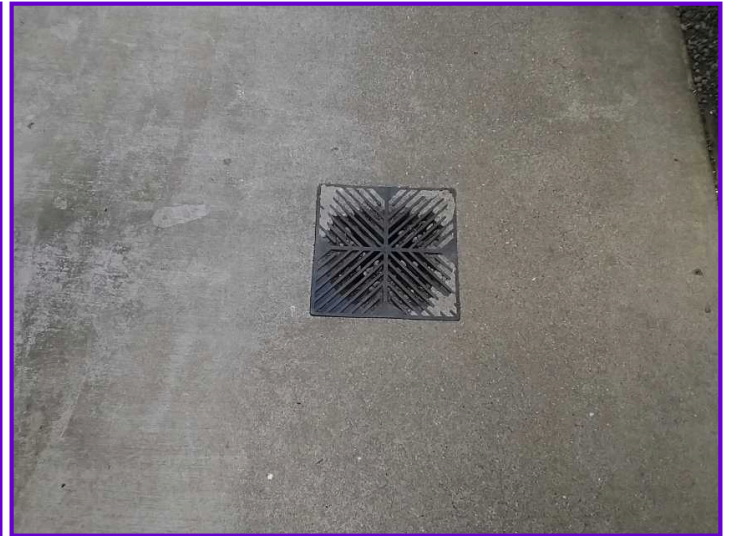
PREVENTIVE: There are area drains on the property.

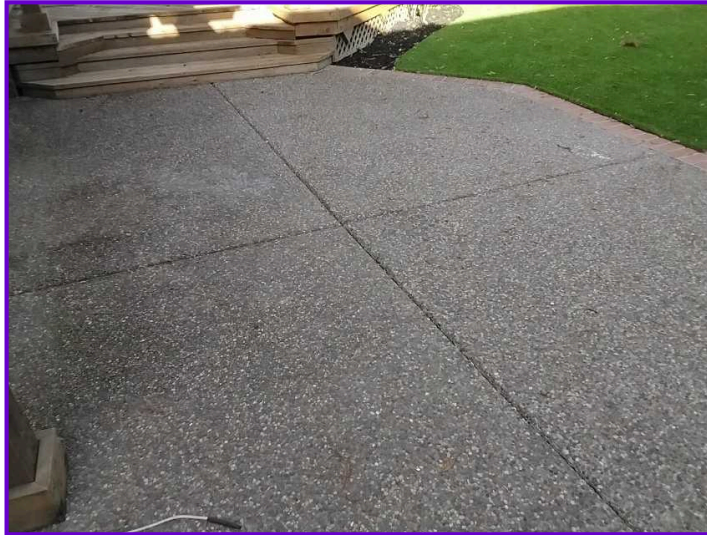
COMMENTS: The patio is functional.

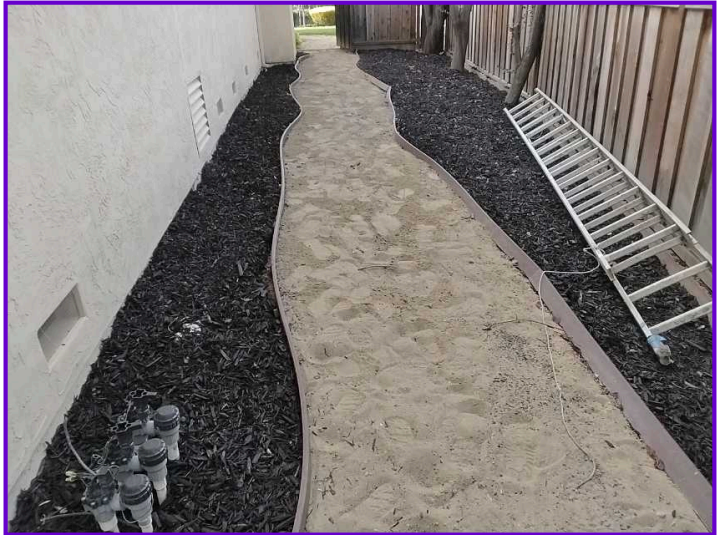
COMMENTS: The walkways at various locations around the residence are functional.

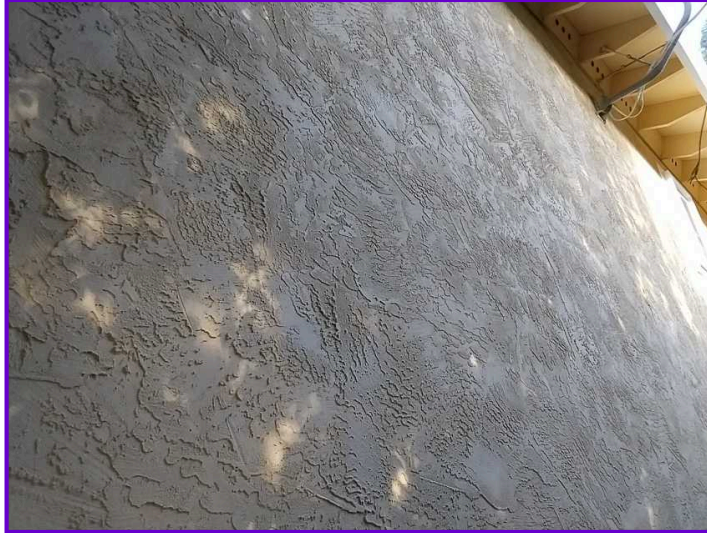
COMMENTS: The exterior wall coverings appear to be functional and in good condition.

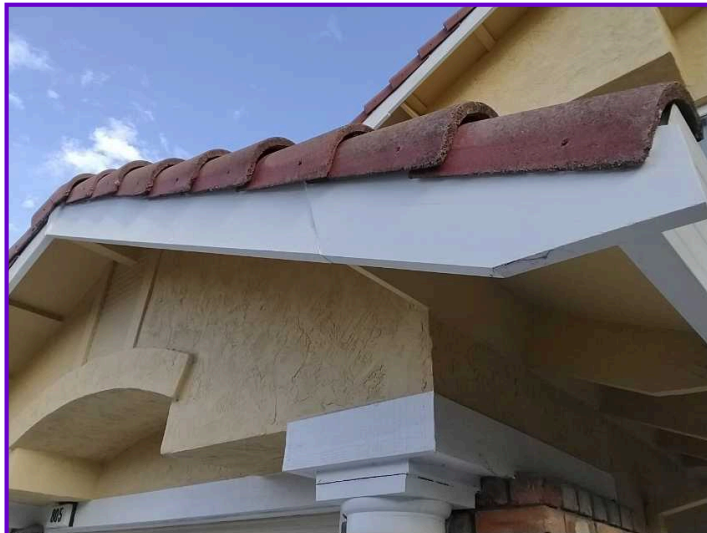
COMMENTS: The fascia board and trim appear to be functional.

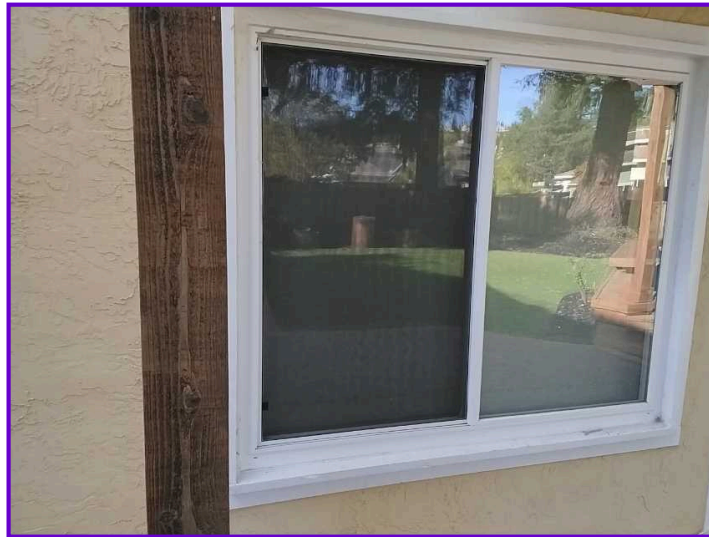
COMMENTS: The provided window and door screens are functional.

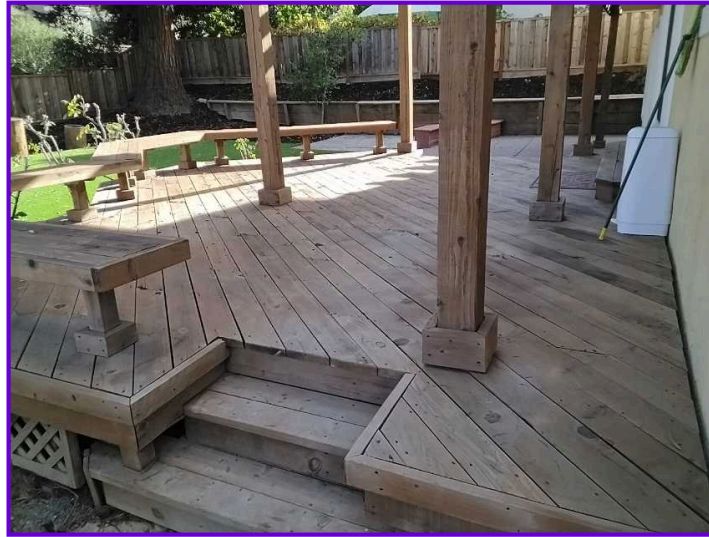
COMMENTS: The deck at the rear of the residence appeared functional, well constructed and structurally sound.

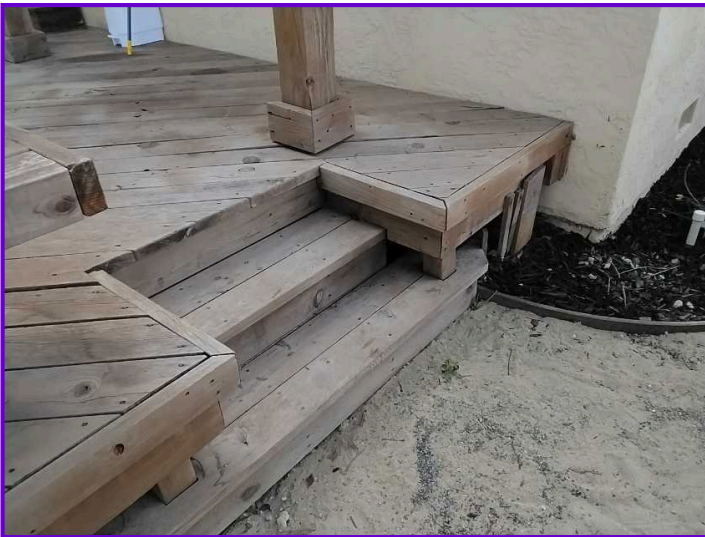
- COMMENTS: The handrails at the attached deck appear functional and secure.
- CAUTION: Handrails were not provided for the stairs at the residence. Standards require stairs with three or more risers have handrails that are grippable, a minimum of thirty-four inches high and with vertical pickets no more than four inches apart.

CAUTION: Handrails were not provided for the stairs at rear of the residence.

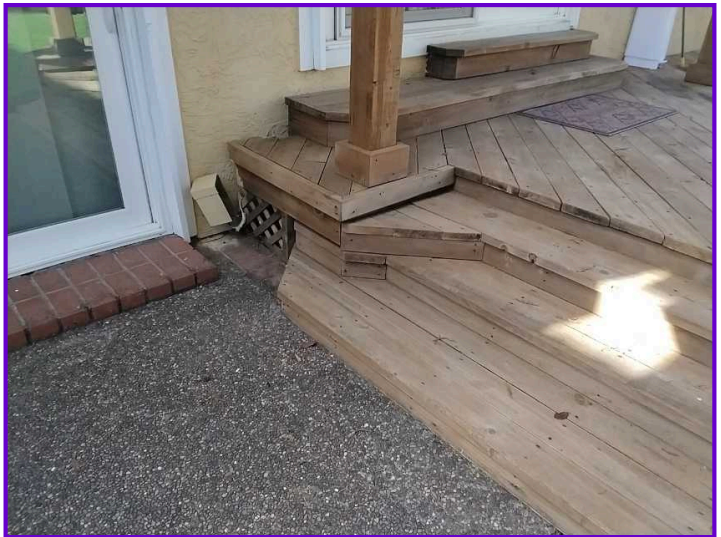
CAUTION: Handrails were not provided for the stairs at rear of the residence.

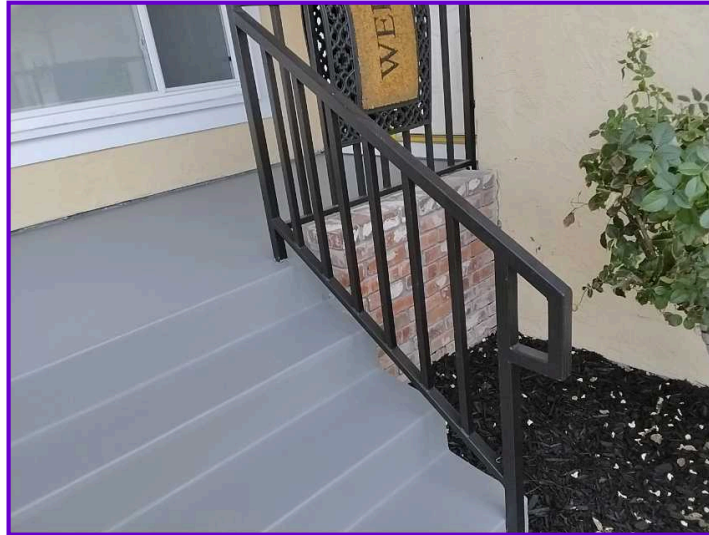
COMMENTS: The handrails at the attached deck appear functional and secure.

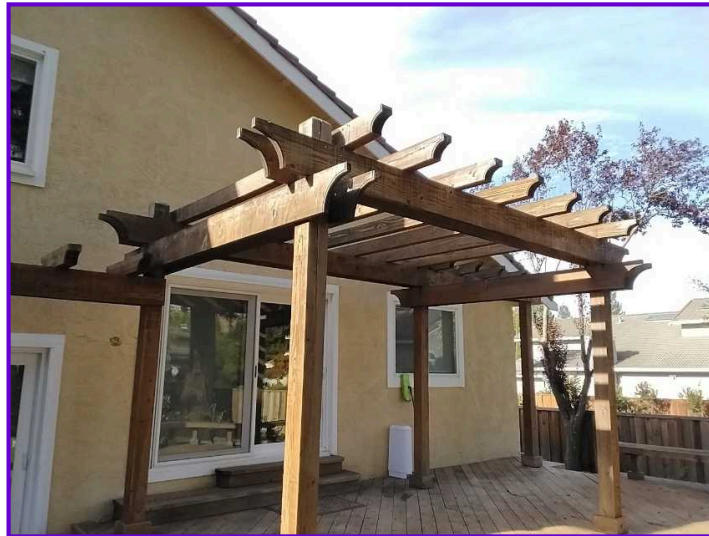
COMMENTS: The pergola at the rear of the residence appears functional.

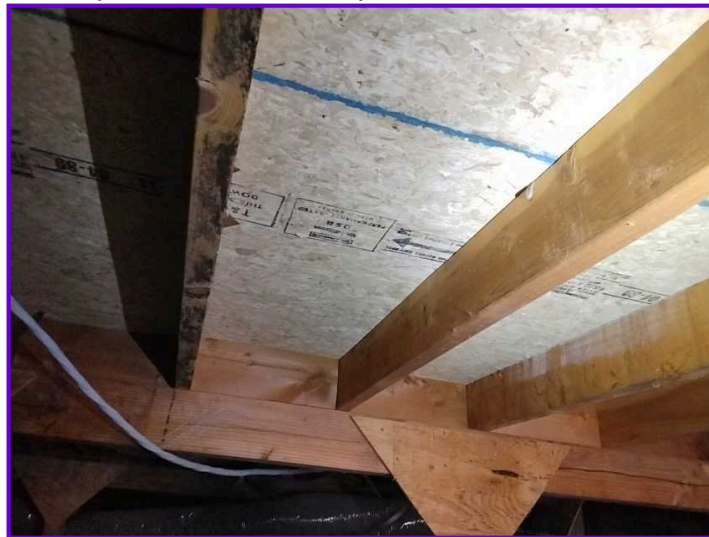
COMMENTS: The visible floor structure components appeared functional.

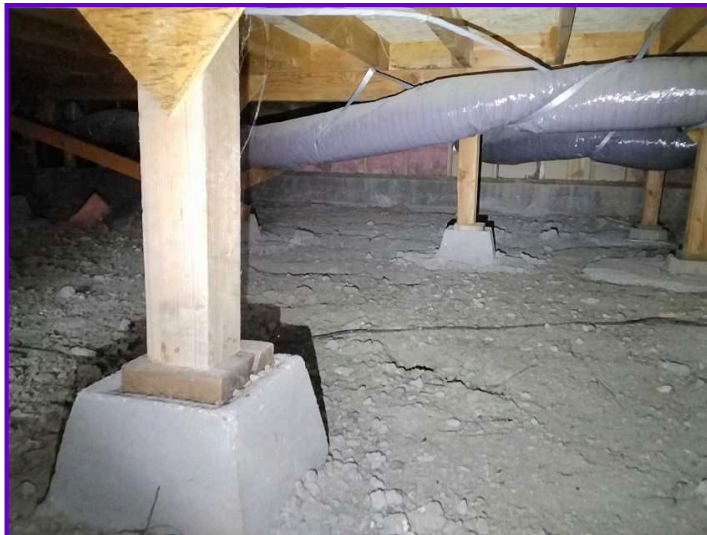
COMMENTS: The supplemental support posts are properly placed and appeared functional at the time of inspection.

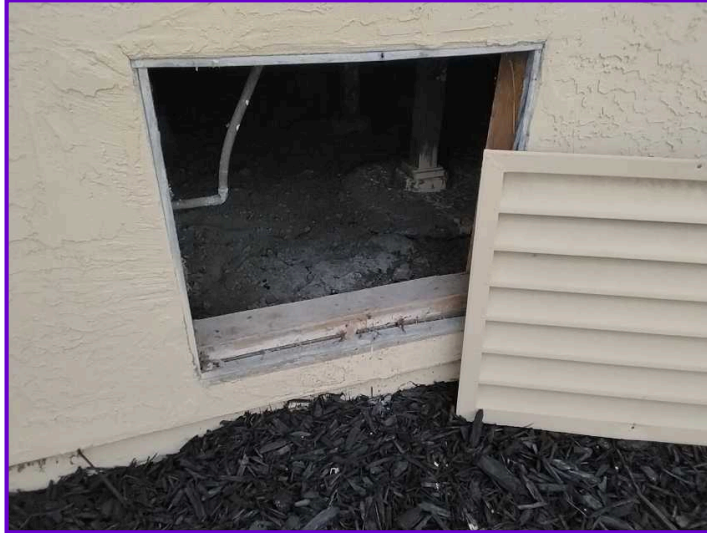
COMMENTS: The crawlspace was entered for inspection of the underfloor areas, systems, and components.

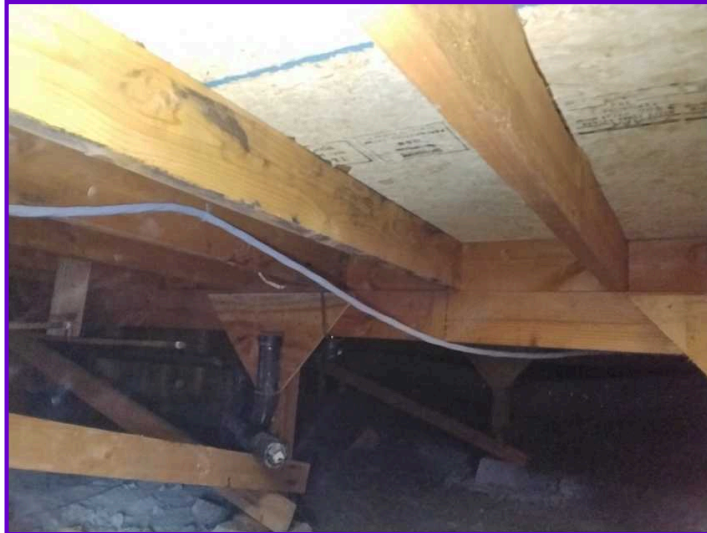
- **PREVENTIVE:** There was no insulation visible in the underfloor areas of the home. Although it may not have been a requirement at the time of construction, retrofitting the crawlspace with insulation can significantly increase the energy efficiency of the home.

PREVENTIVE: There was no insulation visible in the underfloor areas of the home.

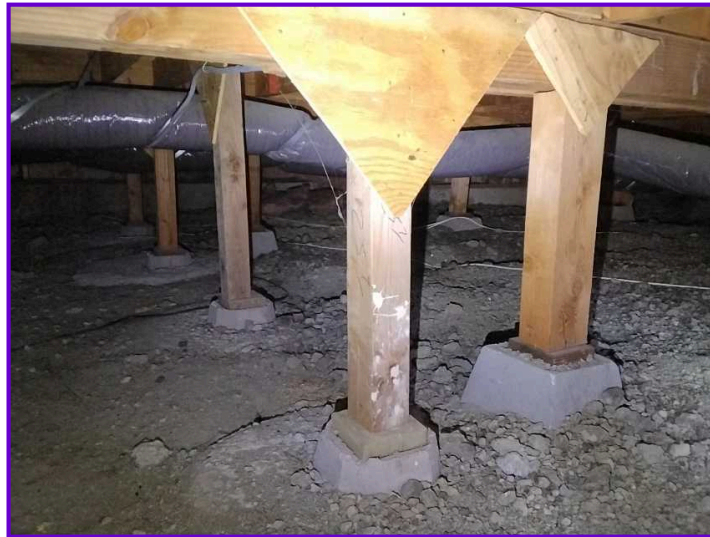
COMMENTS: Where visible and accessible, wood clearances from soil appeared satisfactory.

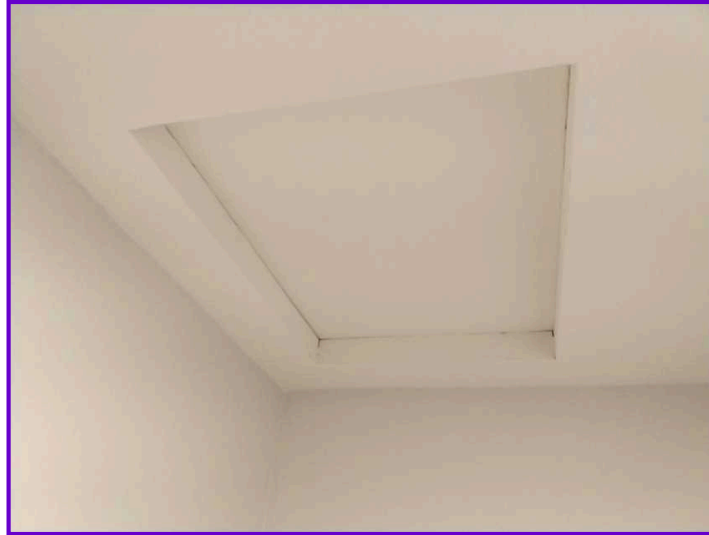
COMMENTS: There is clear access to the attic which allowed inspection of the attic areas and components.

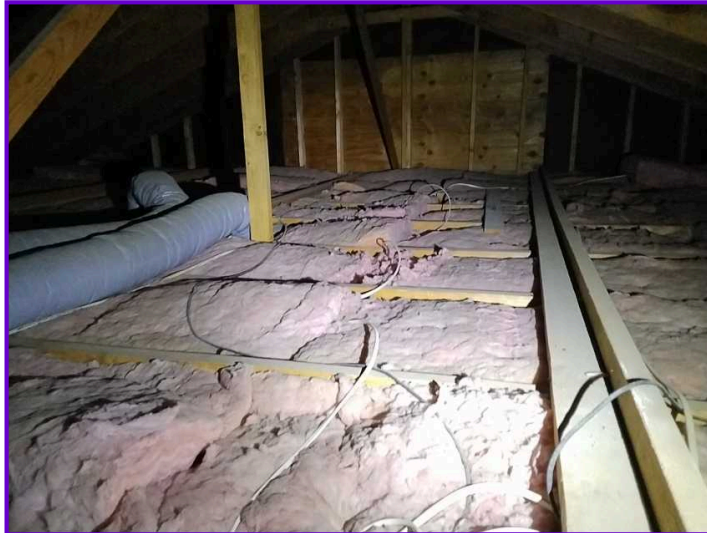
- **PREVENTIVE:** The attic floor is minimally insulated, which would not be considered adequate using current standards, and you may wish to add more for improved energy efficiency.

PREVENTIVE: The attic floor is minimally insulated.

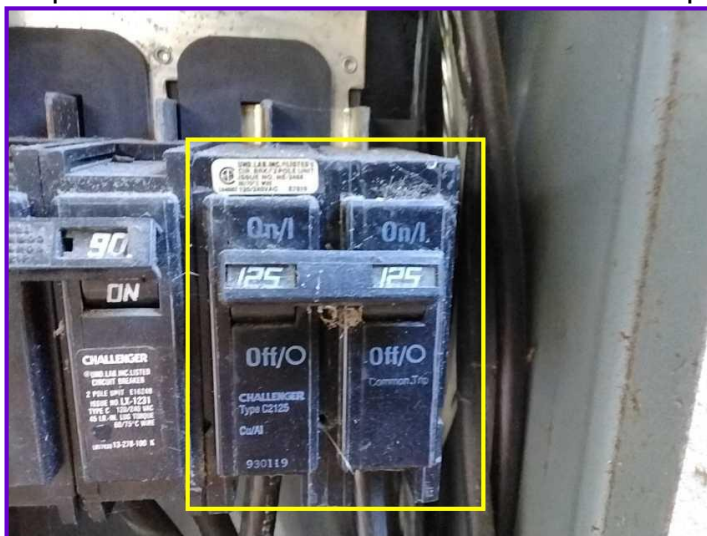
COMMENTS: The 125 amp main disconnect is located inside the main panel.

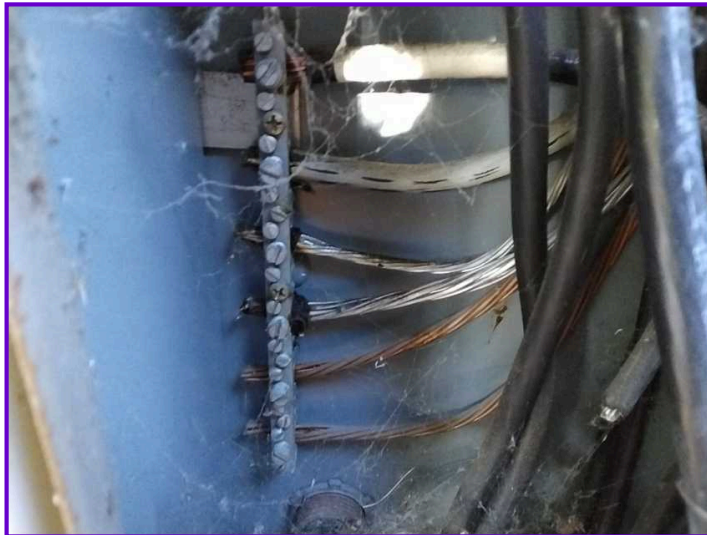
COMMENTS: The main electrical panel appears to be properly grounded.

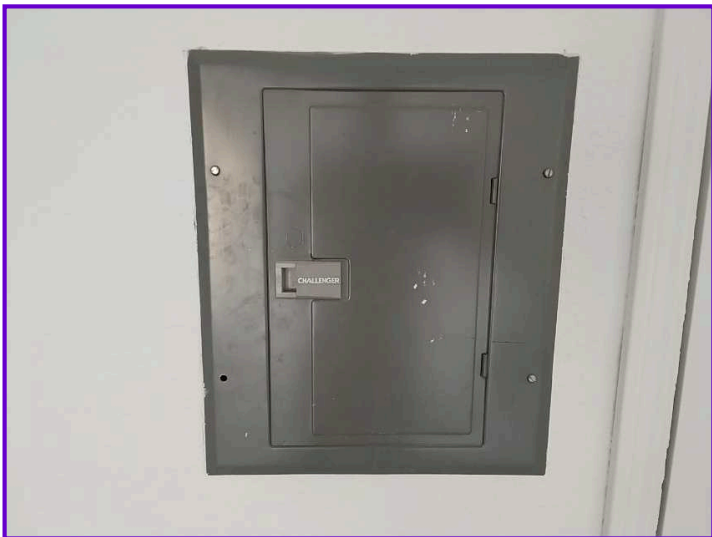
COMMENTS: The exterior cover at the sub panel appears functional.

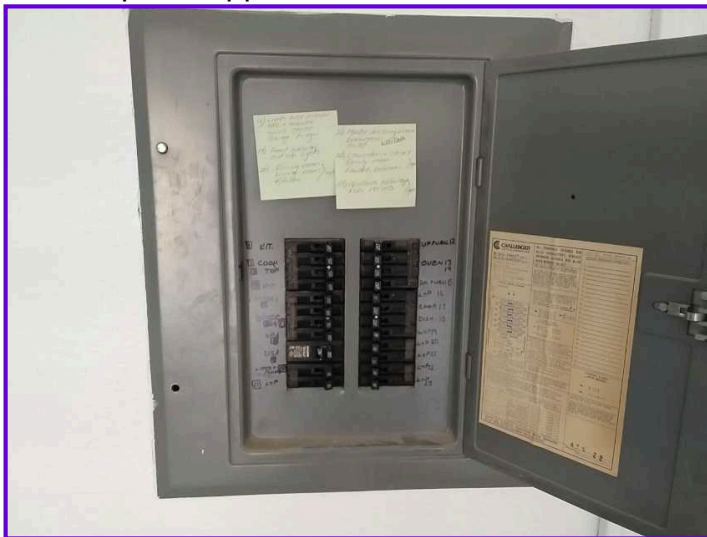
COMMENTS: The interior cover at the sub panel appears functional.

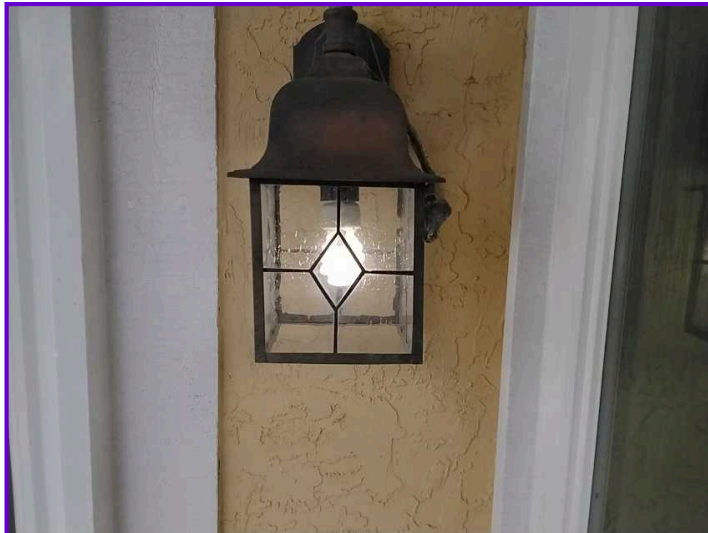
COMMENTS: The tested exterior light fixtures were functional unless otherwise noted.

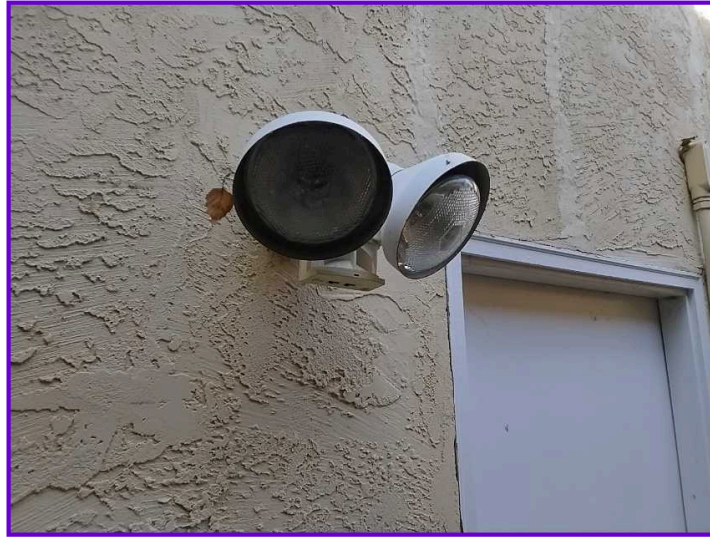
DEFERRED: Light fixtures equipped with sensors or timers are not evaluated or tested.

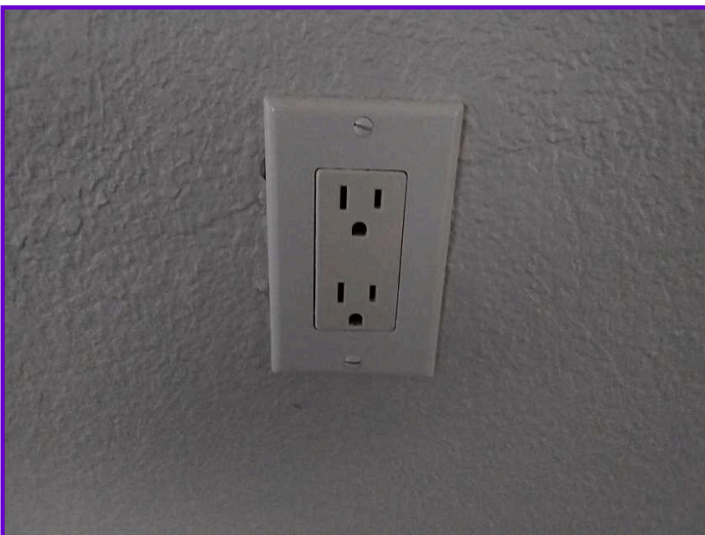
COMMENTS: The tested interior receptacle outlets were functional unless otherwise noted.

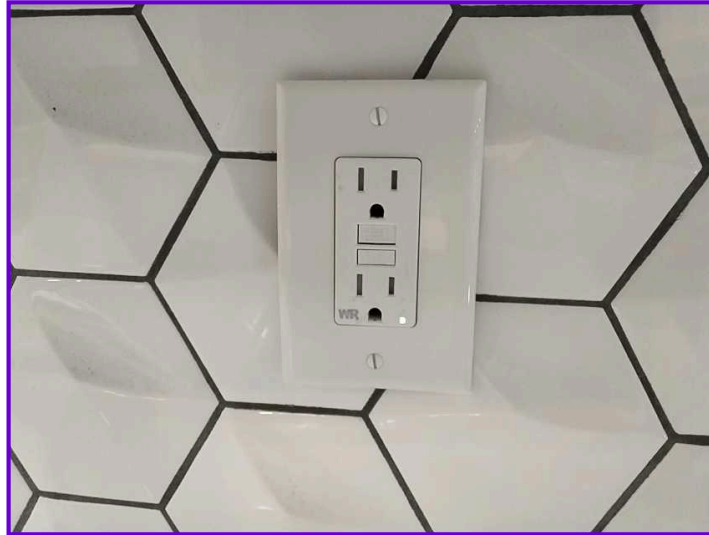
COMMENTS: The GFCI protected receptacle outlets at the home responded correctly when tested.

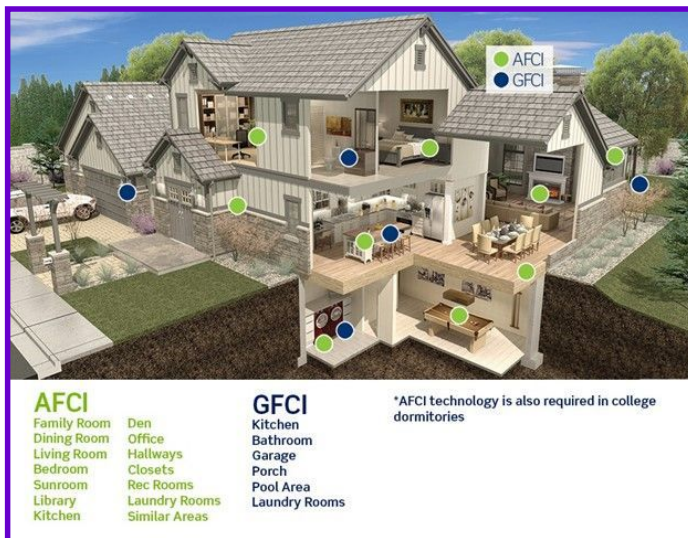
PREVENTIVE: Concerned parties may wish to have a qualified professional install AFCI breakers as a preventive safety measure.

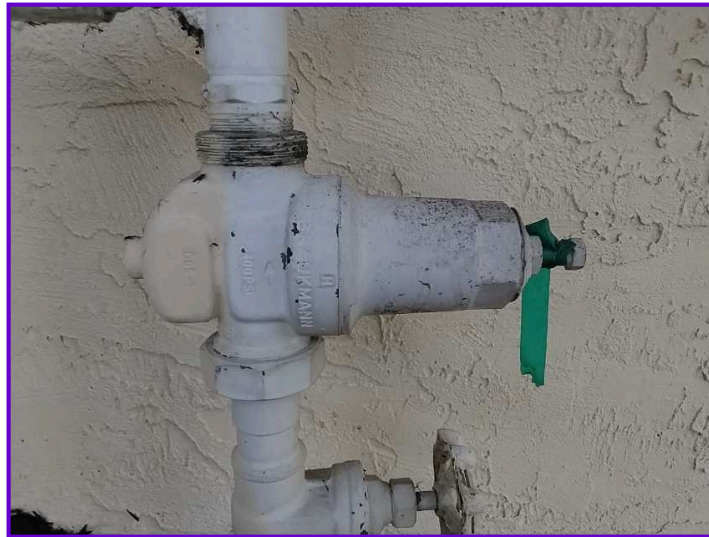
COMMENTS: A functional water pressure regulator was in place on the main water line.

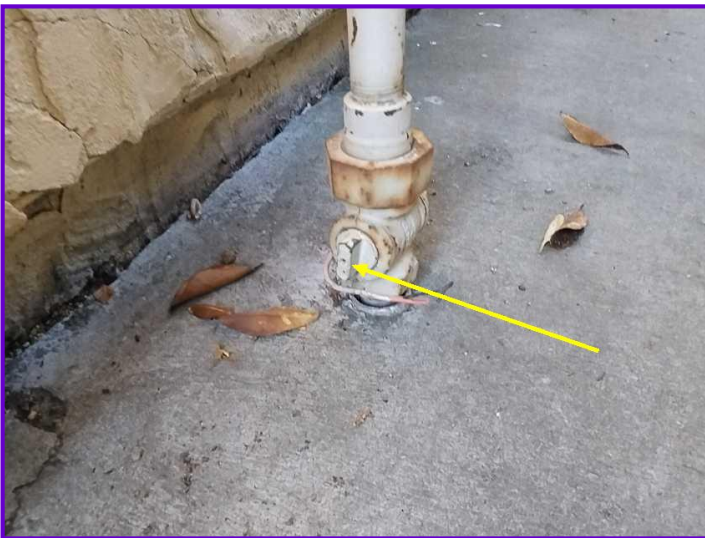
COMMENTS: The manual gas shut-off valve is located at the gas main.

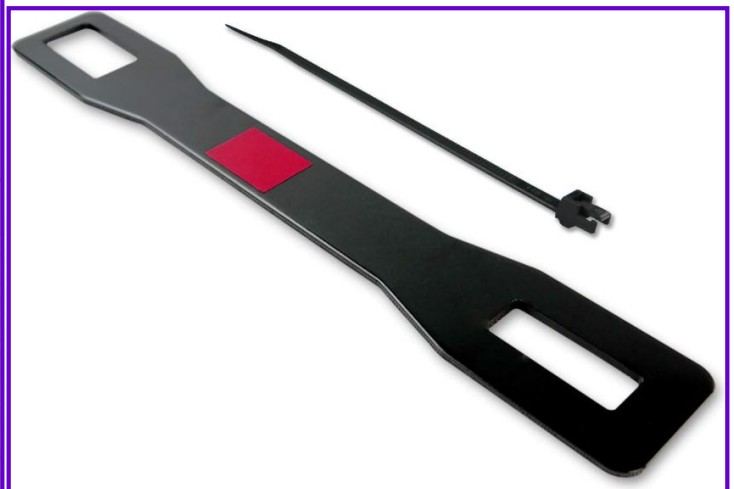
PREVENTIVE: Concerned parties may wish to place a gas shut off wrench at the gas main to facilitate a faster emergency shut down of the gas supply.

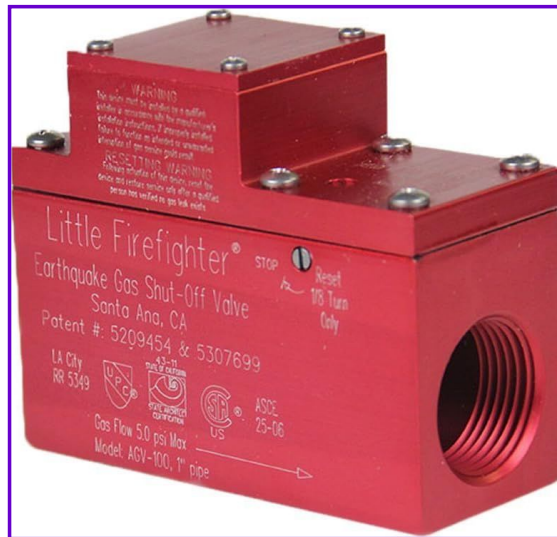
PREVENTIVE: The gas supply system does not have a seismic shut-off valve.

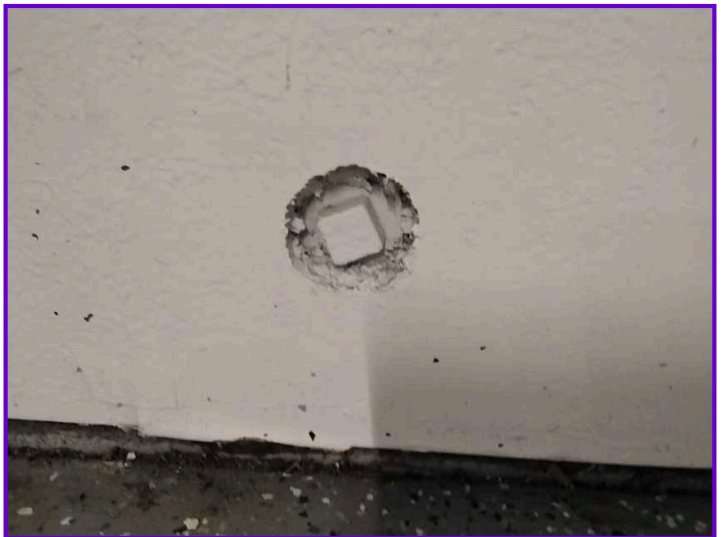
COMMENTS: There is an exterior clean-out in the garage of the home.

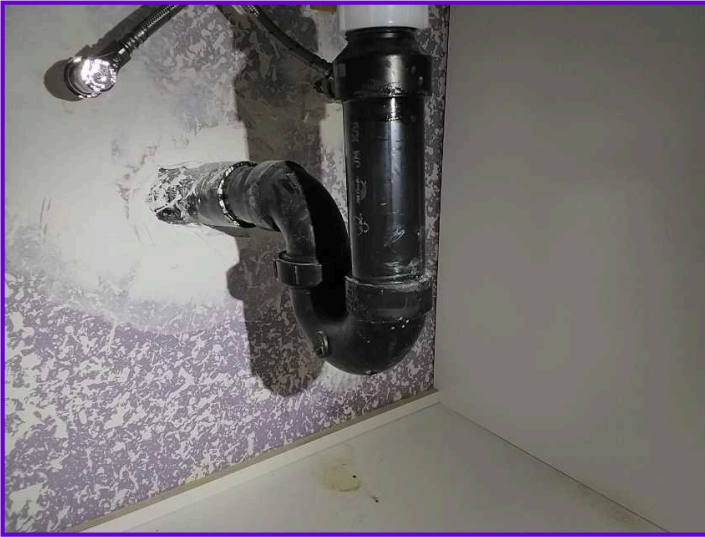
COMMENTS: The majority of fixture drain and vent pipes within the home were functional at the time of the inspection.

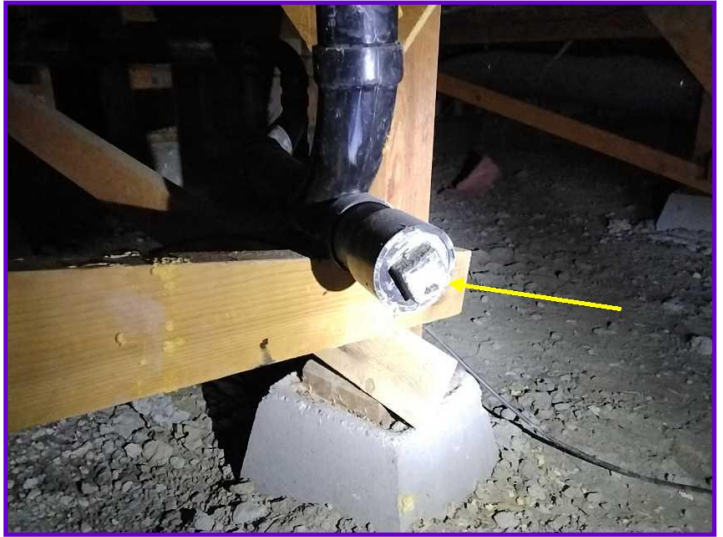
COMMENTS: There is an exterior clean-out under the home.

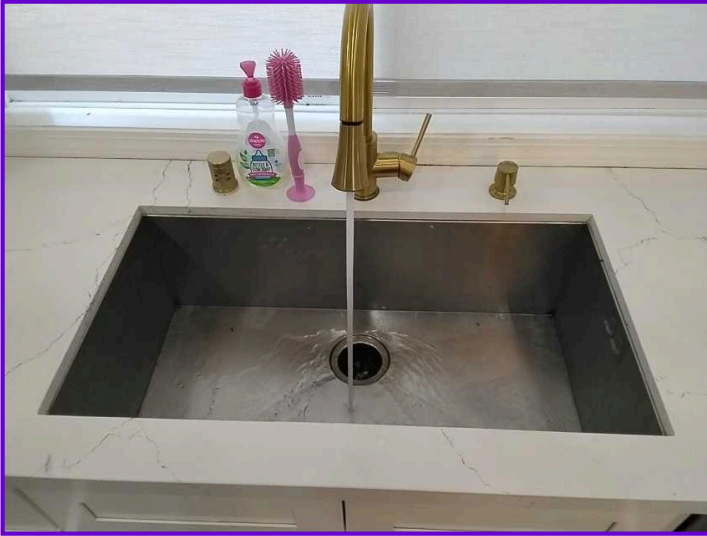
COMMENTS: The kitchen sink and related components are functional.

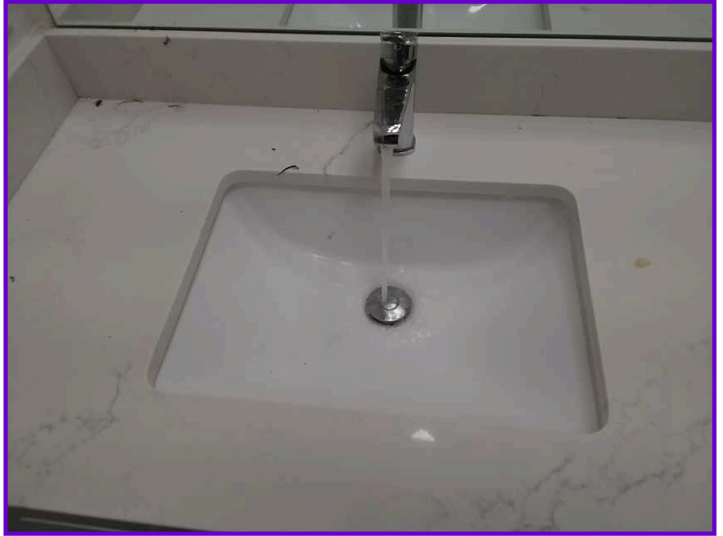
COMMENTS: The bathroom sink and related components are functional.

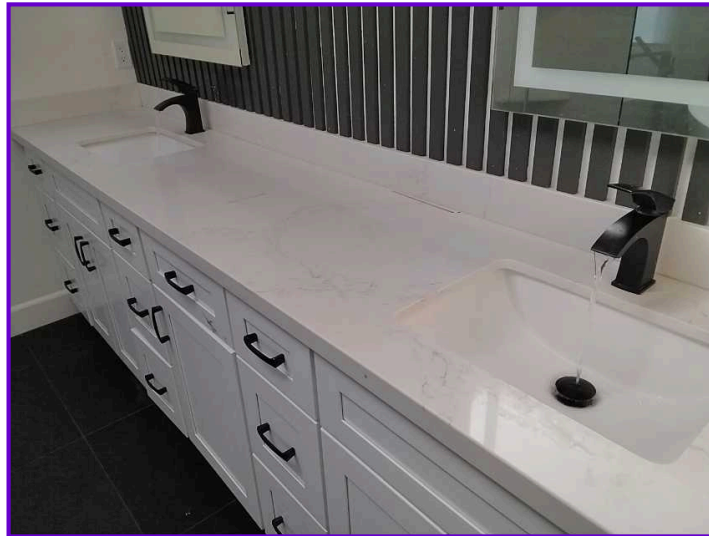
COMMENTS: The bathroom sink and related components are functional.

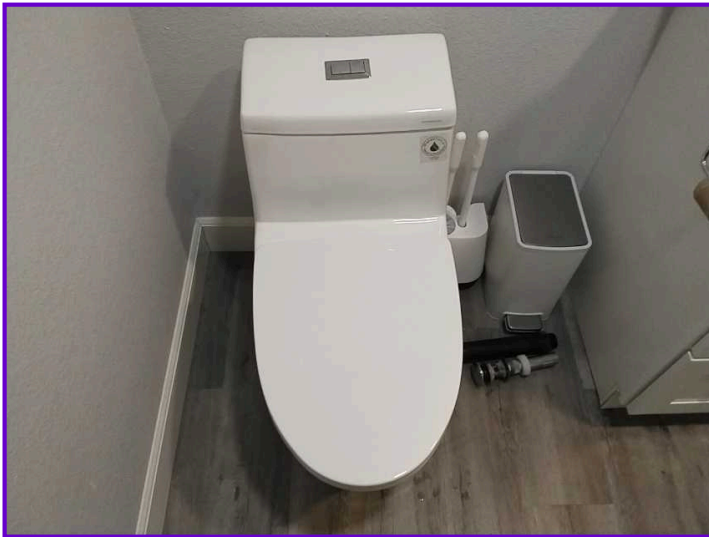
COMMENTS: The toilets responded properly when flushed.

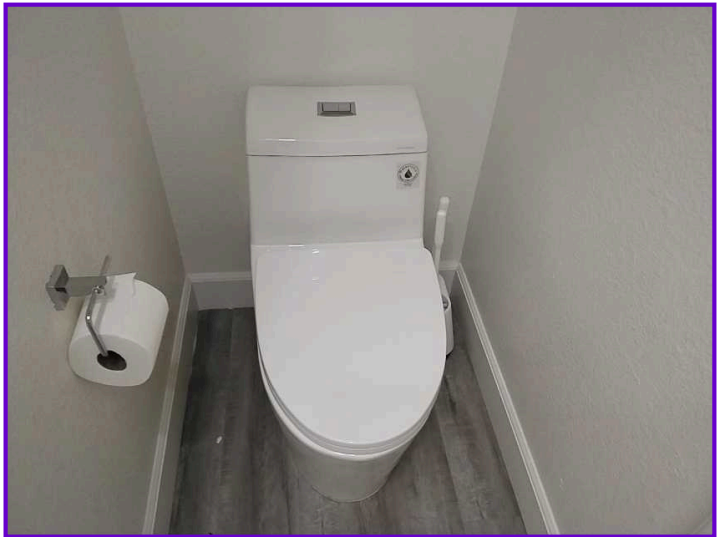
COMMENTS: The toilets responded properly when flushed.

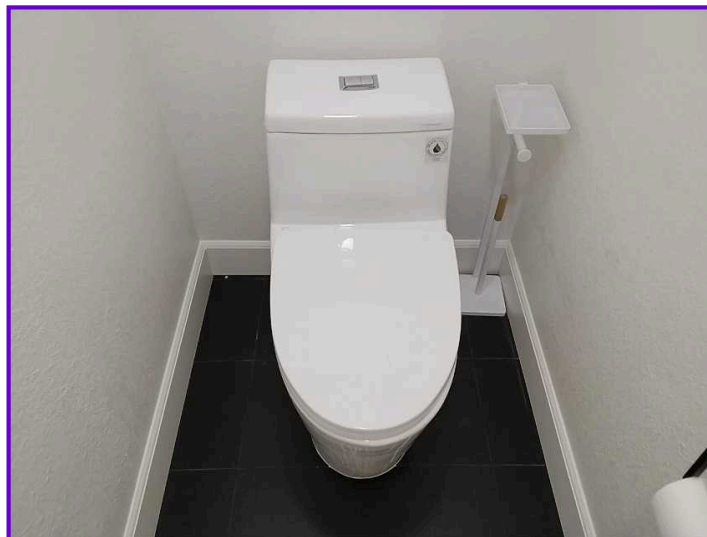
COMMENTS: The toilets responded properly when flushed.

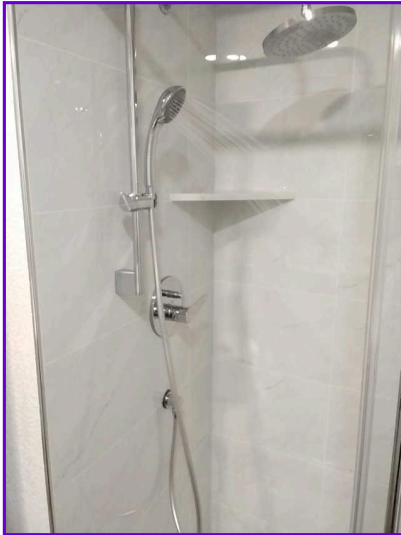
COMMENTS: The stall showers are functional.

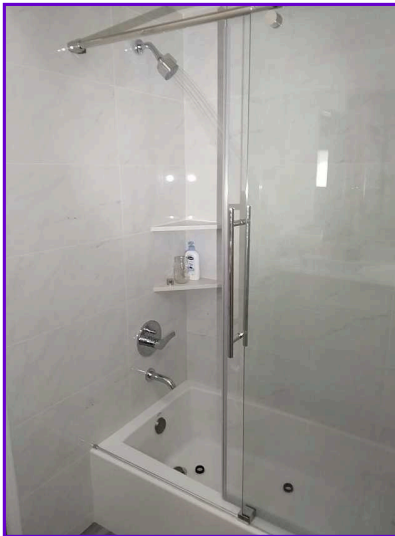
COMMENTS: The tub-shower is functional.

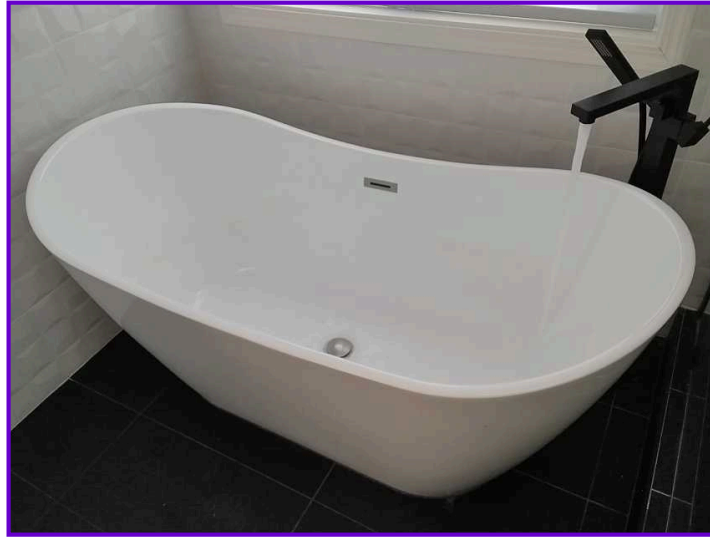
COMMENTS: The tub in the master bathroom is functional.

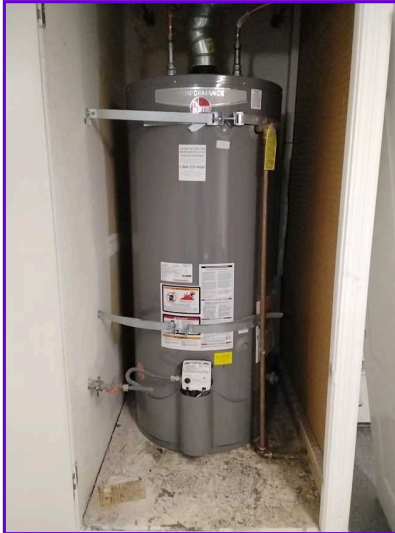
COMMENTS: The water heater was functioning satisfactorily at the time of the inspection, with no evidence of prior or active leakage observed.

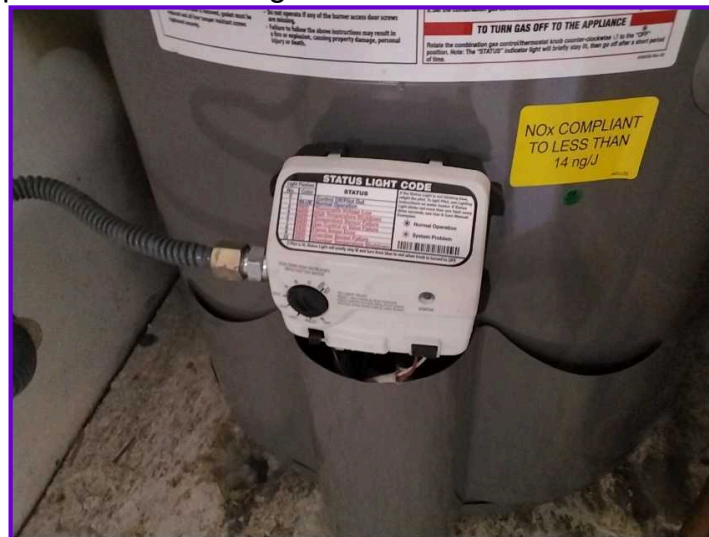
COMMENTS: The temperature and setting controls were functional.

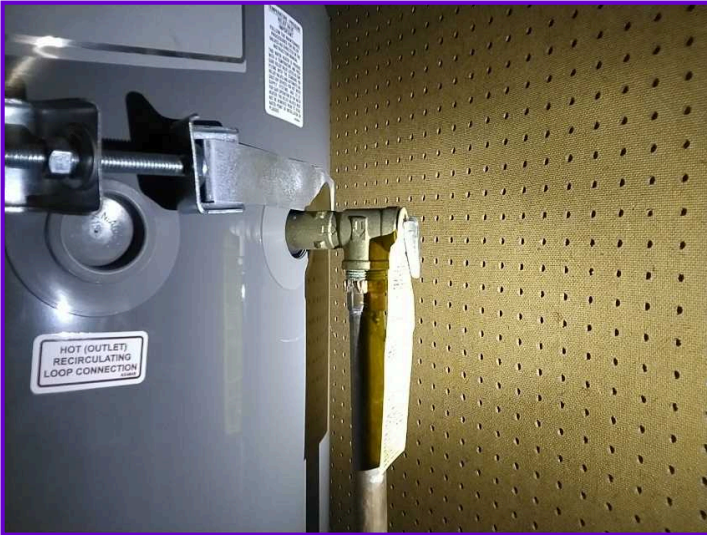
COMMENTS: A temperature and pressure relief (TPR) valve was installed at the water heater as required.

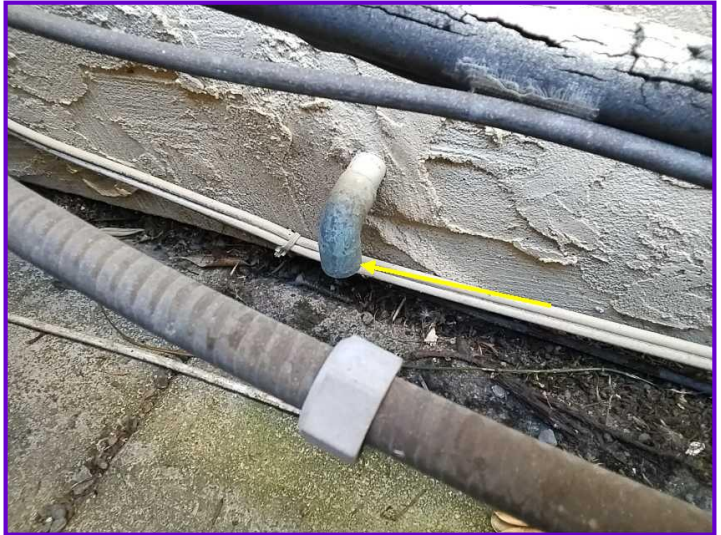
COMMENTS: The valve includes a discharge pipe that discharges to within six inches of the ground at a visible and accessible exterior location as needed.

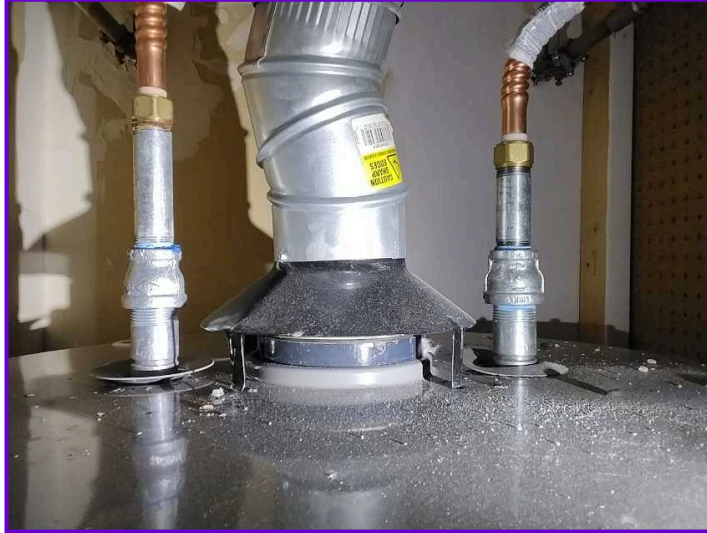
COMMENTS: The vent pipe and cap on the gas water heater appeared to be functional.

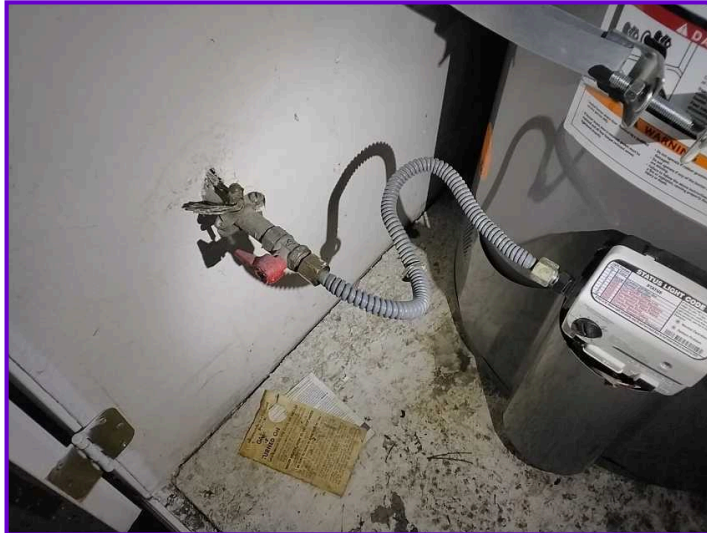
COMMENTS: The gas control valve and connector appear to be functional.

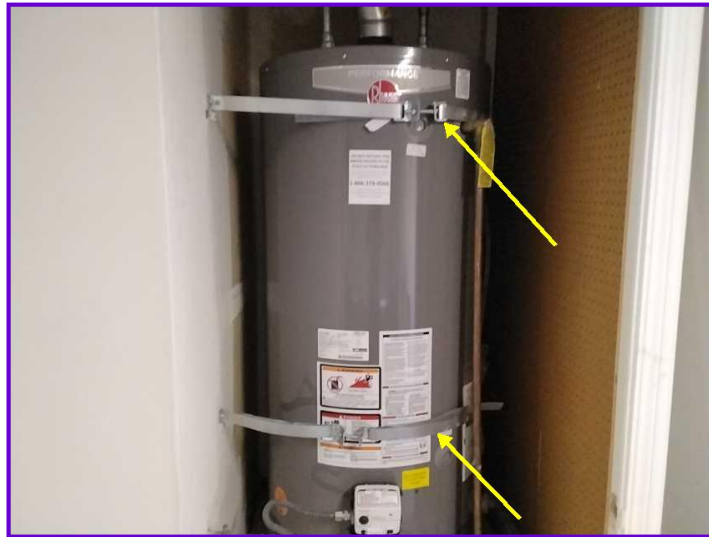
COMMENTS: The water heater is braced, anchored or strapped to help prevent falling or moving during an earthquake.

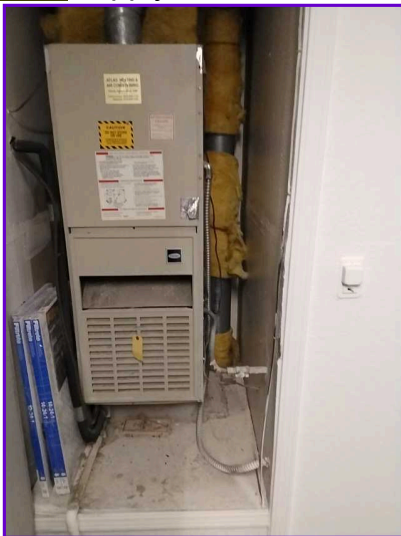
COMMENTS: All forced air heating system components appeared satisfactory unless otherwise noted.

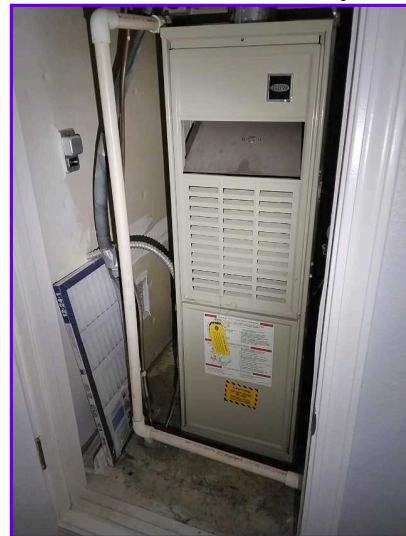
COMMENTS: All forced air heating system components appeared satisfactory unless otherwise noted.

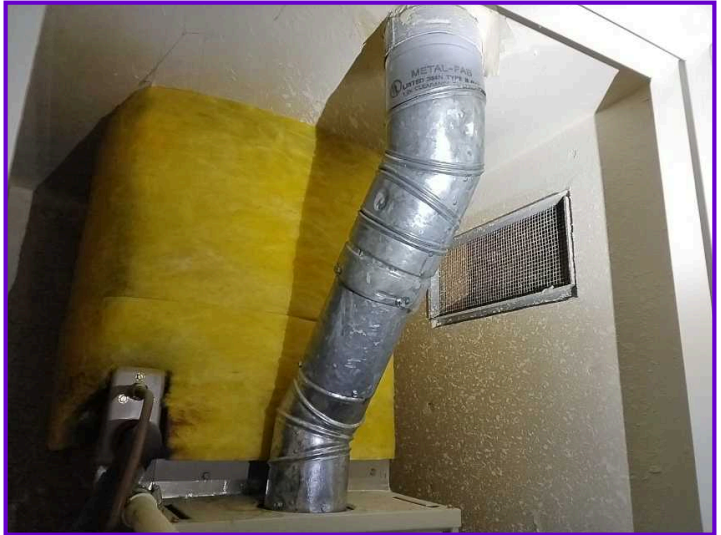
COMMENTS: The furnace venting system components appear satisfactory.

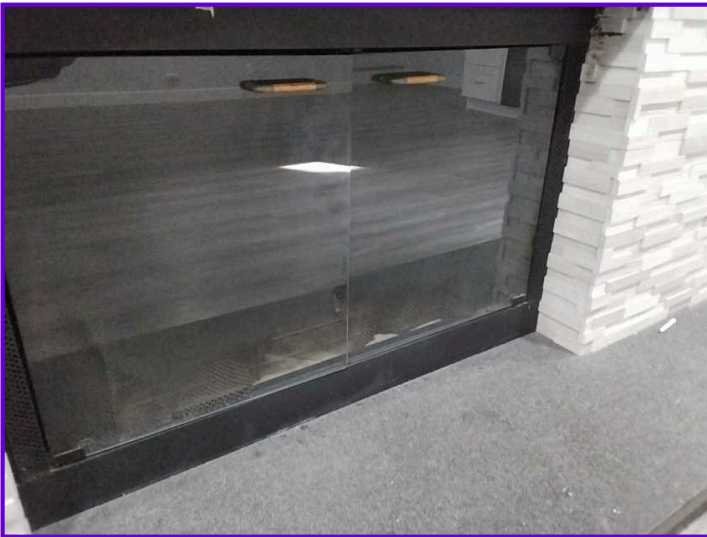
COMMENTS: The fireplace glass doors are functional.

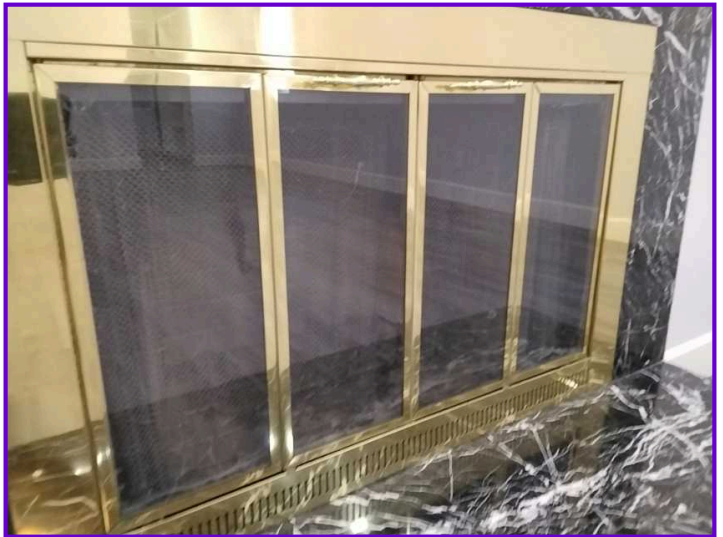
COMMENTS: The fireplace glass doors are functional.

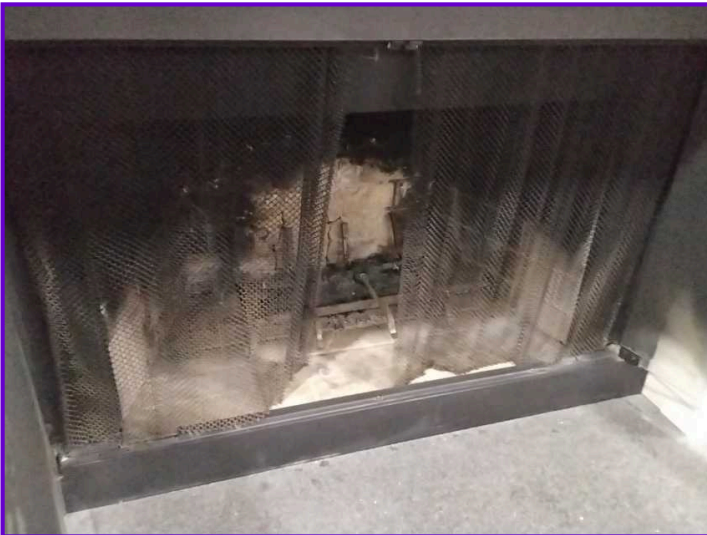
COMMENTS: The fireplace screen appears satisfactory.

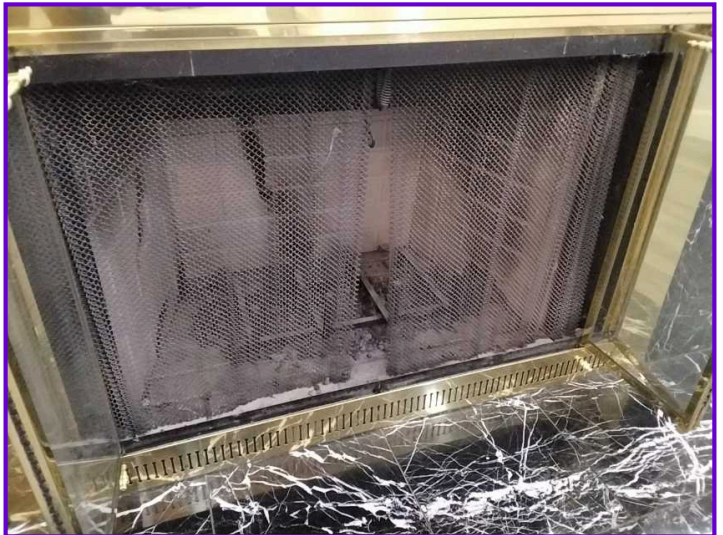
COMMENTS: The fireplace screen appears satisfactory.
