PROPERTY INSPECTION REPORT

805 Eastbrook Court, Danville, CA 94506

DATE OF INSPECTION: 1/1/2025

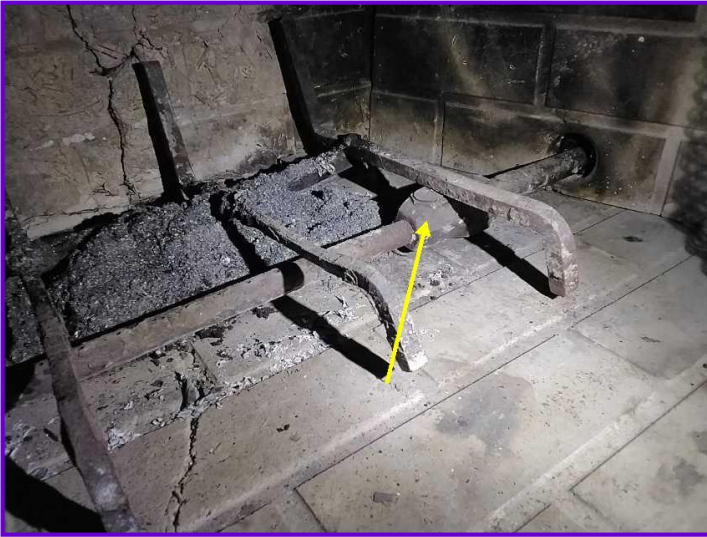
COMMENTS: The gas log starter in the fireplace appeared functional.

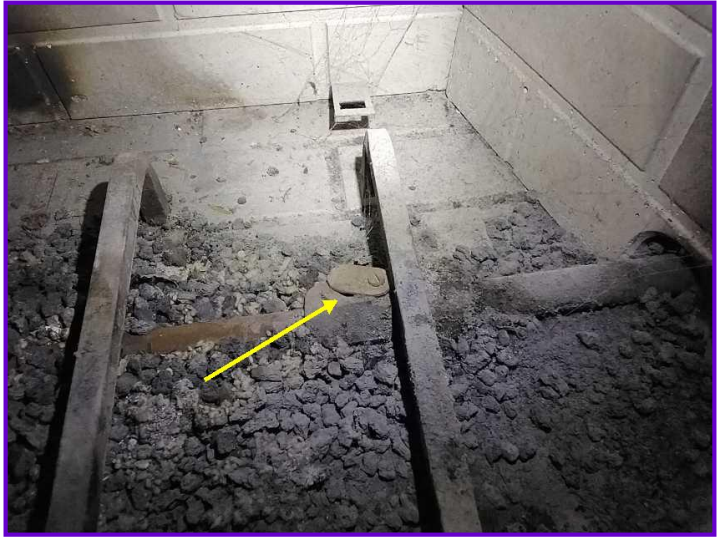
COMMENTS: The gas log starter in the fireplace appeared functional.

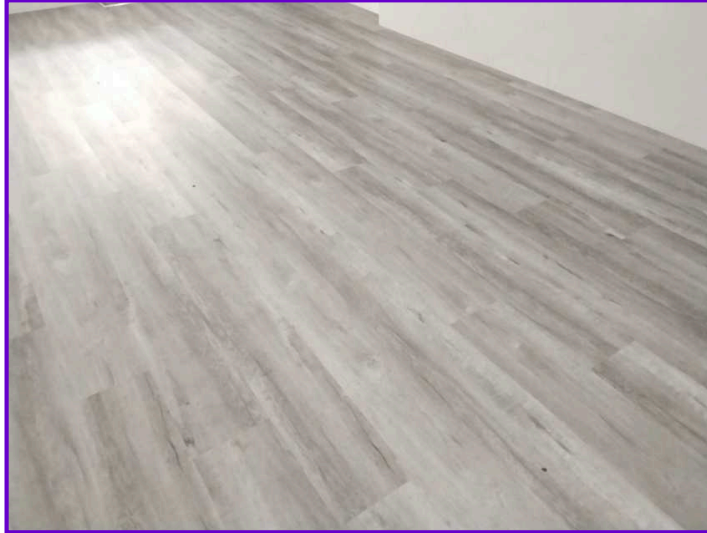
COMMENTS: Where visible and accessible, the majority of floor coverings were in satisfactory condition for their age.

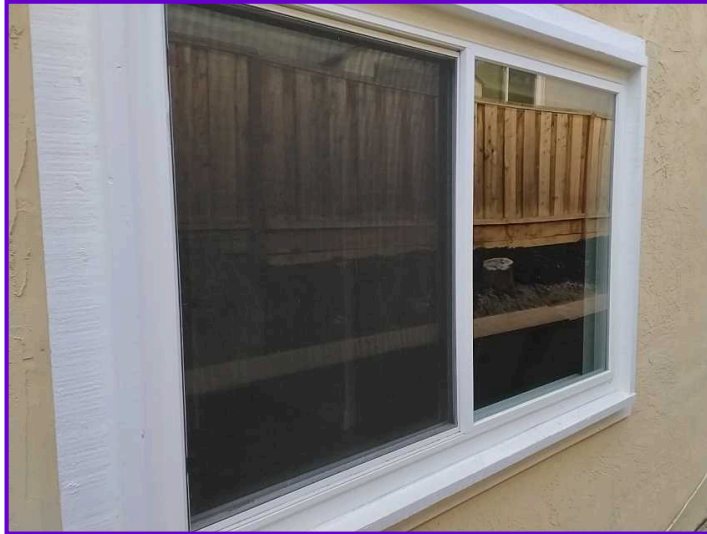
COMMENTS: All tested windows were found to be functional at the time of the inspection.

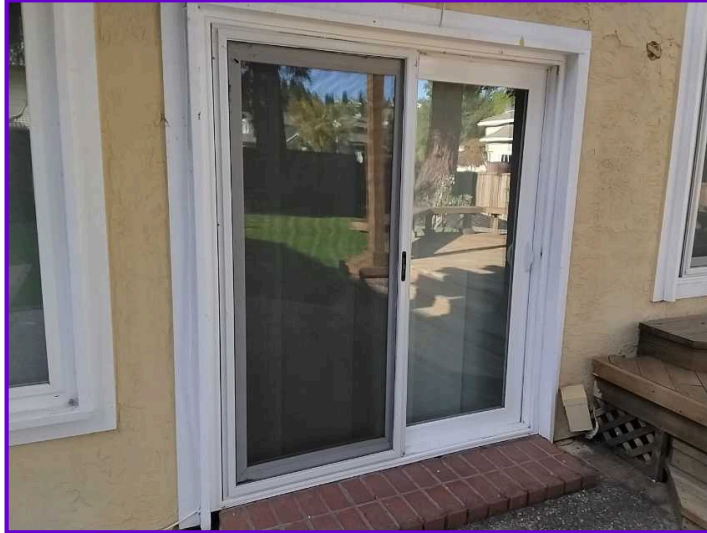
COMMENTS: The exterior doors, latching and locking hardware and the thresholds appeared satisfactory and in functional condition.

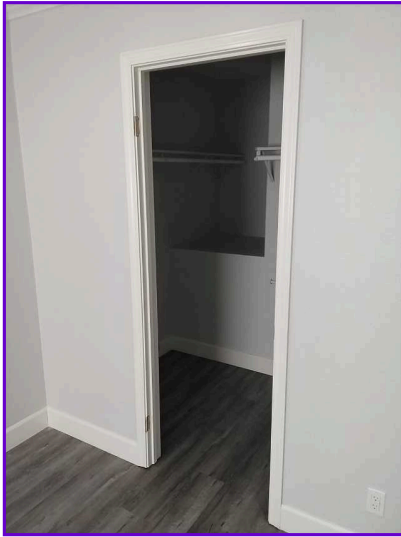
- **DEFERRED:** There are missing closet doors. Concerned parties may wish to have the closet doors replaced.

DEFERRED: There are missing closet doors.

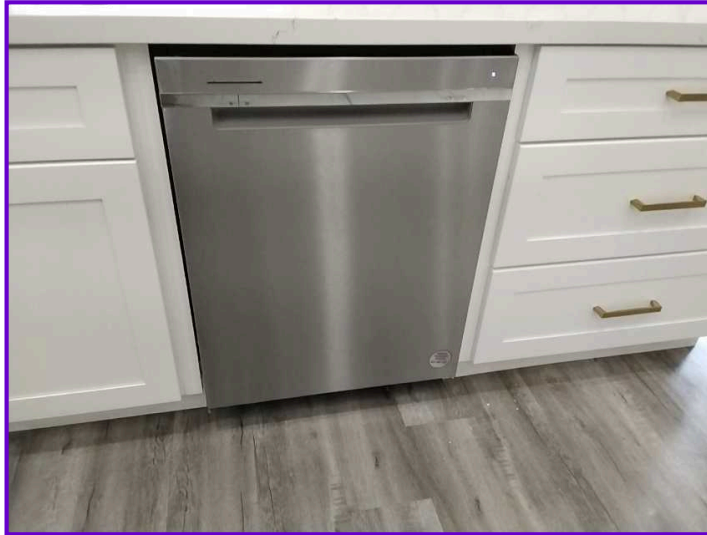
COMMENTS: The dishwasher responded to normal user controls.

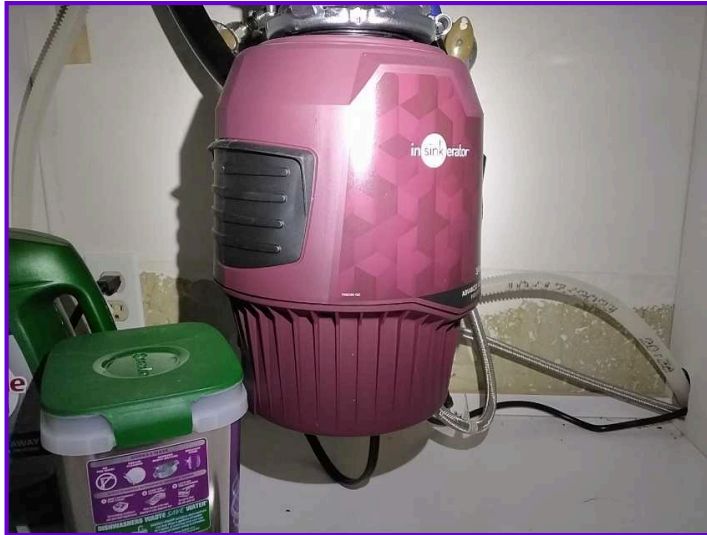
COMMENTS: The garbage disposal responded to normal user controls.

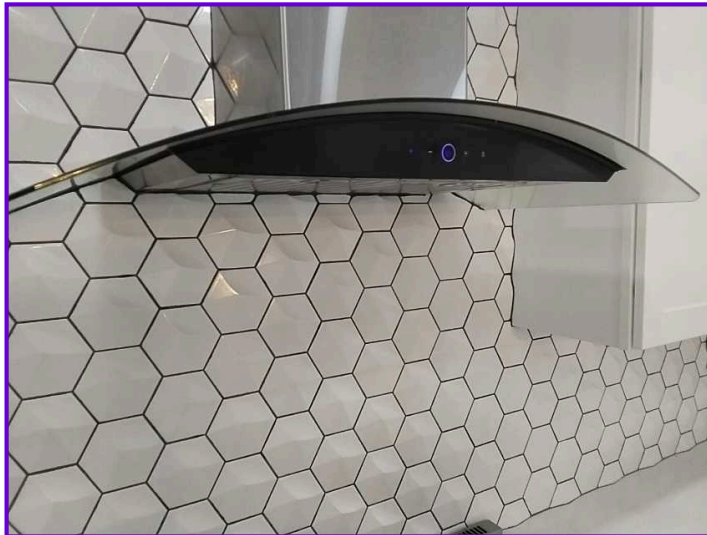
COMMENTS: The built-in vent hood responded to normal user controls.

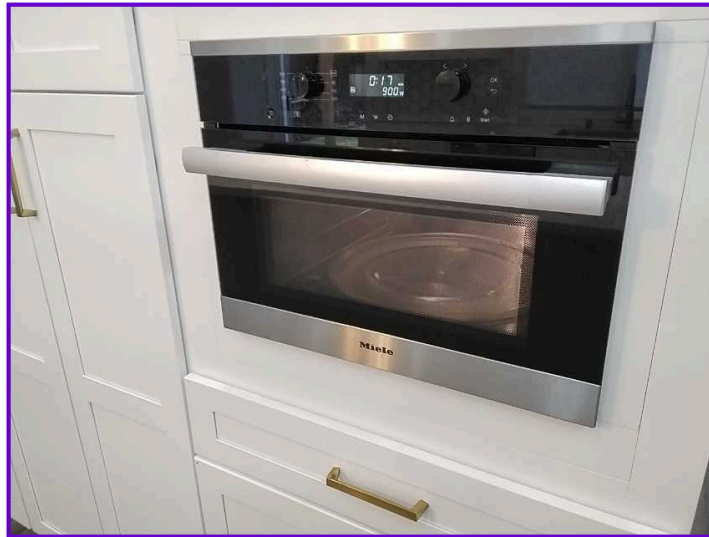
COMMENTS: The built-in microwave oven responded to normal user controls.

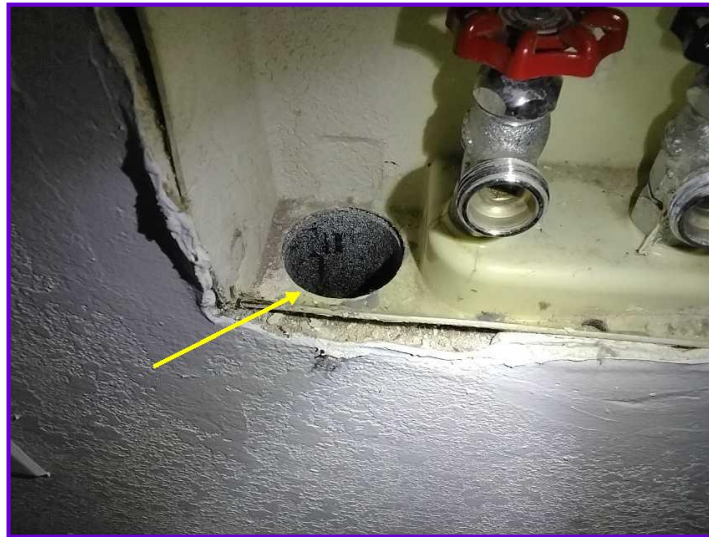
COMMENTS: There is a washer drain line present.

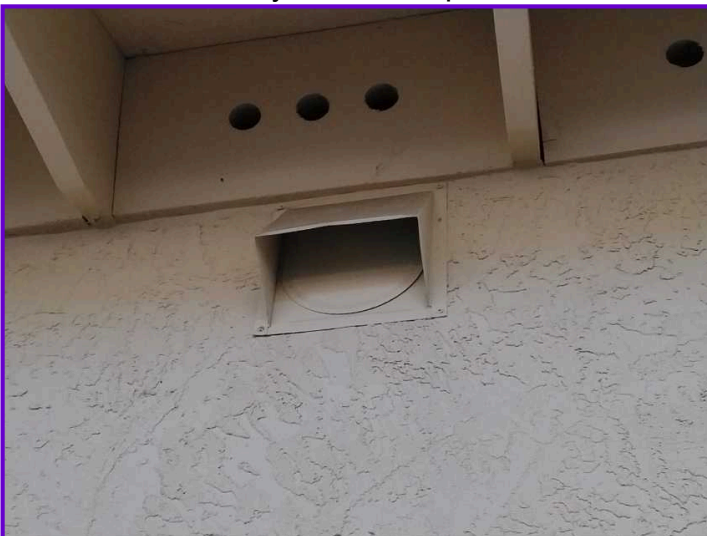
COMMENTS: Dryer exhaust provisions were satisfactory.

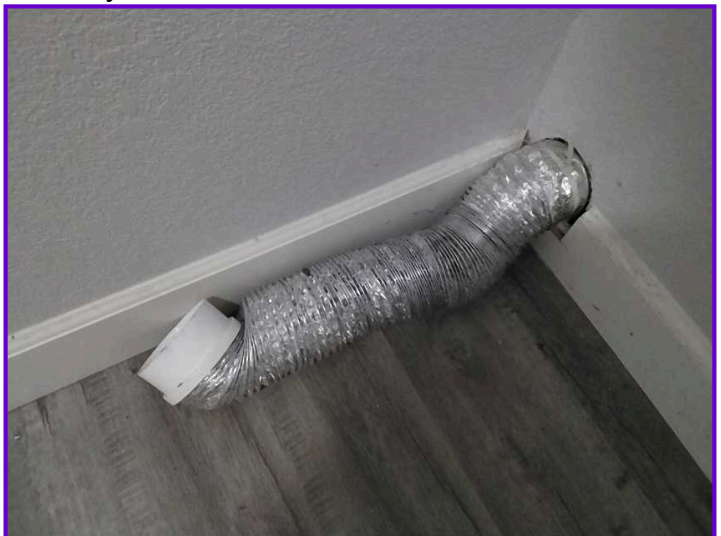
COMMENTS: Dryer exhaust provisions were satisfactory.

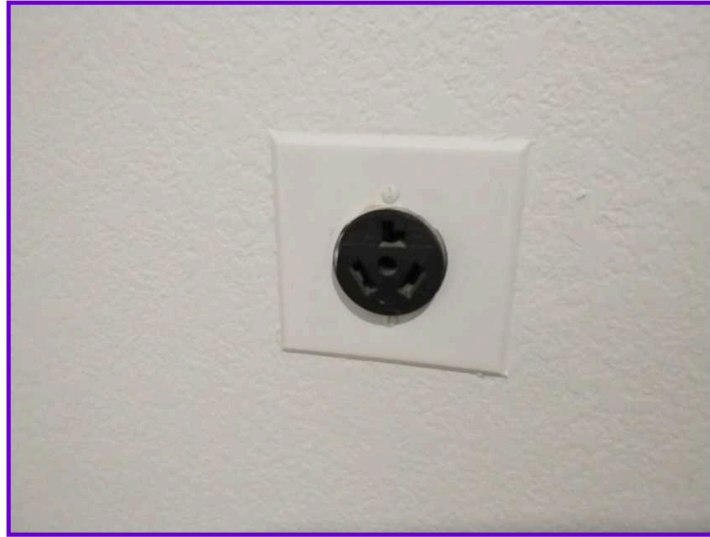
COMMENTS: A 220-volt outlet was provided.

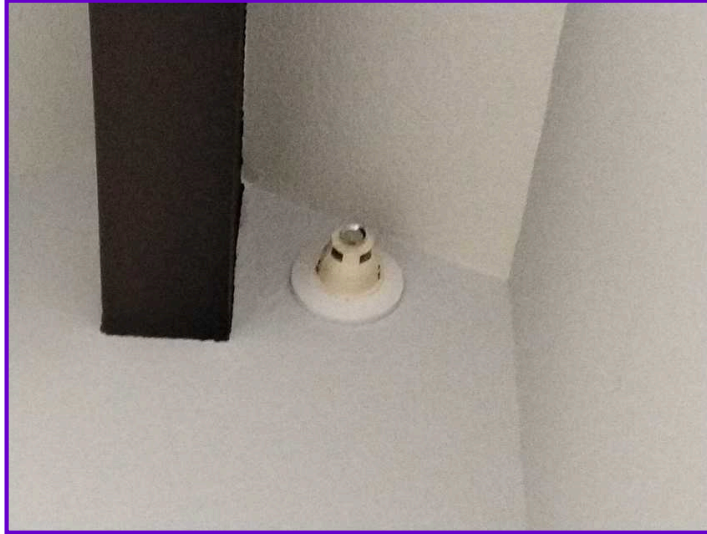
COMMENTS: There are smoke detectors in the bedrooms as required by current building and safety codes.

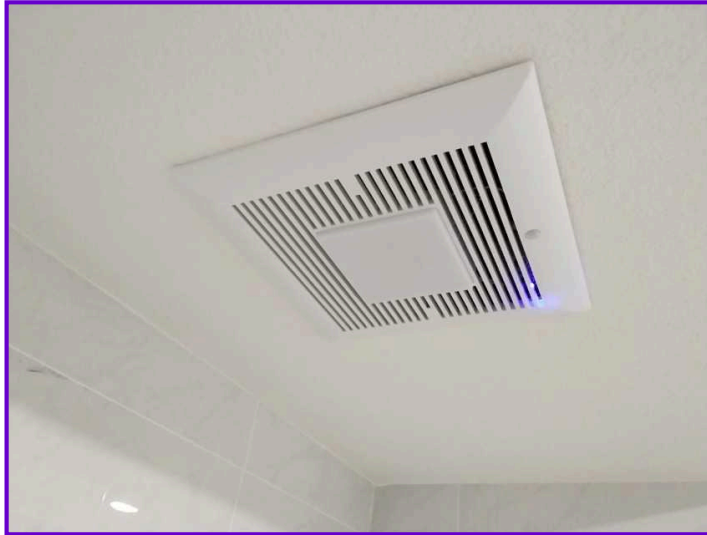
COMMENTS: The bathroom exhaust fans are functional.

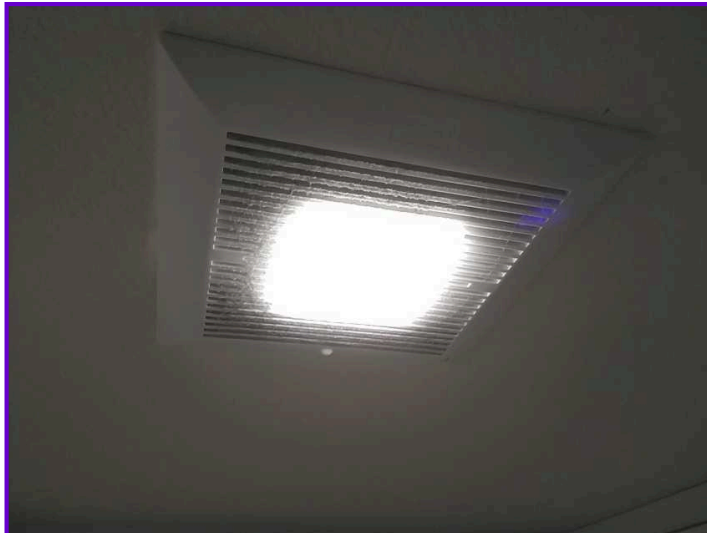
COMMENTS: The laundry room exhaust fan is functional.

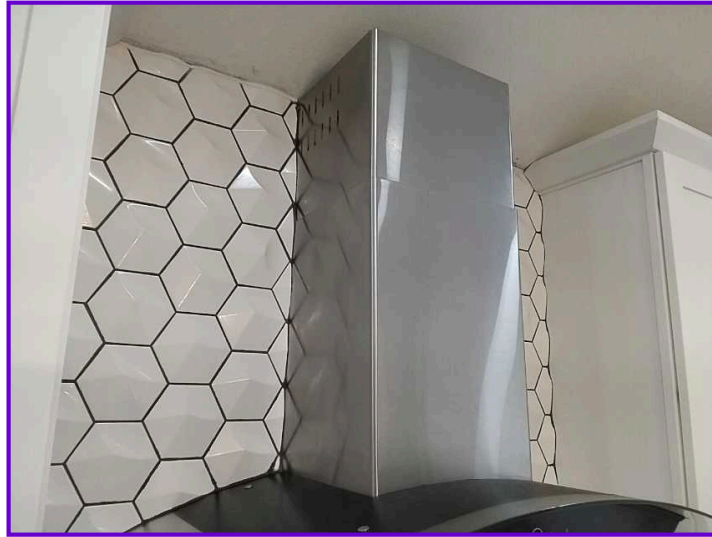
COMMENTS: The kitchen exhaust fan vents externally.

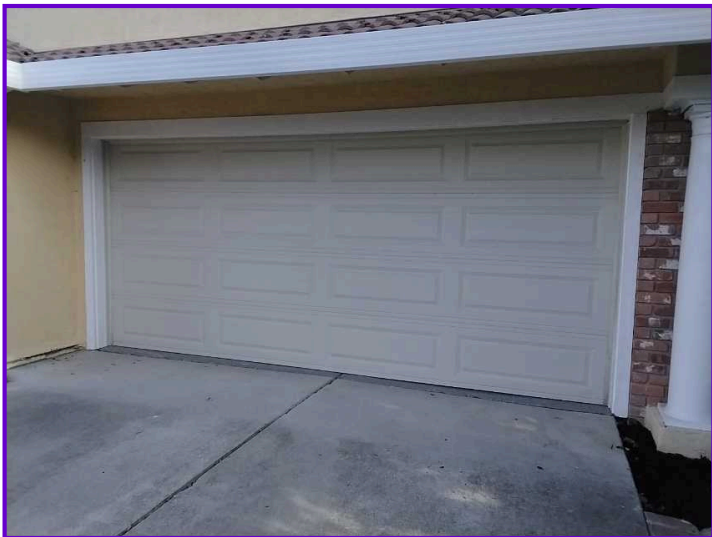
COMMENTS: The sectional garage vehicle door on the right functioned satisfactorily when tested using the automatic opener.

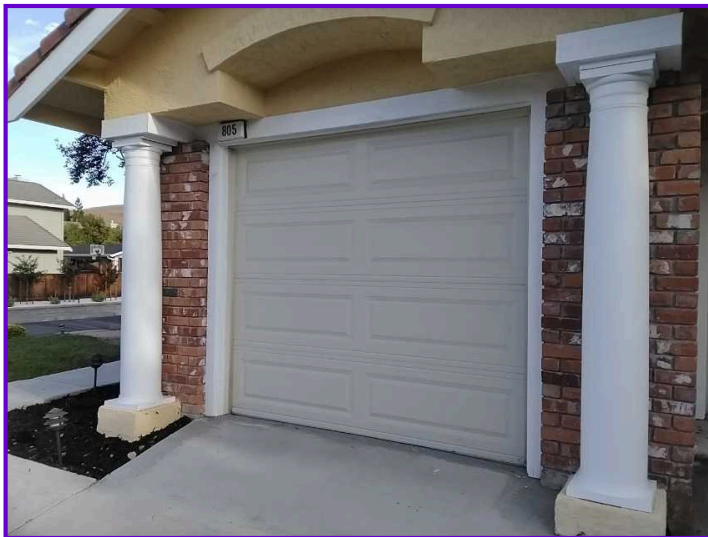
DEFERRED: The left garage vehicle door could not be tested.

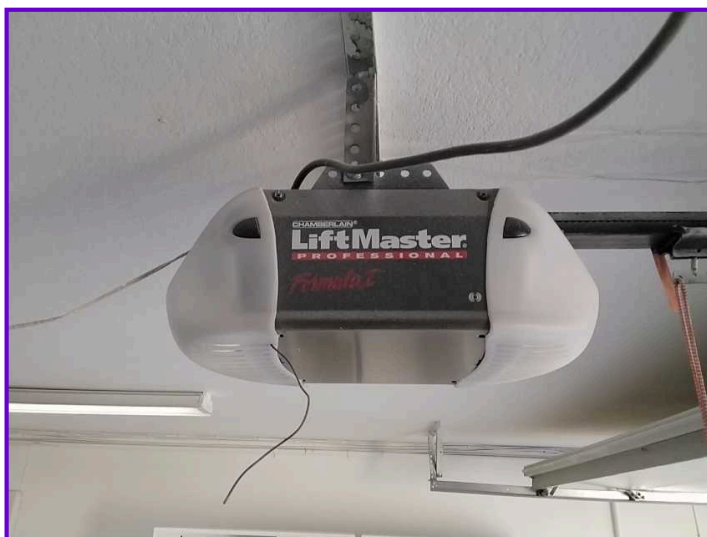
COMMENTS: The automatic garage vehicle door opener and auto reversing feature functioned satisfactorily when tested.

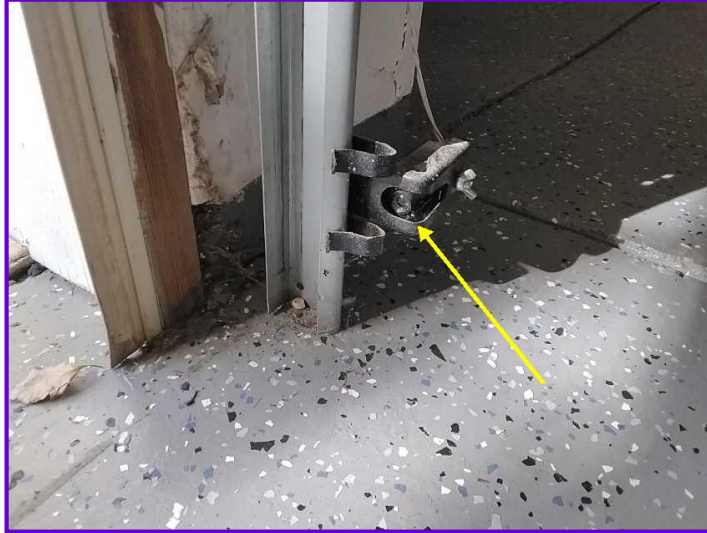
COMMENTS: The safety sensors at the garage vehicle door functioned satisfactorily.

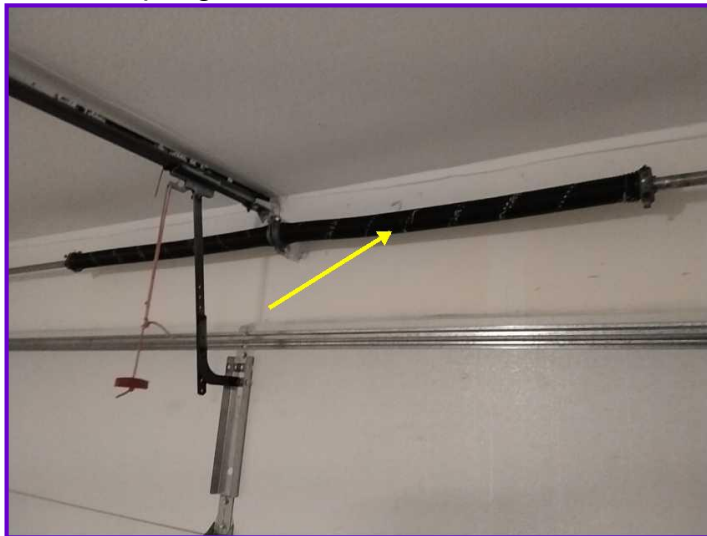
COMMENTS: The vehicle door spring and torsion bar are functional.

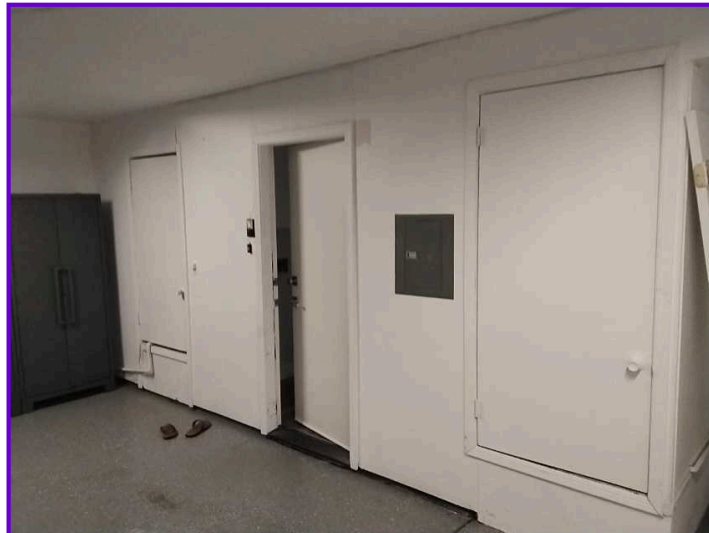
COMMENTS: Where visible, the firewall in the garage appeared to be in satisfactory condition.

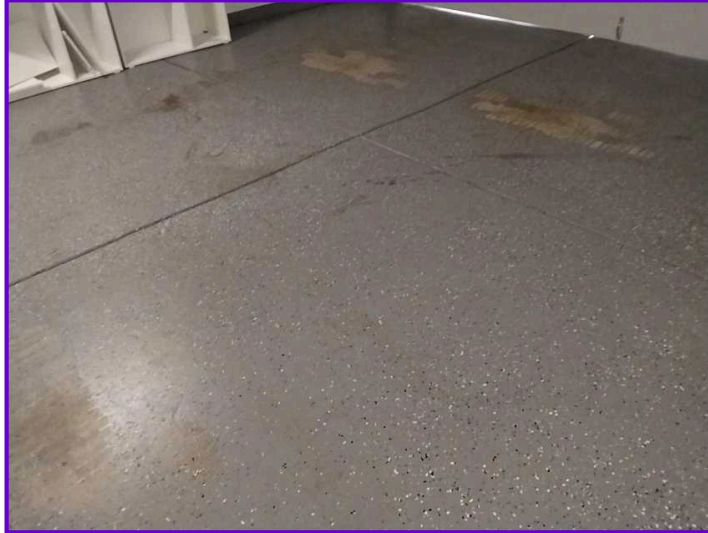
COMMENTS: Where accessible and exposed to view, we noted no significant abnormalities with the garage concrete slab foundation.
