PROPERTY INSPECTION REPORT

805 Eastbrook Court, Danville, CA 94506

DATE OF INSPECTION: 1/1/2025

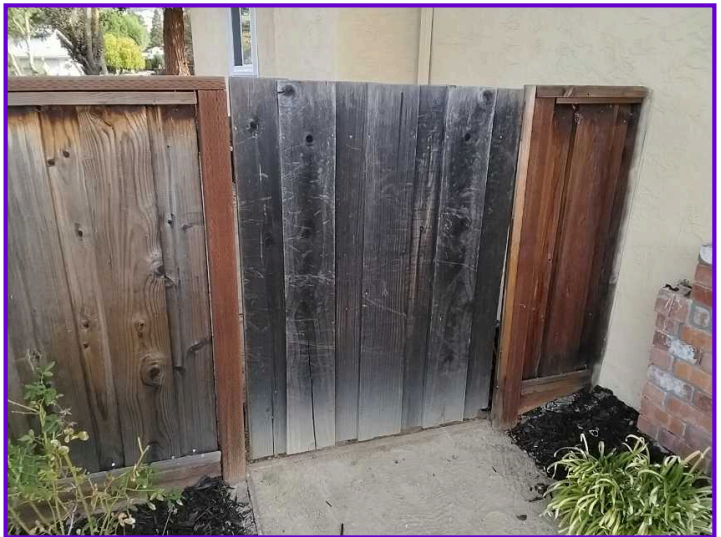
COMMENTS: The gating of the property is functional.

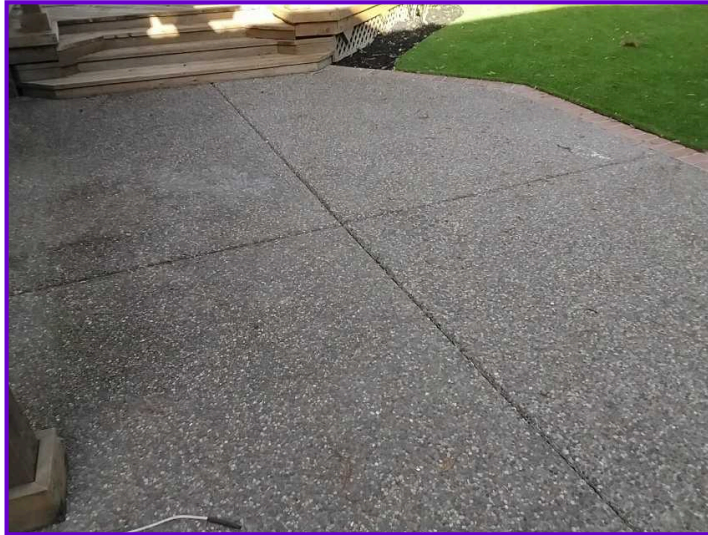
COMMENTS: The patio is functional.

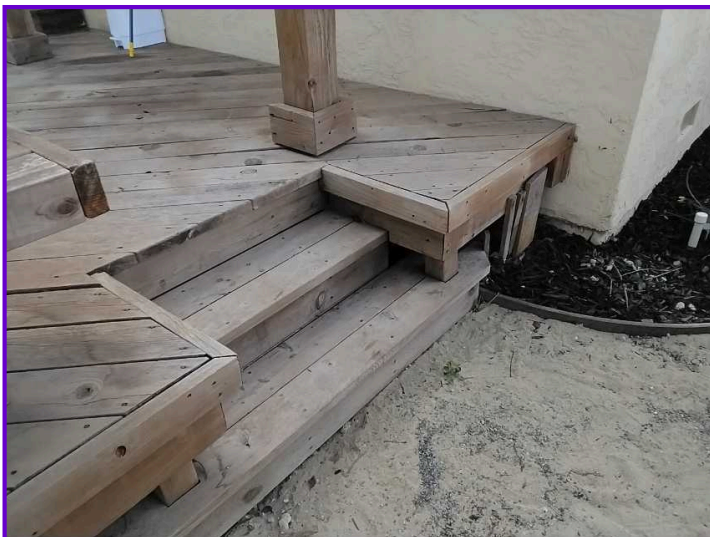
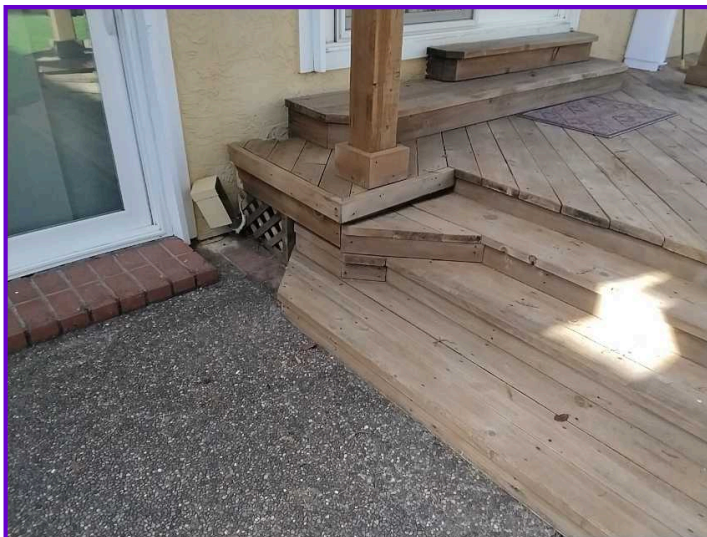
- COMMENTS: The handrails at the attached deck appear functional and secure.
- CAUTION: Handrails were not provided for the stairs at the residence. Standards require stairs with three or more risers have handrails that are grippable, a minimum of thirty-four inches high and with vertical pickets no more than four inches apart.

CAUTION: Handrails were not provided for the stairs at rear of the residence.

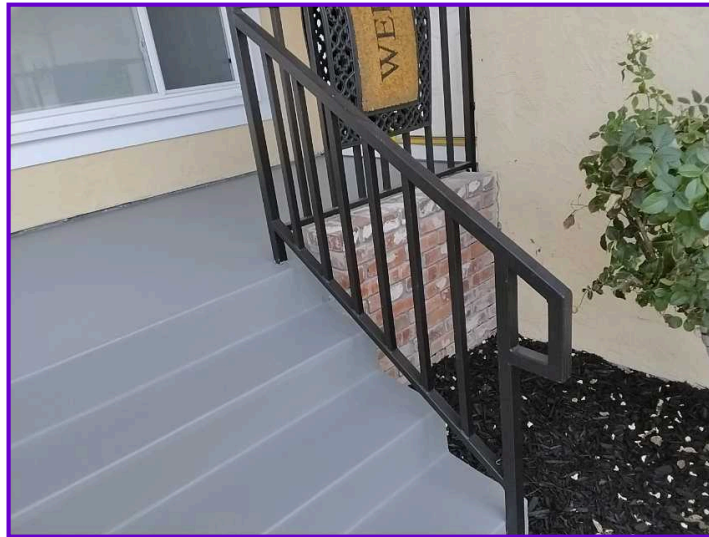
COMMENTS: The handrails at the attached deck appear functional and secure.

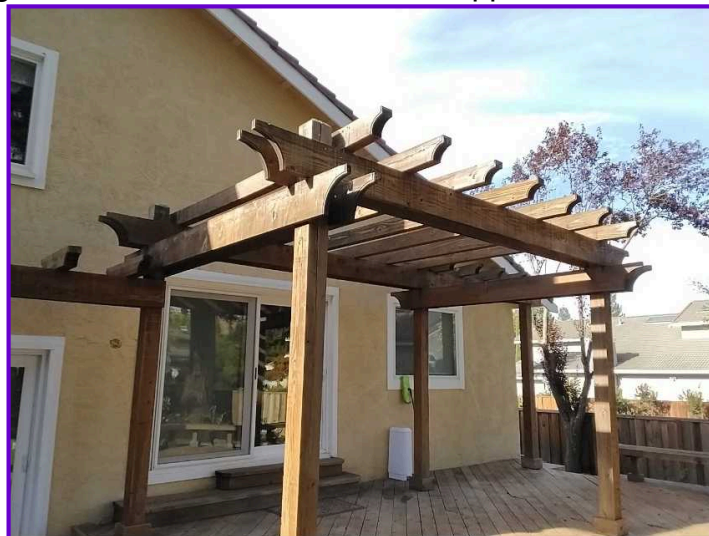
COMMENTS: The pergola at the rear of the residence appears functional.

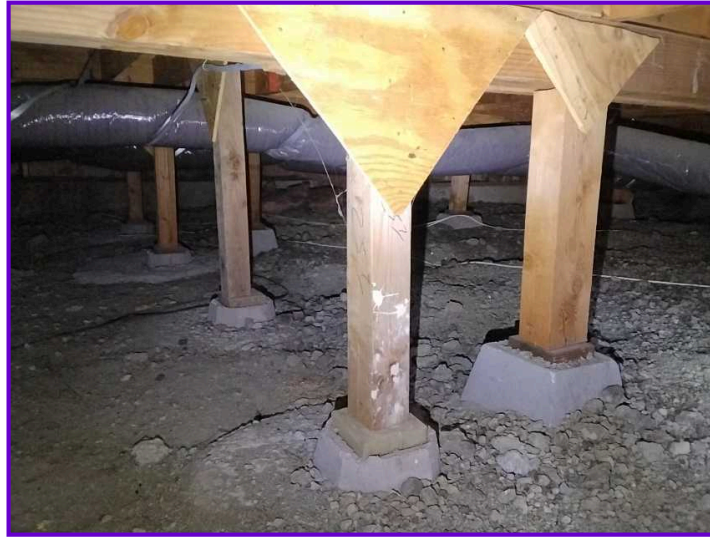
COMMENTS: Where visible and accessible, wood clearances from soil appeared satisfactory.

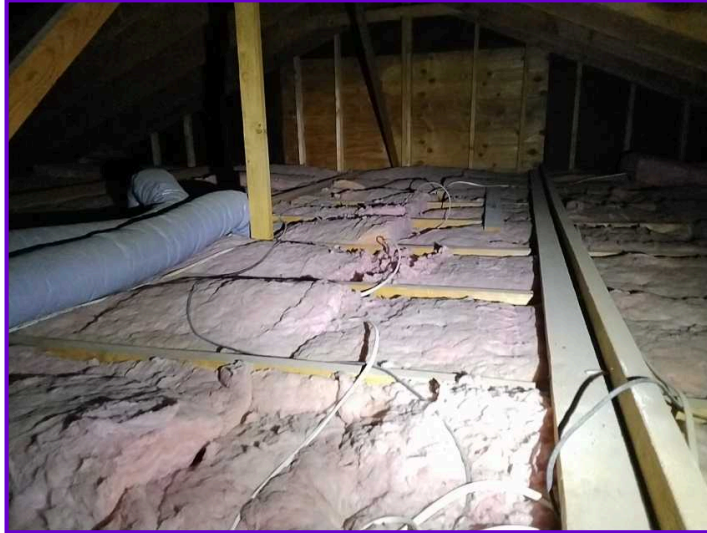
- **PREVENTIVE:** The attic floor is minimally insulated, which would not be considered adequate using current standards, and you may wish to add more for improved energy efficiency.

PREVENTIVE: The attic floor is minimally insulated.

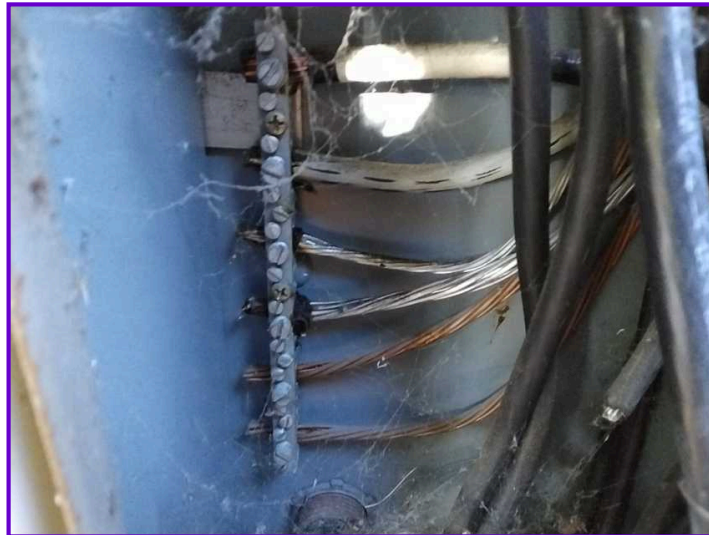
COMMENTS: The main electrical panel appears to be properly grounded.

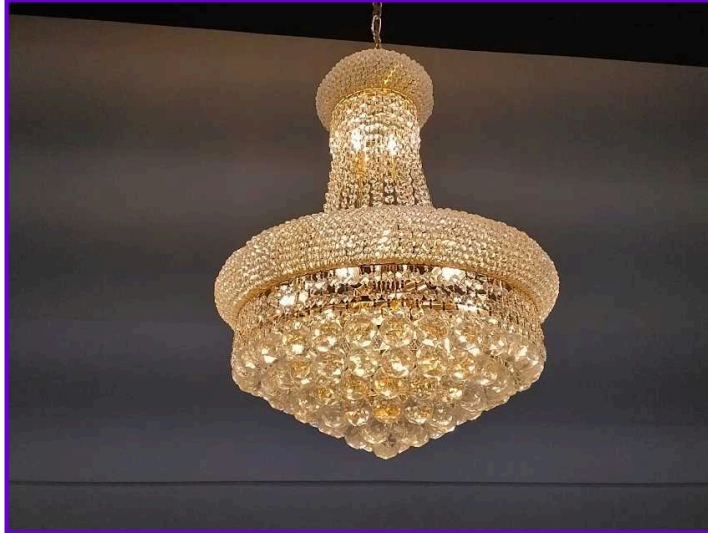
COMMENTS: The tested interior light fixtures were functional unless otherwise noted.

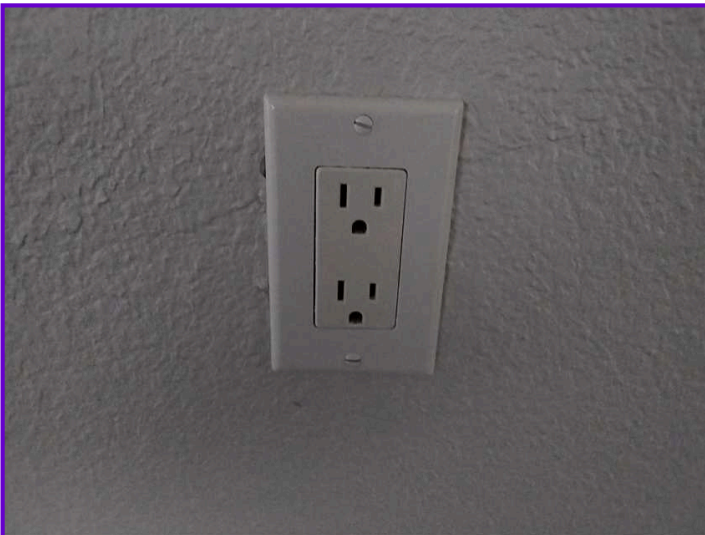
COMMENTS: The tested interior receptacle outlets were functional unless otherwise noted.

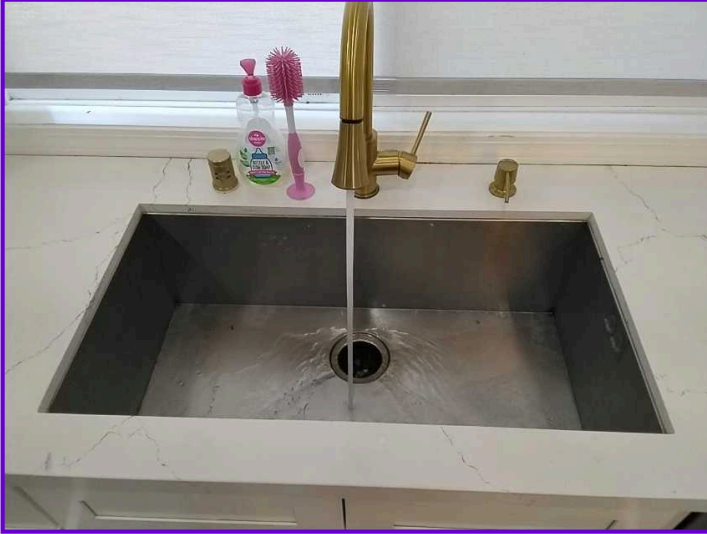
COMMENTS: The kitchen sink and related components are functional.

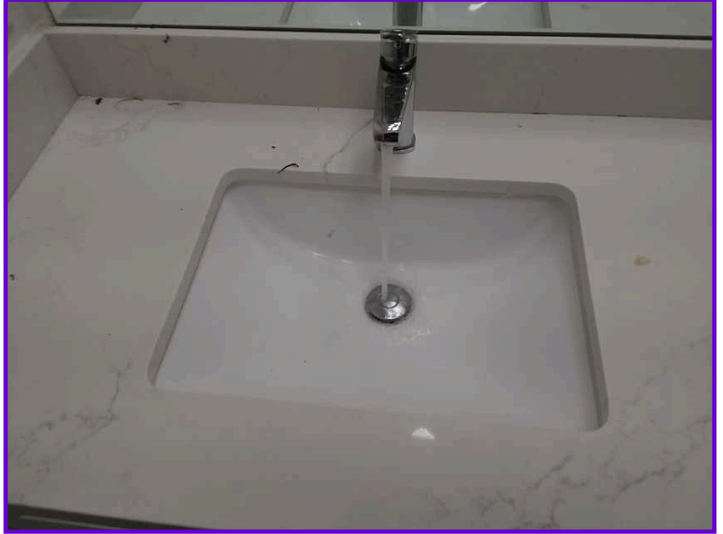
COMMENTS: The bathroom sink and related components are functional.

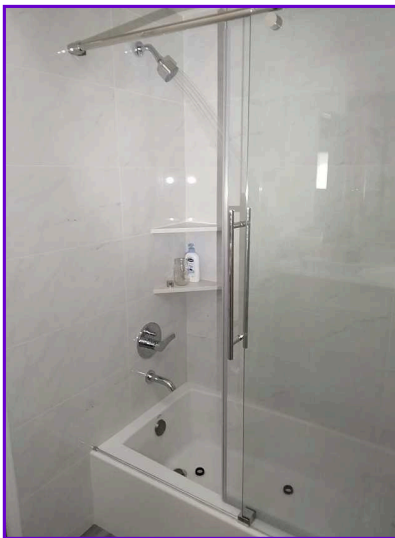
COMMENTS: The tub-shower is functional.

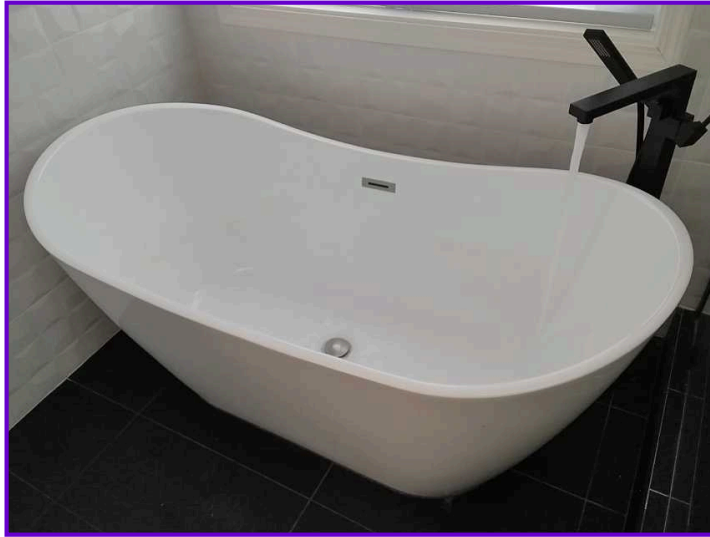
COMMENTS: The tub in the master bathroom is functional.

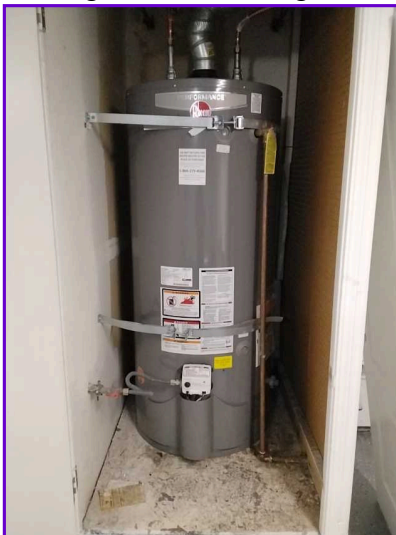
COMMENTS: The water heater was functioning satisfactorily at the time of the inspection, with no evidence of prior or active leakage observed.

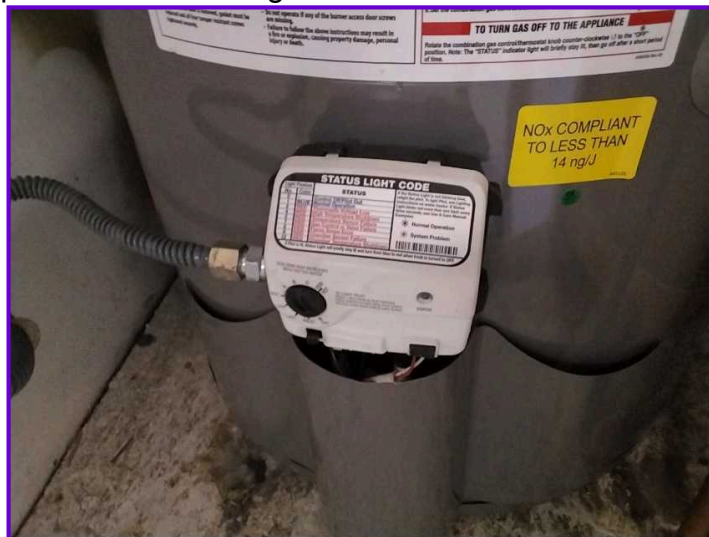
COMMENTS: The temperature and setting controls were functional.

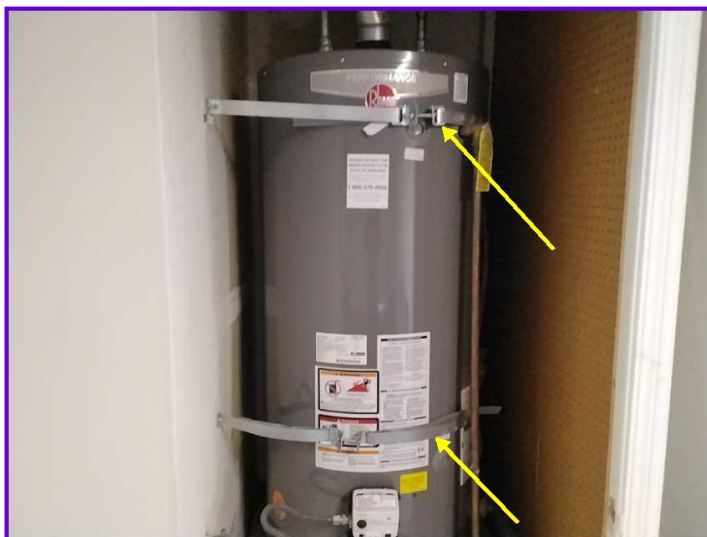
COMMENTS: The water heater is braced, anchored or strapped to help prevent falling or moving during an earthquake.

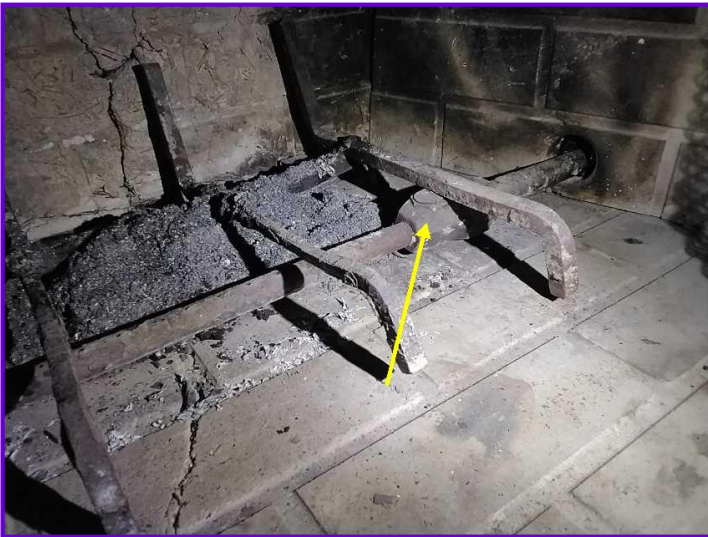
COMMENTS: The gas log starter in the fireplace appeared functional.

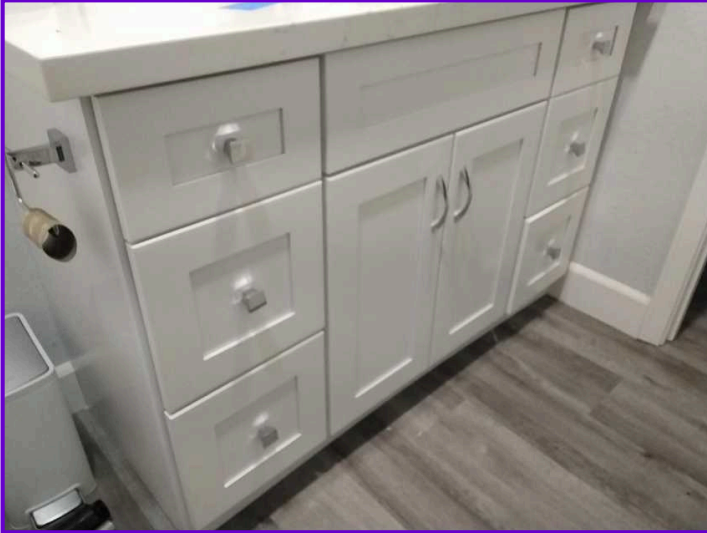
COMMENTS: The cabinetry is functional but may have minor wear that is commensurate with its age.

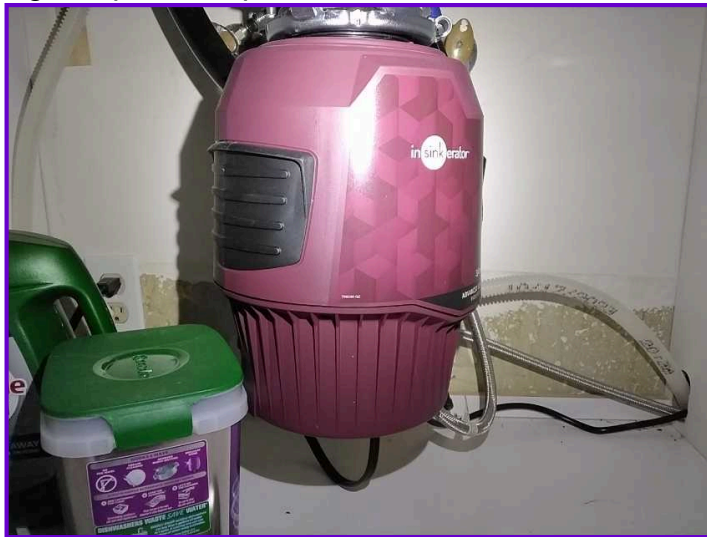
COMMENTS: The garbage disposal responded to normal user controls.

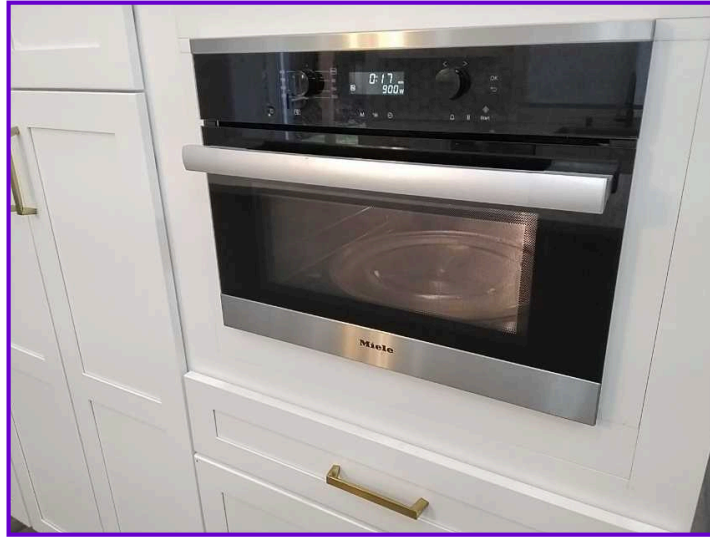
COMMENTS: The built-in microwave oven responded to normal user controls.

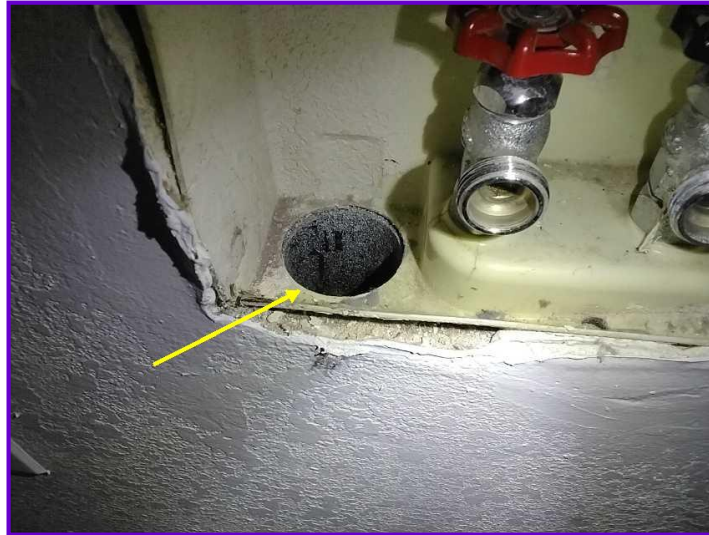
COMMENTS: There is a washer drain line present.

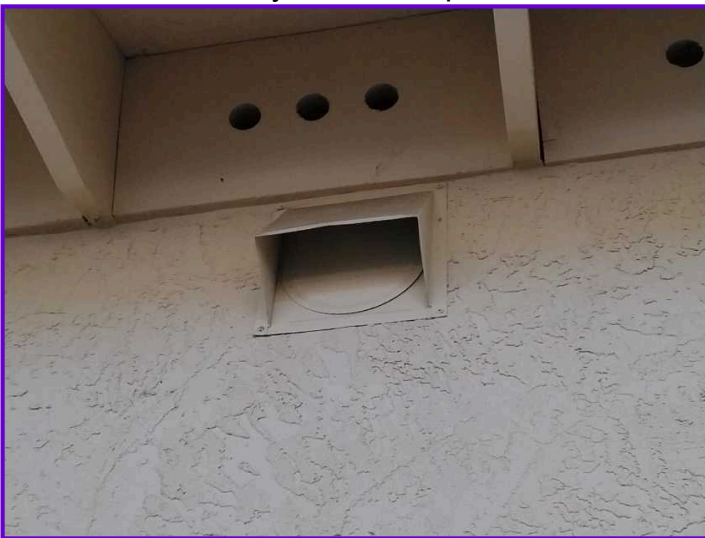
COMMENTS: Dryer exhaust provisions were satisfactory.

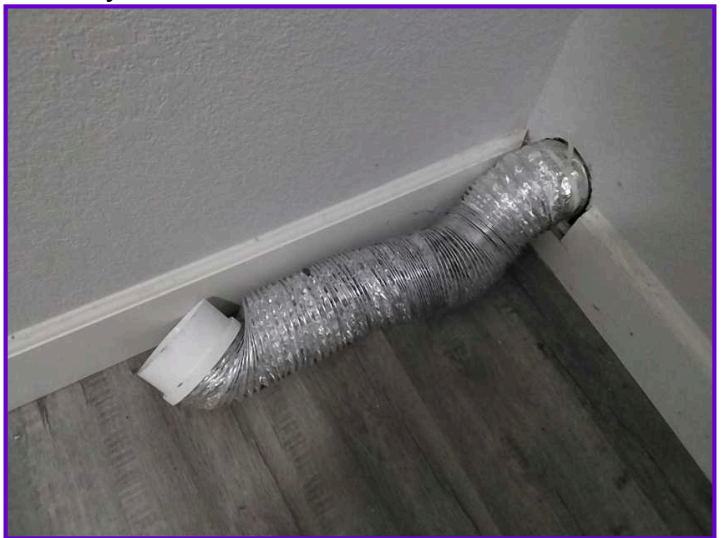
COMMENTS: Dryer exhaust provisions were satisfactory.

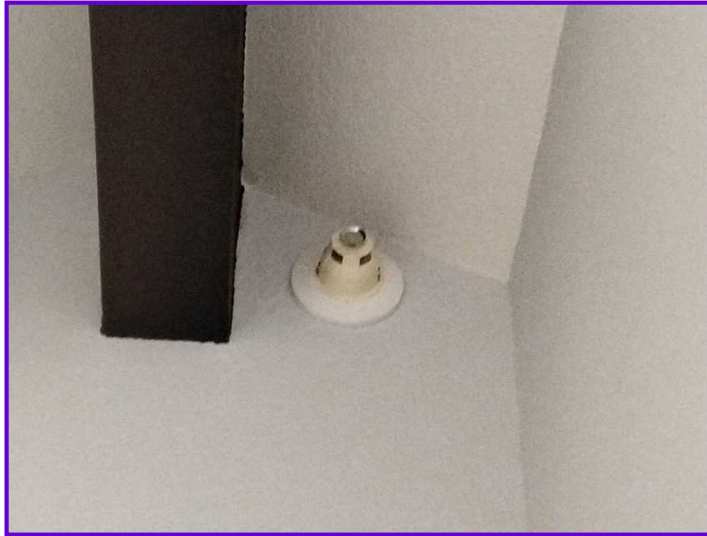
COMMENTS: There are smoke detectors in the bedrooms as required by current building and safety codes.

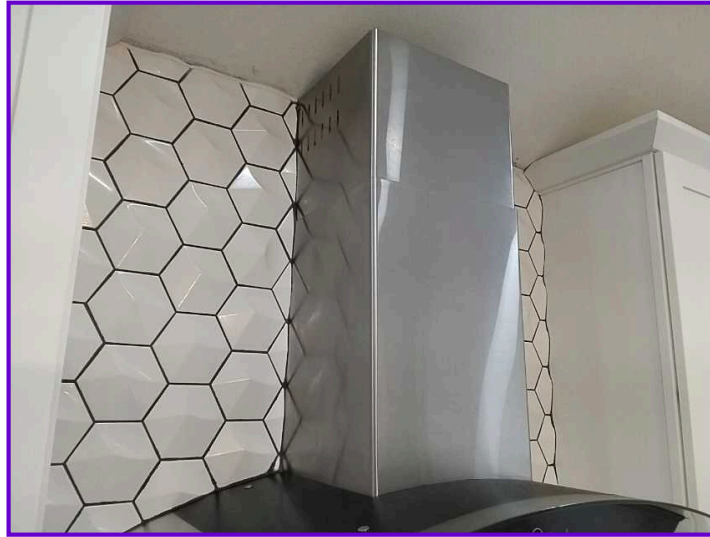
COMMENTS: The kitchen exhaust fan vents externally.

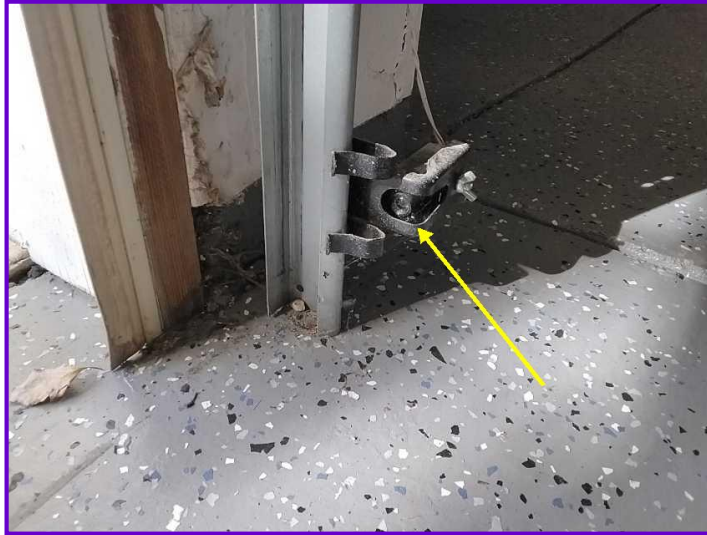
COMMENTS: The safety sensors at the garage vehicle door functioned satisfactorily.
